APPLICATION OF 3D SCANNING TECHNOLOGY IN RESTORATION OF HERITAGE SITE DAMAGED BY NATURAL DISASTER

Susanna Lai Kuen SIU

Antiquities and Monuments Office, Development Bureau, The Government of the Hong Kong Special Administrative Region of the People's Republic of China, 136 Nathan Road, Tsim Sha Tsui, Kowloon, Hong Kong, slksiu@amo.gov.hk

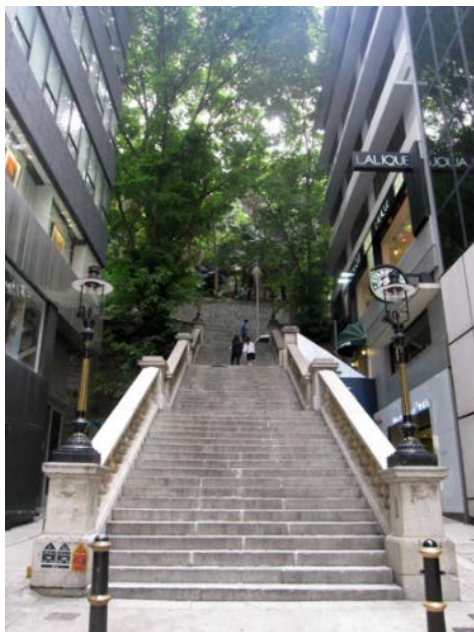
Figure 1: Duddell Street Steps and Gas Lamps, Central, Hong Kong before damage.

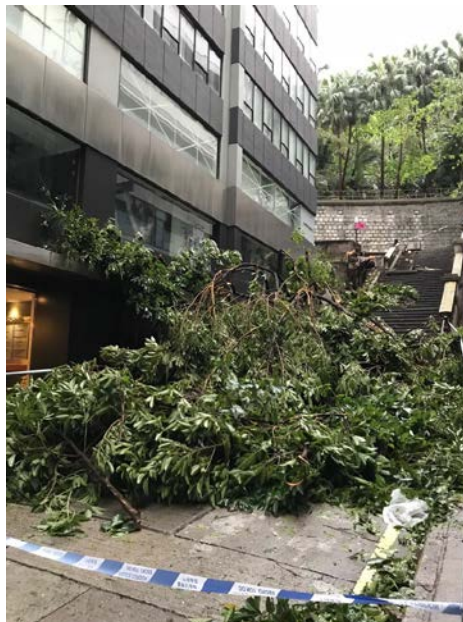
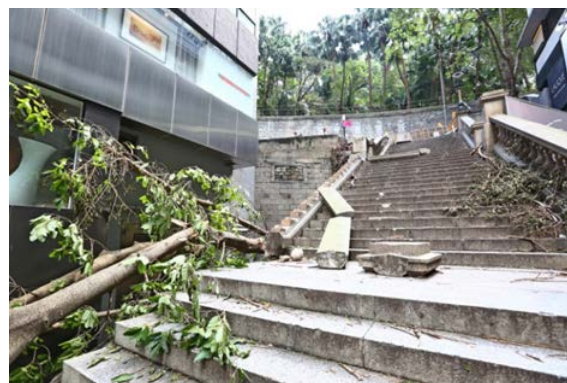
On 16 September 2018, Super Typhoon Mangkhut, which brought damaging winds and record-breaking storm surges to Hong Kong, blew down an adjacent large wall tree, causing significant damage to the monument. Looking up from Duddell Street, the granite handrail on the left had collapsed, and 47 out

of the 101 cement balusters were either badly crushed or broken into multiple fragments. Three out of the four century-old gas lamps had collapsed, and their lanterns had been severely damaged and deformed. Worse still, one of the gas lamp's cast-iron columns was broken into several pieces. The damage was so serious that the monument seemed ostensibly beyond repair.

Figures 2 and 3: The Steps were seriously damaged by the fallen wall tree.

The project team was determined to achieve a faithful restoration of the monument by reusing the damaged original materials and employing traditional craftsmanship. Immediately after the incident, the AMO, Highways Department ("HyD"), and The Hong Kong and China Gas Company Limited ("Towngas") began to document and salvage the broken pieces scattered across the site. In total, 280 damaged parts were salvaged,⁶ sorted and accessioned before being packed and relocated to storage for detailed inspection and safekeeping pending restoration. Regardless of its size, every single fragment of the monument was carefully recorded and collected for future restoration. At the same time, the AMO's staff conducted research on the Steps' history and past maintenance records from existing in-house archives and other media.

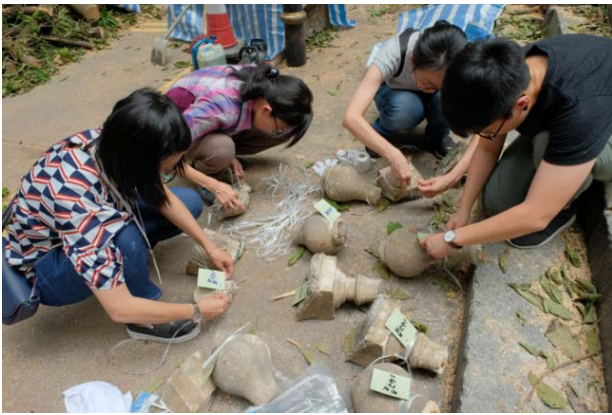
Figure 4: AMO staff salvaging and accessioning the broken parts of the Steps.

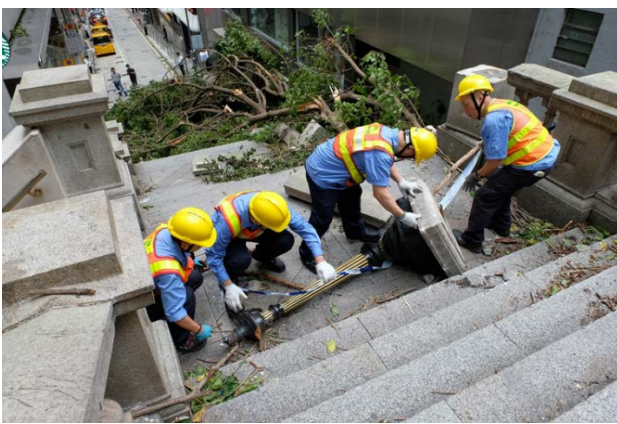
Figure 5: Towngas staff salvaging the broken cast iron column of the gas lamp.

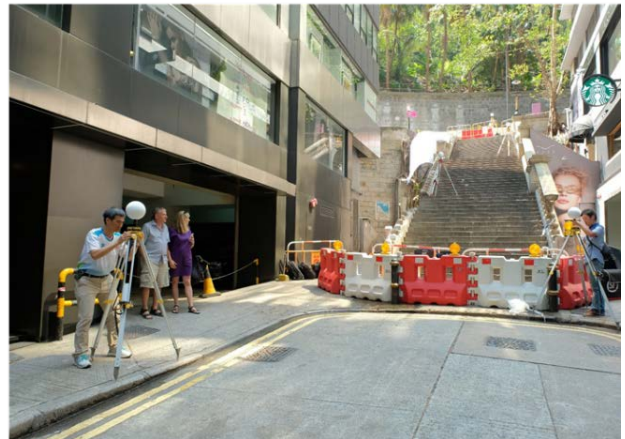
Given the sheer number and the huge size of some of the broken pieces involved, it was decided that 3D scanning technology should be used. The 3DSU scanned the damaged monument on-site in order to capture its condition after the incident. On 2 October 2018, once the site was cleared, a 3D scanning survey was conducted on-site using the terrestrial laser scanner to capture the post-incident situation and to help facilitate its later restoration. A total of 14 scans were made at a 6 mm resolution. While spherical reference targets were placed throughout the site in such a way that there were at least three common reference spheres present in adjacent scans, certain spherical reference targets were also placed over existing survey stations fixed by HyD. Back in the office, all the scans were registered into one and georeferenced horizontally to the HK1980 Grid coordinate system and vertically to the Hong Kong Principal Datum.

Figure 6: 3DSU conducting 3D laser scanning by terrestrial laser scanner on site after the damage.

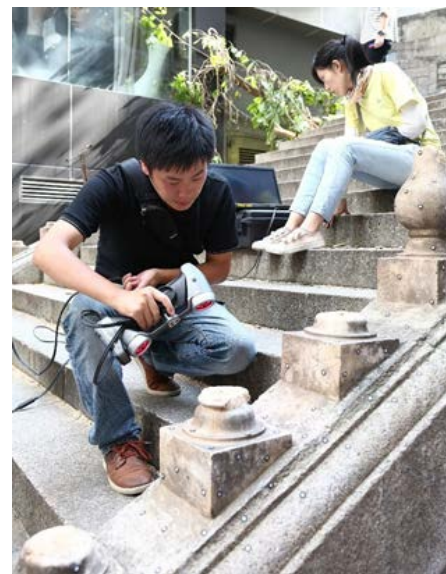
Another on-site 3D scanning survey was conducted using the portable 3D scanner to record the surviving structures at the sides of the Steps. Reflective targets were firstly attached to the surfaces of the Steps, and the scanning was then performed while its digital replica were constructed on the fly in the form of triangular meshes. Photographs were taken so that a photorealistic texture could, if necessary, be applied to the final mesh model.

Figure 7: 3DSU using a portable 3D scanner to scan the surviving structures on site.

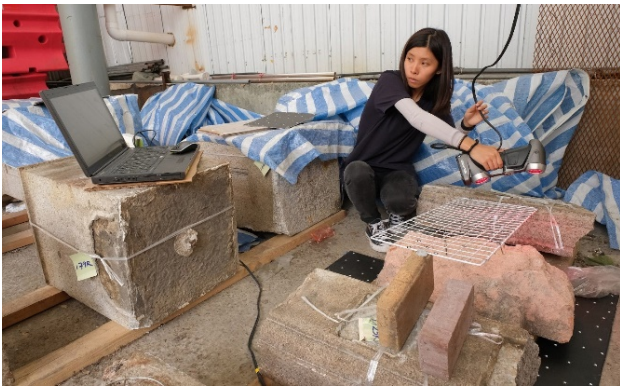
All major granite fragments relocated to HyD's store for temporary storage were also scanned using the portable 3D scanner in order to acquire accurate data for their shapes and dimensions. Instead of attaching the reflective targets onto the granite fragments, in this case they were stuck onto plastic or metal frames available at the store. Once prepared, these frames could then be placed stably over each granite fragment in turn, thereby reducing the set-up time and speeding up the scanning process. Photographs were taken to supplement the scanning data.

Figure 8: 3DSU using the portable 3D scanner to scan the large granite fragments at HyD's store.

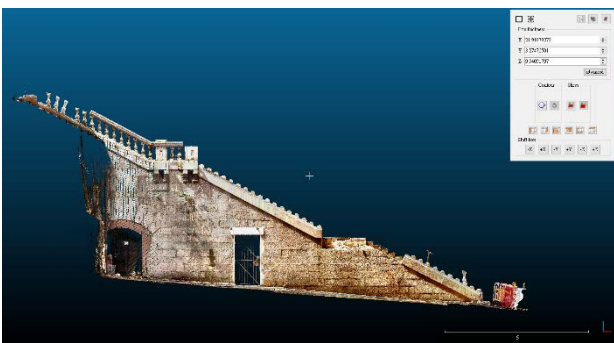
The incident scene and major granite fragments had been digitally captured in the form of a registered point cloud and triangular meshes, respectively.

Figure 9: Point cloud of the Steps obtained after damage.

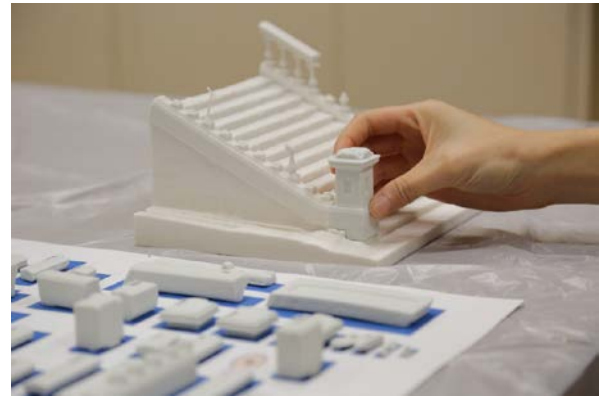
Miniature replicas of the granite fragments were 3D-printed and given numbers identical to those assigned to their full-size granite originals. These replicas were used for desk-top investigation and as a means of devising an appropriate

Figure 10: Miniature replicas of numbered granite fragments were 3D-printed and reassembled in the office.

restoration approach. They were also reassembled to reconstruct the scene in the office, which would help facilitate the fragments' future reassembly on site. The team reassembling the granite fragments on-site could then work according to the model and reassembly procedure prepared by the project team. The restoration work could thus be done accurately and efficiently. As a consequence, the time required and costs involved in the on-site restoration work were significantly reduced. More importantly, the level of inconvenience caused to the users of the Steps by their closure was greatly reduced.

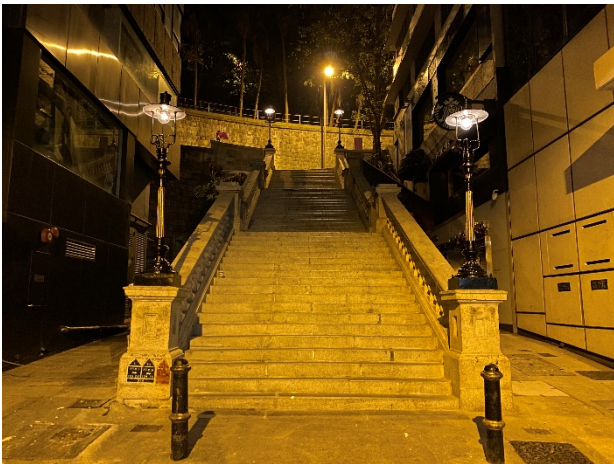
Figure 12: The Steps after restoration works completed.

After the completion of the restoration work, the 3DSU once again conducted 3D scanning to obtain a complete and up-to-date survey dataset for proper documentation of the fully restored monument.
