Assessing the Impact of the Türkiye February 2023 Earthquakes on Cultural Heritage Sites: A Multi-Disciplinary Approach Utilizing ARIA Maps and Social Media Collaboration

Keywords: Earthquake impact assessment, Cultural heritage, InSAR, Social media collaboration, ARIA Maps, Citizen Science

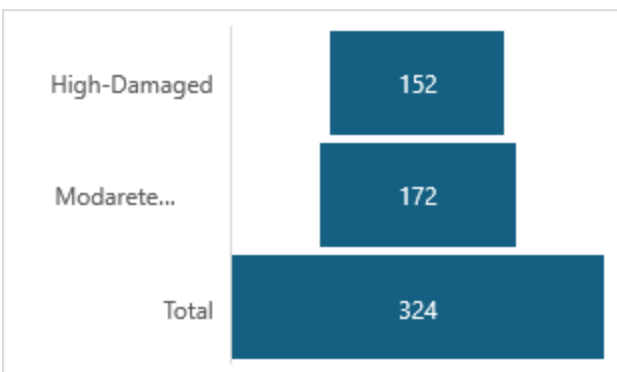
Figure 6. Total number of the damaged cultural heritage item

The damage has been clustered into 3 classes: high-damaged, damaged, and none, with the application of k-means clustering of ARIA maps. The total number of cultural heritage sites that are damaged according to the ARIA maps is shown as follows:

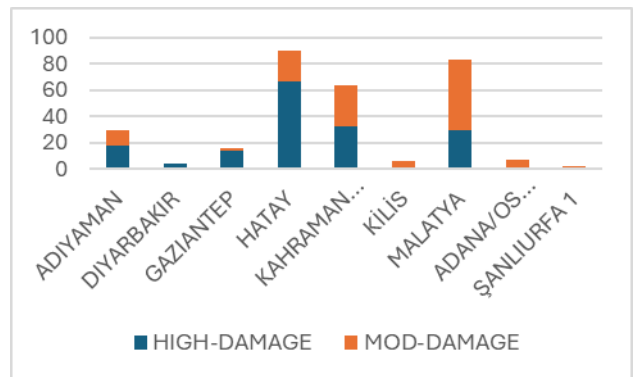
Figure 7. Number of damaged cultural heritage items per location

The damaged cultural heritage items per location is shown as following.

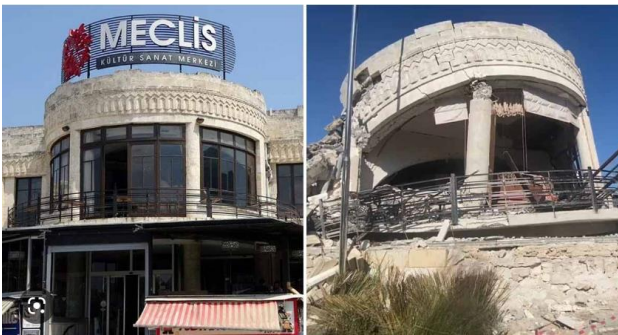
Figure 9. Hatay State Parliament Building before and after (source :[Kayipriitim web page](#))

A historic structure in Antakya, the provincial capital of Hatay, is the Hatay State Parliament Building, also called the Hatay Republic Parliament Building. It is very important historically because, from 1938 to 1939, during the short life of the Hatay State, it housed the parliament. The Ottoman Empire and the French Mandate of Syria and Lebanon were overthrown, and the Hatay State was founded. Türkiye and Syria both claimed the area that was once known as Alexandretta, or Hatay. The Republic of Hatay was established in 1938 after talks and a referendum; it later gained some degree of independence but remained influenced by Türkiye. When the Hatay State briefly gained independence in 1939, it was united with Türkiye by a popular referendum, and the parliament building functioned as its political centre. During the February 2023 EQ, the building was significantly damaged, as shown in the following Figure 9. Our analysis shows that the east-west displacement is -0,476 m, the north-south displacement is 0.952 m, and the line of sight displacement of the ascending direction is -0.33 m.

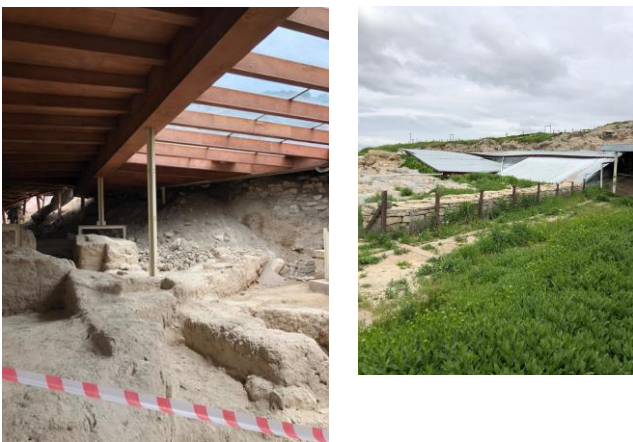
Figure 10. Damage on Arslantepe Mound.

As shown in the above Figure 10, slight damage has been seen with the falling roof on the ground. Our analysis shows that there is moderate damage in the field with -0.48 m, 0.05 m, and -0.08 m NS, EW, and LOS displacements, respectively.

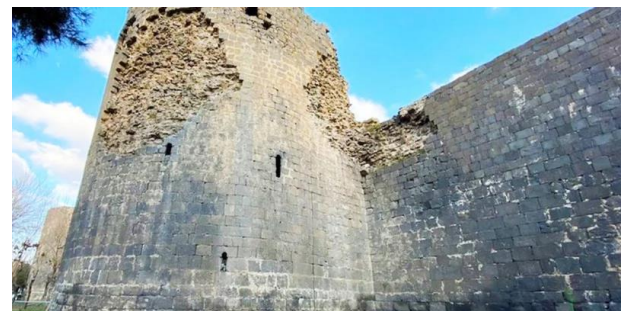
Figure 11. Damaged Fortress (Image source: [Yesil Gazete](#))

The Diyarbakır Fortress and Hevsel Gardens comprise an important cultural environment on an escarpment in the Upper Tigris River Basin. This location has served as an important centre throughout history, from the Hellenistic, Roman, Sassanid, and Byzantine periods to the Islamic and Ottoman periods and up to the present. The stronghold is notably notable for its spectacular city walls, which span 5.8 kilometres and include numerous towers, gates, buttresses, and 63 inscriptions from various historical periods. These walls, built of basalt, have undergone several modifications throughout the ages, reflecting the craftsmanship and architectural styles of their various times (UNESCO, 2024). Our analysis shows moderate damage to the site in the ARIA maps.
