Multi-temporal Monitoring for Road Slope Collapse by Means of LUTAN-1 SAR Data and High Resolution Optical Data

Xiang Zhang, Xinming Tang, Tao Li, Xiaoqing Zhou, Haifeng Hu, Xuefei Zhang, Jing Lu

Land Satellite Remote Sensing Application Center, Ministry of Natural Resources of P.R. China

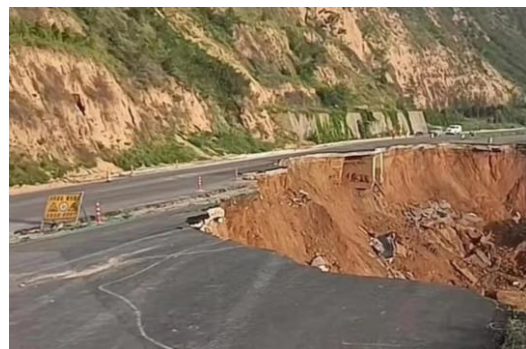
Figure 1. Collapse area of 108 national highway.

On August 10, 2023, slope collapse occurred in Pucheng section of 108 National Highway in Weinan City, Shaanxi Province in China. The Land Satellite Remote Sensing Application Center of the Ministry of Natural Resources conducted pre-disaster deformation monitoring of the collapse area by using L-SAR satellite images. The collapse area in Weinan, Shaanxi Province had a shape variable of more than 6 cm within 16 days. According to the preliminary judgment of internal industry, there had been a short-term obvious deformation before the collapse. The west side was adjacent to the 108 National Highway, and the collapse caused the interruption of the road. The collapse area is located at the 108 National highway K16+600 to K16+900, the collapse of the body about 200 meters long, about 400 meters wide, about 2.5 meters thick, the total square of about 200,000 square, the collapse caused by the quake lake about 200 meters long, about 4 meters wide

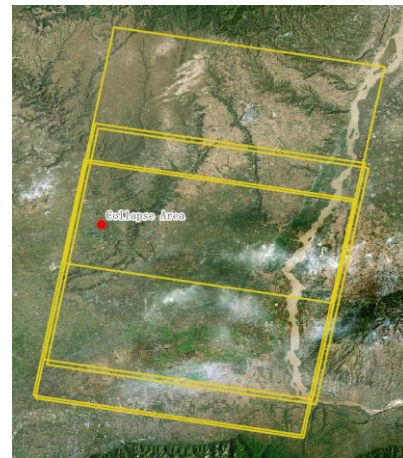
Figure 2. Study area and Lutan-1 covered area.

The road slope collapse is located in Pucheng section of 108 National Highway in Weinan City, Shaanxi Province in China, shown as Figure 2. The collapse area is near the Luo River, due to the soil collapse the total square of about 200,000 square, which induced the Channel blockage. Earth poured into the Luo River and blocked its channel, forming a barrier lake with a reservoir of about 650,000 cubic meters. It poses a threat to the safety of life and property of people downstream.

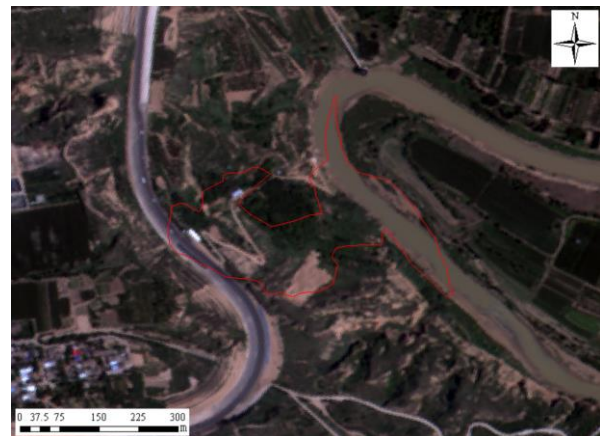
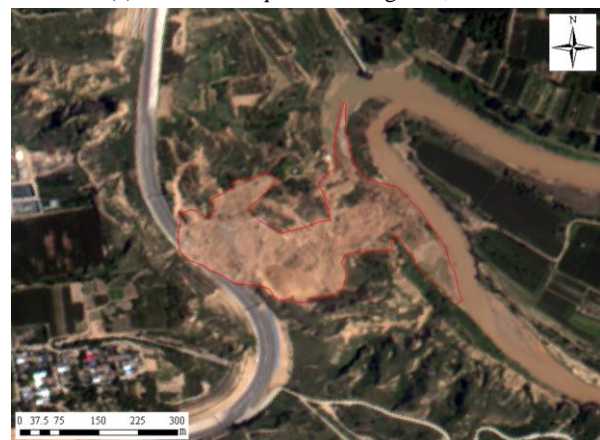
Figure 7. Gaofen-2 optical data before and after the collapse

The optical images of Gaofen-2 acquired on August 5, 2023 and August 15, 2023 are used to compare the changes before and after the collapse. It can be seen that the west side of the collapse area is close to the 108 National Highway, and the lower edge of the collapse slope body is the Luohe river, which interrupted the road, and the collapse body rushed into the river and caused a small dammed lake.

(a) Gaofen-2 acquired on August 5, 2023

(b) Gaofen-2 acquired on August 15, 2023

Multiple temporal Gaofen-7 and Gaofen-2 optical data with high spatial resolution was employed to analyse the road slope collapse. Before and after the collapse, there are obvious spectral characteristics variations over the disaster area, which can help us to identify the range and influence of collapse. The results indicated that the range of the collapse area was clearly characterized based on the high spatial resolution of Gaofen-7 and Gaofen-2 optic data, shown as Figure 7 and Figure 8.

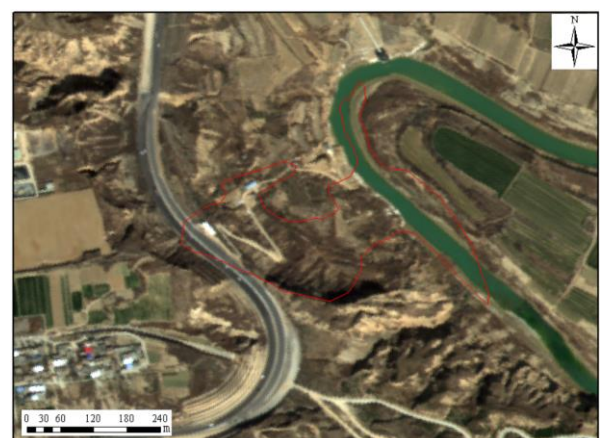
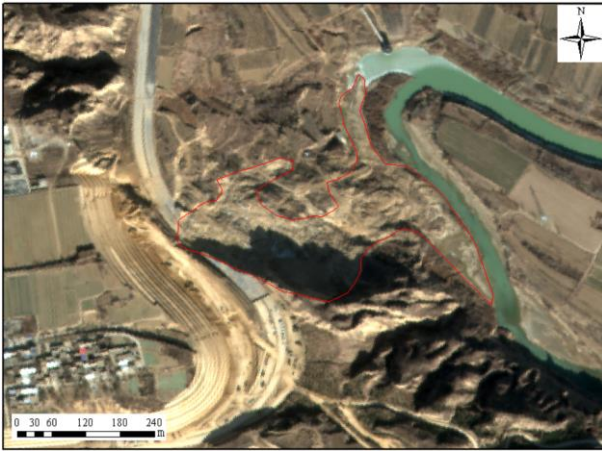
(b) Gaofen-7 image acquired on Junaray 3, 2024
Figure 8. Gaofen-7 optical data for collapse monitoring

In comparison with Gaofen-7 data before and after the collapse, the obvious collapse area can be extracted. In addition, the road was diverted due to the collapse, and the construction of roads and infrastructure is also evident in the image acquired on January 3, 2024.

(a) Gaofen-7 image acquired on March 14, 2023

The interference processing with Lutan-1 data before and after collapse cannot obtain effective deformation information because the collapse body changes significantly and the coherence deteriorate. The effective information of the collapse area is obtained by high resolution optical data before and after the collapse. In particular, the data of Gaofen-2 was acquired around the time of the accident collapse, which well characterized the collapse range. The data before and after the collapse of Gaofen-7 were also obtained. Due to the time interval, the surface changed obviously. Meanwhile, the construction situation of the national highway diverted due to the slope collapse was effectively monitored in Gaofen-7 data after the accident.
