Analysis of morphological changes under controlled environmental conditions using UAV image-based bathymetry in very shallow waters

Paulina Kujawa ¹, Jaroslaw Wajs ¹, Damian Kasza ¹

¹ Department of Geodesy and Geoinformatics, Wrocław University of Science and Technology, Wrocław, Poland - (paulina.kujawa, jaroslaw.wajs, damian.kasza)@pwr.edu.pl

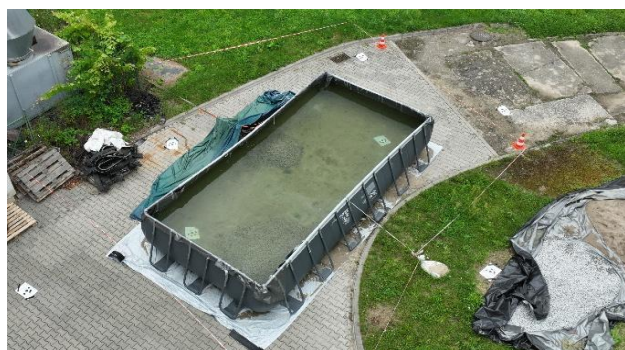
The experiment was performed in a finite-sized water reservoir with dimensions 7.3 m × 3.7 m and a maximum depth of 1 m. It replicates the shallow water of a coastal area (see Figure 1). The bottom of the tank is composed of river sand and rocks (aggregate). The water is highly transparent, ensuring full visibility of the bottom. The water depth is maintained at approximately 0.8 m

Figure 1. A study site with a pool simulating shallow waters.

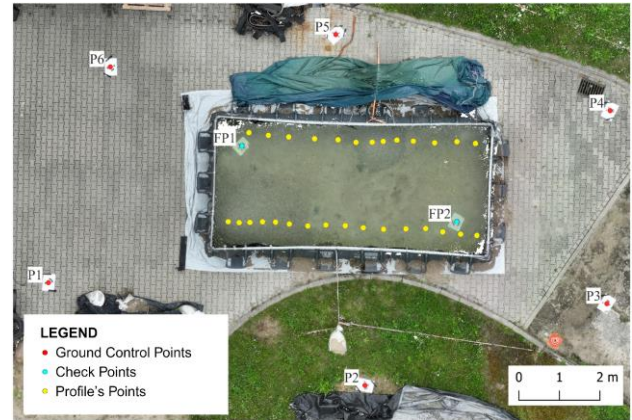
Photogrammetric processing was performed in Agisoft Metashape Professional, version 2.2.1. Localization of each GCP is shown in Figure 3. The quality metrics are summarised in Table 1. There is a noticeable variation in RMSE values between scenarios, probably due to differences in environmental conditions during data collection. Although the measurements were performed in a repeatable manner using the same methodology and equipment, some days were cloudy while on others there were local sun glints on the water's surface. As the

Figure 3. The study site with the location of the GCPs, CPs and profile's points.

The corrected point clouds were then compared with the GNSS-measured profiles (included in Figure 3). The results of this comparison are shown in Table 3. An accuracy assessment based on bottom profiles revealed a negative ΔZ following refraction correction, with respective averages of -20 mm and -32 mm for low and high flights, and standard deviations of 11 mm and 27 mm, respectively. For each pair (a and b), the flight at a higher altitude resulted in a more negative bias and greater dispersion. This can be attributed to the influence of a greater GSD and lower reconstruction precision. The best fit was obtained in scenario 2a, with an average bias of -11 mm and a standard deviation of 7 mm. The largest dispersion was observed in scenario 3b, with an average bias of -38 mm and a standard deviation of 38 mm.

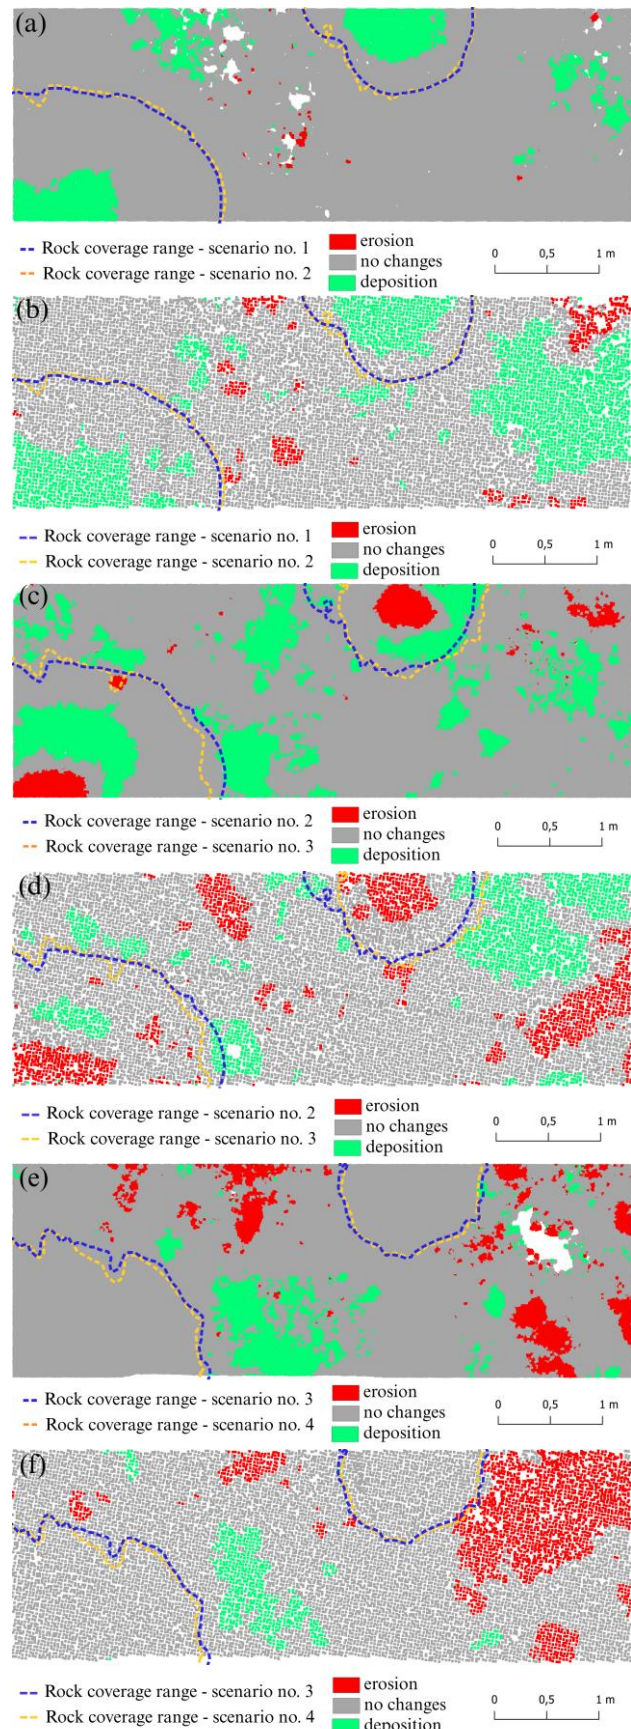
In the next stage, the LoD_{95} was calculated for each pair of epochs and used as the threshold to classify morphological changes. The results obtained for the uncertainties are presented in Table 4. Morphological changes were analysed using the M3C2 method to compare scenarios with different flight altitudes. The results of the identified zones of erosion, no changes and deposition are shown in Figure 4. The photogrammetric uncertainty values ($\sigma_{sfm,z}$) and water surface model error values ($\sigma_{ws,i}$) for each scenario range from 3 to 11 mm, confirming the high quality of the reconstruction. The LoD_{95} values determined for the compared pairs of scenarios range from 25 to 35 mm. Lower thresholds (25–27 mm) were obtained for flights at lower altitudes (scenarios a), while higher thresholds (32–35 mm) were observed for flights at higher altitudes (scenarios b). This suggests that the model's accuracy and capacity to detect subtle morphological changes decrease with increasing flight altitude. This is consistent with the discrepancies observed in the accuracy of control points and the outcomes of bottom profile comparisons.

Figure 4. Morphological change detection between scenarios: (a) no. 1a and 2a; (b) no. 1b and 2b; (c) no. 2a and 3a; (d) no. 2b and 3b; (e) no. 3a and 4a; (f) no. 3b and 4b.

The resulting classes of morphological change were used to compare pairs of scenarios and are presented in map form. The visual results are consistent with the assumed morphological manipulations and accuracy analyses:

- (i) Epochs 1–2: only simulated accumulation was applied between these epochs. The maps show sedimentation zones dominating, with only occasional erosion zones. This may be the result of sand surface reconstruction, for example due to high sand surface roughness, limited contrast or turbidity.
- (ii) Epochs 2 and 3: erosion and deposition simulations were applied to both types of substrate. The maps show the presence of these processes.
- (iii) Epochs 3–4: During this period, only sand sedimentation and erosion processes were applied. Changes are concentrated in sandy areas, while rocky areas remain unchanged.
