## SLAM-based survey supporting vulnerability assessments of built heritage at risk

**Keywords:** SLAM-based systems; 3D model assessment; vulnerability assessment; historical churches; structural analysis.

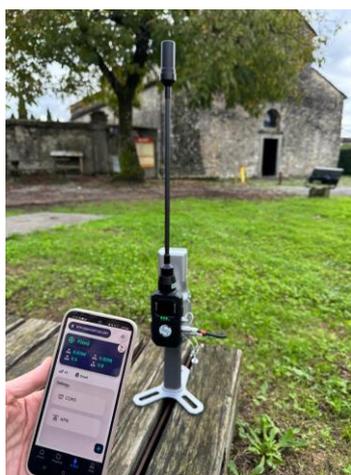
Figure 3. Stonex X70GO with RTK module during fieldwork.

The survey of the churches was carried out using Stonex's portable SLAM X70GO system, equipped with a GNSS-RTK module that allows direct georeferencing of the acquired data (Figure 3). The scans, conducted both inside and outside the buildings, were planned following ring paths, a useful strategy to strengthen the acquisition geometry and reduce drift, a major criticality of SLAM systems.

Each SLAM-based system has specific characteristics that influence its performance, versatility and operating times. The main differences concern the physical configuration of the instrument, the type and number of LiDAR sensors, the presence of cameras, the availability of a RTK module for georeferencing (Table 1).

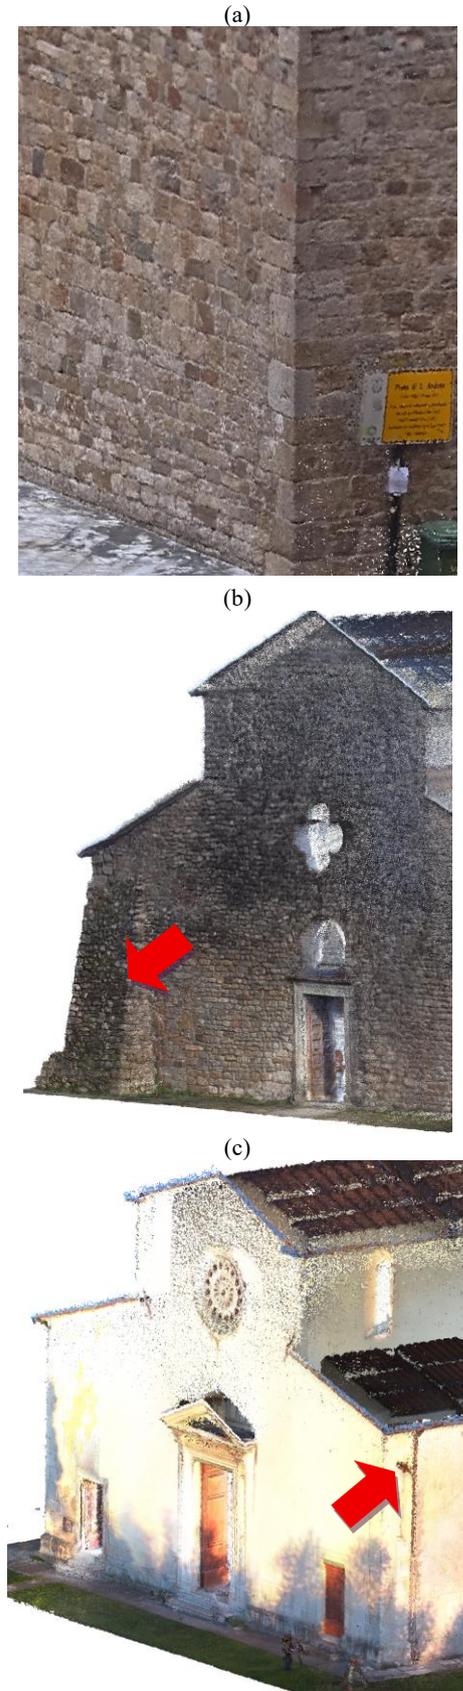
Figure 4. Analysis of earthquake-resistant structures and elements in the collapse mechanisms: bonding in Church of Sant'Andrea (a), contrast element in Church of Sorano (b), tie-rod anchor in Church of Santo Stefano (c).

Figure 4 exemplify how observing the model allows us to recognize and qualify the elements being evaluated. In this case, the evaluation is done simply by observing the 3D model, assumed as the digital referent of the real building. Considering the façades of various churches, some of the elements whose presence and characteristics contribute to the Level LV1 assessment are highlighted.

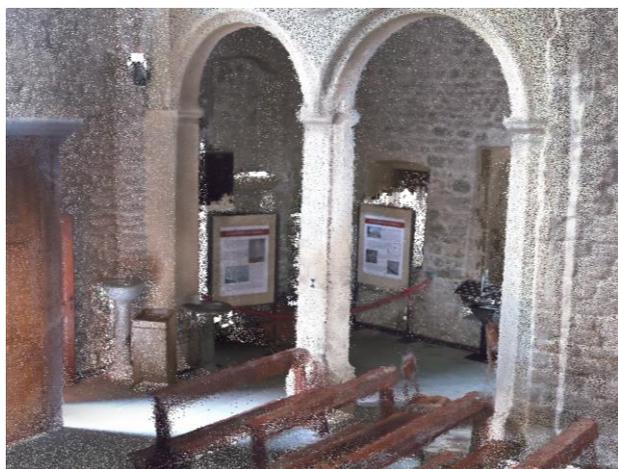
Figure 12. Church of Sorano: the panel used for noise analysis.

**3.3.1 Noise:** A test was conducted to quantify noise in data acquired by the X70GO system, with the aim of providing an operational characterization of the measurement noise under typical acquisition conditions rather than an absolute sensor calibration. A planar reference surface (about 1 m x 1 m) was then extracted directly from the SLAM survey of the Church of Sorano, and used as a geometric reference (Figure 12). The validity of this reference was assessed by comparing planes estimated from different range-limited subsets of the data, yielding angular differences between plane normals on the order of  $0.01^\circ$  and offsets below 0.3 mm, which are negligible with respect to the observed residual dispersion. Based on this validated reference, the noise was estimated from the orthogonal residuals to the plane and characterized using RMS; given the close agreement between RMS and robust MAD estimates across all tests, RMS values are reported as representative noise metrics (Table 2).

The estimated noise level on two independent dataset, acquired along a different trajectory but covering the same surface, is approximately 2.5 mm for close-range acquisition (within 5 m), increases to about 2.6 mm for typical indoor acquisition (within 10 m), and reaches approximately 2.8 mm when no range filtering is applied, reflecting a mixed-range operational scenario.

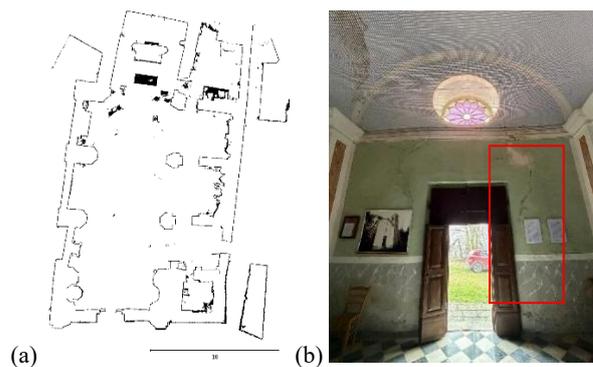
Figure 13. Church of Vico: (a) plan, (b) counter-façade (photo). Cracks on the counter-façade: point cloud (c) “standard” and (d) “densified”.

Given an estimated measurement noise of approximately 2.5–3 mm ( $1\sigma$ ) under the considered operational conditions, the reliable geometric detectability of crack-related features is expected only for amplitudes significantly larger than the noise level, typically beyond  $3\sigma$  ( $\approx 1$  cm) in real-world data. Features with amplitudes on the order of  $2\sigma$  ( $\approx 5$ –6 mm) lie at the detection limit and may be identified only under favourable sampling and incidence conditions, often requiring complementary cues (e.g., intensity/RGB contrasts or point dropout patterns) rather than metric depth measurements. Figure 13 shows a vertical fracture next to the entrance to the Church of Vico, with a maximum width of approximately 4 cm, making it clearly visible in the point cloud, particularly in the densified version. Considering the different buildings surveyed - i.e., with non-homogeneous materials and construction characteristics and slightly varying survey conditions - we can conclude that fractures with centimetre-scale widths are recognizable in the point cloud model.
