Photogrammetric and Semantic Reconstruction of Architect Sinan's Ayakapi Hammam: Reversing Inappropriate Interventions through HBIM

Keywords: Scan-to-HBIM, UAV, 360° camera, heritage documentation, photogrammetry, conservation and preservation

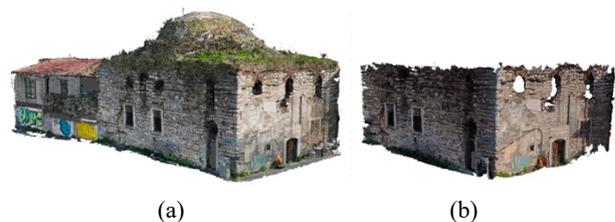
Figure 5. a) Point Cloud from UAV b) Point Cloud from 360° panoramic camera.

The current physical condition of the Hammam is documented through an integrated photogrammetric survey combining aerial photographs acquired via UAVs and panoramic photographs captured through a 360° panoramic camera. In total, 110 aerial photographs were acquired by UAV, while 472 panoramic photographs were obtained using the 360° panoramic camera. All datasets were processed using Structure-from-Motion (SfM) and Multi-View Stereo (MVS) algorithms to generate a high-density 3D point cloud that accurately represents the geometry and surface texture of the building, shown in Figure 5.

Post-processing was carried out using Agisoft Metashape and Autodesk ReCap Pro. UAV and panoramic photogrammetric datasets were geometrically aligned and registered within a unified coordinate system to ensure spatial consistency and scale accuracy. Noise filtering and outlier removal operations were applied to eliminate erroneous or redundant data points produced during the SfM and MVS reconstruction. The cleaned point cloud was subsequently imported into ReCap Pro, where further refinement, segmentation, and mesh optimization were performed to improve surface continuity and geometric unity, resulting in a high-fidelity digital representation of the existing state.

The point cloud datasets obtained from the UAV survey and the 360° panoramic camera were imported into CloudCompare software, where a cloud-to-cloud procedure was applied for data integration. Following the alignment process, the datasets were fully overlapped as seen in Figure 6, enabling a visual assessment of their spatial overlaps. To verify the reliability of cloud-to-cloud registration, a systematic visual inspection was performed using both horizontal and vertical sections. Transition areas where inconsistencies such as gaps and wall intersections were most likely to occur were checked. The inspection confirmed a satisfactory spatial correspondence between the datasets, and no significant anomalies or discrepancies were observed that could compromise the subsequent modelling stages.

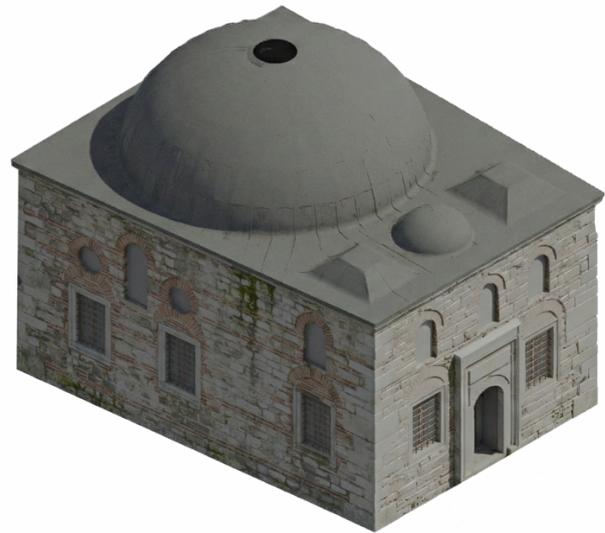
Figure 9. Reverse Reconstruction Model of the Ayakapi Hammam.

The reverse reconstruction model (see Figure 9) was developed by integrating the 16th century LOD 100 model obtained from relatively well-preserved Ottoman hammams sharing comparable plan typologies, structural systems, and construction techniques- using the direct scan-to-HBIM model representing the current condition of the structure. These two reference models were jointly used to assess missing, altered or deteriorated architectural elements and to guide interpretative decisions regarding their plausible historical configurations.

Point cloud obtained through photogrammetry was used as a visual and proportional reference. In order to verify dimensions, and overall massing consistency, the point cloud was selectively overlaid onto the base HBIM geometry within the Adobe Photoshop environment, deliberately avoiding a full mesh-based reconstruction. This point cloud superposition process ensured that the model remained parametric and information-driven while maintaining consistency with the documented physical condition. Material degradation and aging effects were limited throughout the model. To show long-term environmental exposure and weathering, minor surface-level visual interventions, such as cleaning of surface and some infill were applied without generating explicit decay or damage patterns.

Throughout the reverse reconstruction process, the effects of late additions, incompatible repairs, and irregular deformations due to disuse have been minimized, moreover the vegetation over the dome has been cleaned. However, traces of long-term use, material weathering and age-related transformation have not been completely eliminated. Thus, the model does not represent a “perfect” architectural condition, but a possible intermediate state within historical continuity.

Using parametric structural elements defined in the HBIM environment, partially collapsed vaults, deformed wall surfaces, or structural relationships that had lost their continuity and proportional integrity were re-evaluated. These interventions were not with intended to achieve formal completeness or visual idealization. Instead, they were undertaken to clarify the hammam’s spatial organization, construction logic, and structural system. In this sense, reverse reconstruction is used as an analytical approach to support architectural understanding rather than as a restoration proposal.
