DIGITAL DOCUMENTATION AND FAST CENSUS FOR MONITORING THE UNIVERSITY'S BUILT HERITAGE

Silvia La Placa¹, Elisabetta Doria²

KEY WORDS: Fast Survey, Digital Census Cards, 3D Model, Relational Database, University Built Heritage, Management System.

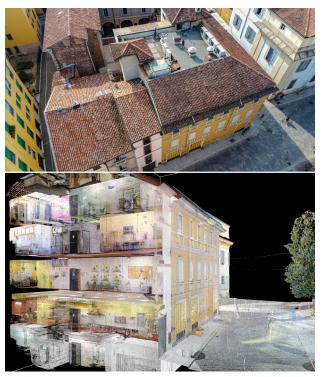
Figure 1. Top: drone photograph of the case study building at the University of Pavia. Bottom: image from point cloud in which the interior and underground six levels are visible.

The case study on which the methodology is being applied is a building in the historical centre of Pavia (Figure 1) currently in a state of disuse owned by EDiSU Pavia, *Ente per il Diritto allo Studio Universitario*, which is the subject of tenders for renovation and intervention works for the location of a subsidised catering service for students and employees of the University. The research project was conducted with the aim of obtaining the database for documentation and knowledge to support the client in activating the phases of intervention and new functional use.

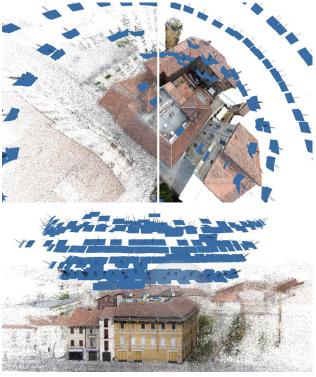
Figure 3. Flight trajectories were planned for full and complete coverage of areas of interest and registration between different point cloud was obtained using target points (flight distance, data overlap, timing, and photographic shots).
