The potential of close-range photogrammetry in evaluating the severity of road surface deformations

Mihnea Căţeanu¹, Sorina Mihaela Miclescu²

Keywords: close-range photogrammetry, Structure-from-Motion, road surface deformations, 3D surface reconstruction, LiDAR.

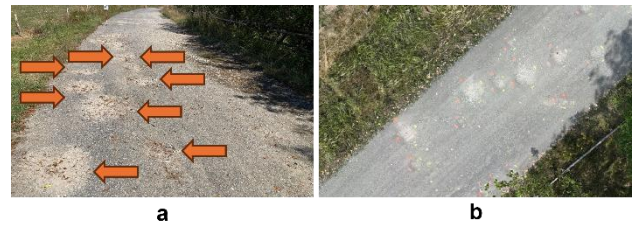
Figure 2. (a) Defects of varying severity as seen from the ground; (b) defects as seen from aerial imagery collected via UAV (Unmanned Aerial Vehicle) photogrammetry, after marking with fluorescent paint.

A 45-metre sector of public road covered with asphalt was chosen for this study, due to its poor condition and numerous potholes of varying areas and depths. The road sector is located in the “Dumbrăvița” municipality of the “Brașov” county, in the central part of Romania (Figure 1). The road surface is in a highly degraded state, as large quantities of timber have been transported over the last decades because this road connects a network of forest roads to the main artery in the area. A total of 32 potholes were identified visually in the field and subsequently marked with fluorescent spray paint, to aid in their identification on the acquired datasets (Figure 2).

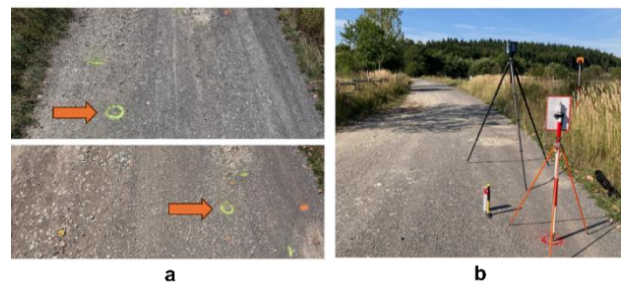
Figure 3. (a) Metal bollards driven into the road surface to serve as GCPs; (b) TLS scanning with checkboard reference targets, which are also installed on the metal bollards.

Before images were captured using a GoPro Hero10 action camera, 6 metal bollards were driven into the road surface, to serve as Ground Control Points (GCPs). These bollards were marked with spray paint, to aid in their identification on subsequently collected images (Figure 3a). The coordinates for these points were determined in the *Stereographic 1970* reference system, by topographical survey. This involved using a total station and two reference points established near the study area, determined using Real-Time Kinematic (RTK) GNSS. These GCPs have a dual purpose: (1) they allow for data collected using different sensors to be georeferenced in the same system and (2) they are necessary to properly scale the models, as the GoPro Hero10 instrument is not a photogrammetric camera.

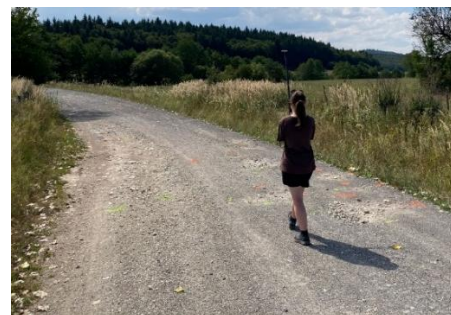
Figure 4. Collection of near-nadir images from a height of approx. 2 meters, using a GoPro Hero 10 action camera mounted on a monopod.

Images of the road surface were collected from a height of approx. 2 metres, by mounting the GoPro Hero 10 camera on a monopod and carrying it on foot over the study area in four parallel tracks, as follows:

- Two near-nadir tracks, on either side of the road (Figure 4).
- Two tracks of oblique imagery collected at an angle of approx. 45 degrees, one from each side of the road.
-

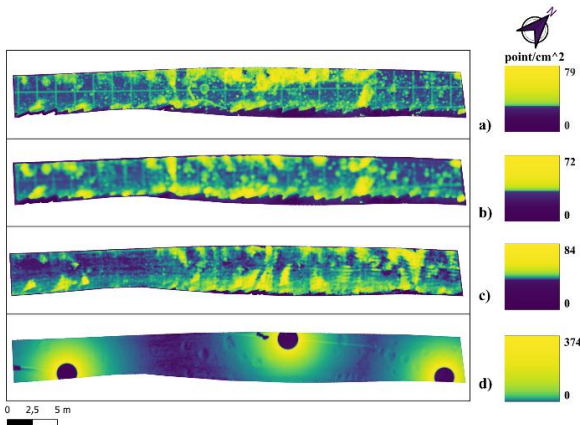
Figure 7. Point cloud density distribution for the *double_oblique* (a), *single_oblique* (b) and *nadiral* (c) variants for 3D surface reconstruction. For comparison, (d) shows the density for the point cloud obtained from LiDAR scanning.

After image alignment, GCPs were used to georeference and scale the models. Afterwards, models were built from the overlapping images, with *Quality* set to “*High*” and *Face count* set to “*Medium*”. Finally, point clouds were generated from the models, using the “*High*” setting. The resulting point clouds contain between 66.7 and 86.7 million points and have average densities of 5.5 – 7.1 points/cm². As can be seen in Figure 7,

close-range photogrammetric point clouds do not reach the highest densities achievable by LiDAR scanning, but on the other hand have a better spatial distribution. The LiDAR point cloud density exhibits a common pattern, with a very high number of points near the scanning positions and densities falling rapidly as the distance to the scanner increases (Figure 7d).

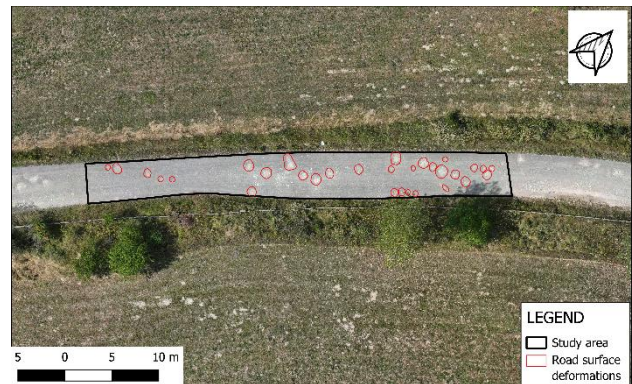
Figure 9. Road surface defects affecting the analysed road section.

A number of 32 defects affecting the road surface (all classified as potholes) were identified in the field and subsequently on the orthomosaic collected via aerial photogrammetry, with extents ranging from 0.21 to 1.70 m^2 and an average extent of 0.65 m^2 (Figure 9). Deformations were calculated from the TLS point cloud (to serve as reference). The *nadiral* variant, which did not use any oblique imagery, was found to have gaps on the left side of the road section. Because of this, some of the volume deformations could not be calculated from this dataset. Therefore, deformation volumes estimated from close-range photogrammetry data are presented only for the *oblique* and *double_oblique* variants. Deformations range in volume from 1.1 to 33.2 dm^3 , with an average of 9.1 dm^3 and a total deformation volume for the studied road section of 290.2 dm^3 .

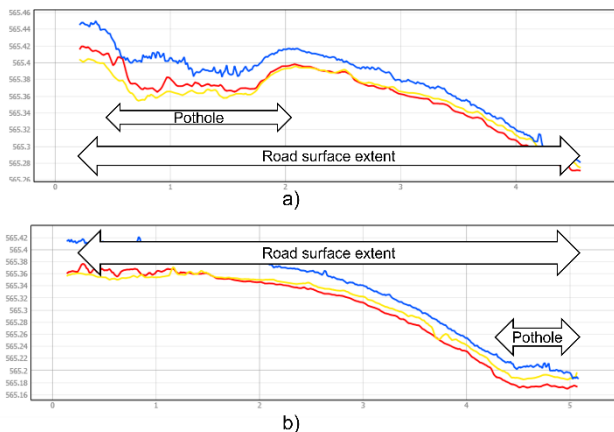
Figure 11. The largest (a) and smallest (b) road surface deformations of the study area, as seen on cross-views of the road surface; the *double_oblique* 3D model is represented in red, the *single_oblique* one in yellow and the *nadiral* one in blue. Note the transversal inclination of the road surface itself, with the right side approx. 0.25 cm lower than the left one.

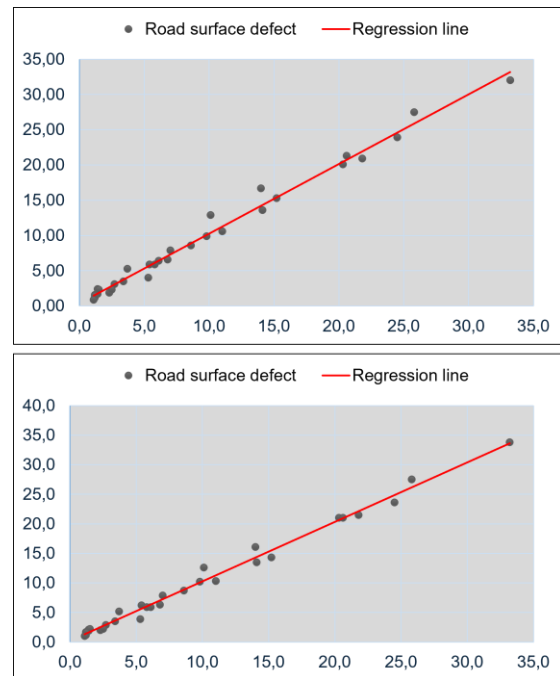
Figure 12. Correlation between defect volumes determined using close-range photogrammetric data collected using the *single_oblique* (top) and *double_oblique* (bottom) approach, and reference volumes determined from TLS data.

To establish the level of agreement between volumes determined from close-range photogrammetry and reference volumes determined by TLS, the difference between volumes was determined for each of the 32 defects and with statistical indicators for these errors were calculated (Table 2). Volumes from the *double_oblique* and *single_oblique* data collection approaches were also plotted against reference volumes (Figure 12).
