## BIM AND UAV PHOTOGRAMMETRY FOR SPATIAL STRUCTURES SUSTAINABILITY INVENTORY

The paper describes the basic concept of the integration between UAV surveying results and BIM. As a case study, it was considered the large spatial shell that served as a hangar for the Antonov An-225 Mriya, the largest in the world strategic cargo aircraft with a maximum take-off weight of 640 tons. Due to an explosion inside, the hangar and aircraft were significantly damaged. The key point of the study is the damage estimation by analysis and modeling of this unique engineering structure. The study has included several steps: hangar structure documentation (before damage), UAV surveying of the hangar (for ongoing condition estimation), terrestrial measurements for the control, and integration of 3D models inside BIM for structural analysis. Deploying the UAV allowed us to generate detailed 3D models of the hangar by means of photogrammetry and computer vision methods. The inclusion of the field geodetic measurements into the processing made it possible to increase significantly positioning accuracy of the results to the sub-centimeter level and served as a ground truth for the models obtained based o

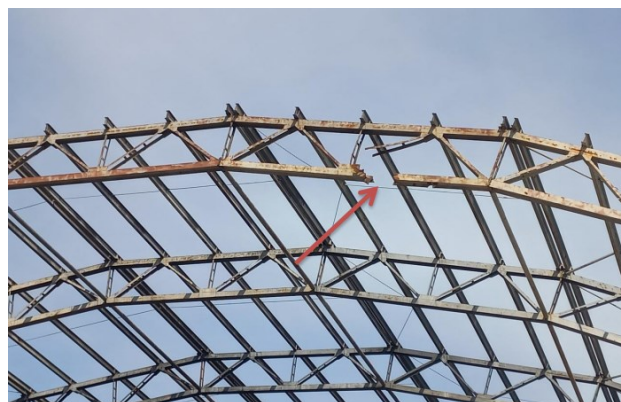
Different parts of the hangar coverage have different types of damage (Figures 5, 6, and 7).

**Figure 5.** Truss rupture.

accounted for in the simulation. The simulation for the broken truss in the arch (Figure 5) is presented in Figure 17.

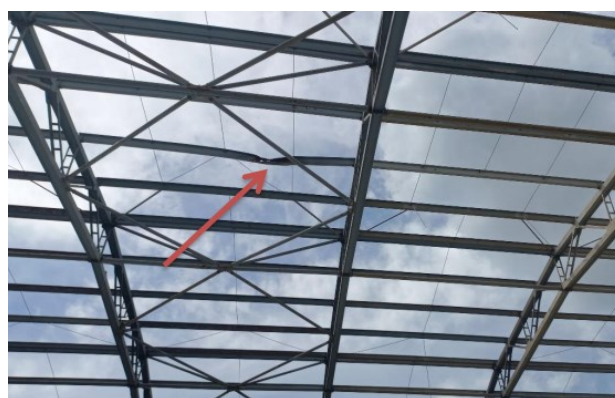
**Figure 6.** Truss deformation.

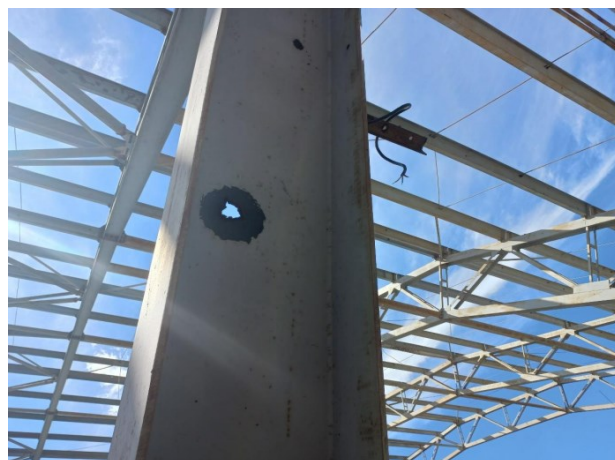
The roof was almost destroyed. Many elements of the frame have ruptures, deformed parts, holes, and failures due to fire burning effect.

**Figure 7.** A bullet hole inside the bar.

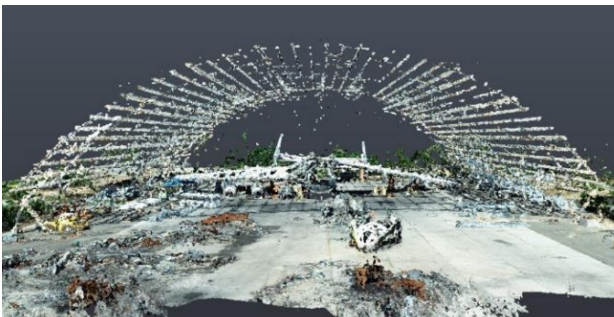
The total orientation error equals 4.2 mm, which satisfies the necessary requirements. The high redundancy of images allowed us to build a dense point cloud of over 500K points. The unfiltered point cloud is given in Figure 11.

**Figure 11.** Point cloud.

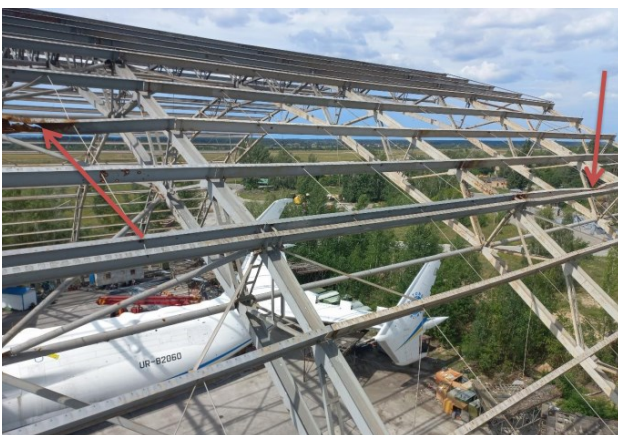
Figure 15. Coverage bar failure.

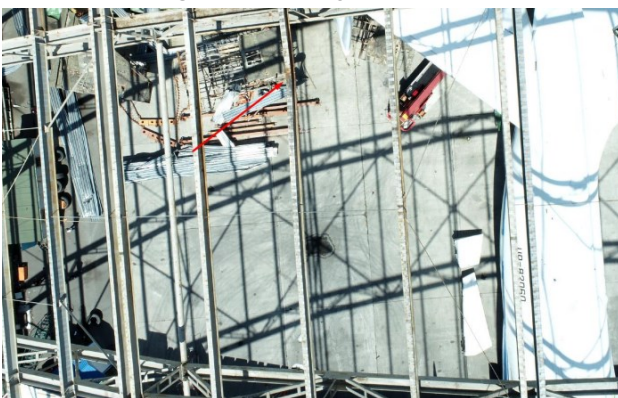
Figure 16. Bar buckling failure.
