# A Complex Study of the Kahovka Reservoir Changes After Dam Collapse

Roman Shults

Interdisciplinary Research Center for Aviation and Space Exploration, King Fahd University of Petroleum and Minerals, 34463  
Dhahran, Saudi Arabia – [roman.shults@kfupm.edu.sa](mailto:roman.shults@kfupm.edu.sa)

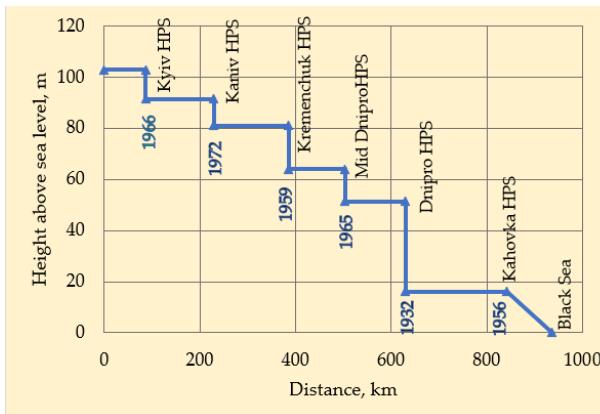
Figure 1. Longitudinal profile of the Dnipro River upstream and the dams that were built.

The idea of constructing a dam downstream of the Dnipro River was proposed many years ago. The primary reason was the presence of a nearly 100 km stretch of rapids near the modern city of Zaporizhzhia, which hindered shipping from the northern part of the country to the Black Sea. The name Zaporizhzhia in Ukrainian means “city that is placed after rapid.” Consequently, the first dam and hydropower station, “Dniproges,” was built in 1932. Its construction enabled navigation along the entire length of the Dnipro River to the Black Sea. After World War II, the Soviet government adopted an ambitious “nature transformation” plan. According to this plan, it was decided to build a system of dams and reservoirs on the Dnipro River (Fig. 1).

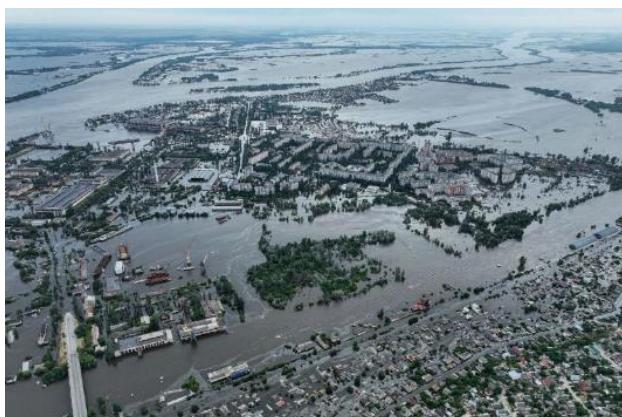
Figure 2. UAV imagery of a flooded Kherson after a couple of days of the dam destruction (approx. 10th of June 2023) (CNN, 2023).

Since 1955, six hydropower stations and their maintenance reservoirs have been constructed: Kyiv station (1966), Kaniv station (1972), Kremenchuk station (1959), Middle Dnieper power plant (1965), Dnipro station (1932, rebuilt in 1947), and Kakhovka station (1956). The Kakhovka Reservoir was created to support the Kakhovka station and was filled in 1958. It covered a total area of 2155 km<sup>2</sup>, stretched 240 km in length, with an average width of 23 km. The average depth was 8.4 meters, and its total water volume was about 18.2 km<sup>3</sup>. The reservoir also supported agriculture in southern Ukraine and supplied water to major cities such as Kherson, Kryvyi Rih, Nova Kakhovka, and the Crimean Republic. During the Russian-Ukrainian conflict, the station and dam were seized by the Russian army and were not adequately controlled by either side. After numerous shellings, on the morning of June 6th, 2023, the dam's central part collapsed, causing water to leak. By midday, the dam completely failed, flooding large areas downstream along the Dnipro River (Fig. 2).

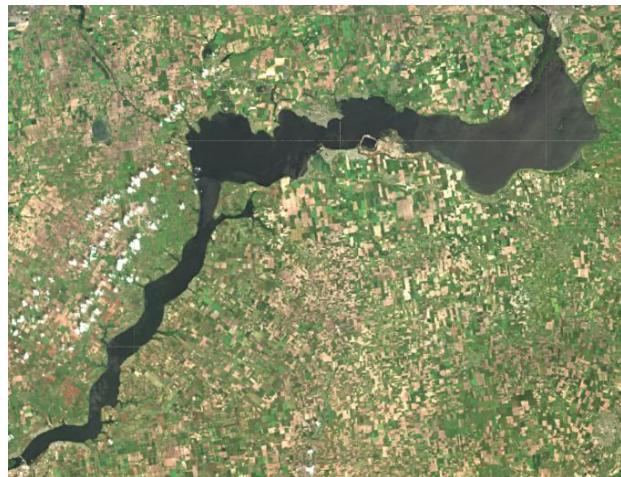
Figure 3. Color mosaic of Sentinel-2 images of the study area (May 2023).

To assess the loss of the reservoir water surface, a change detection algorithm must be applied. Based on the analysis conducted in (Shults et al., 2025), the classification approach for change detection has been chosen. The classification was performed using two Sentinel-2 mosaics: before the dam collapse (01/05/2023-01/06/2023) and after the dam collapse (01/07/2023-01/08/2023). Figures 3 and 4 clearly illustrate the changes in the study area resulting from the dam's collapse.

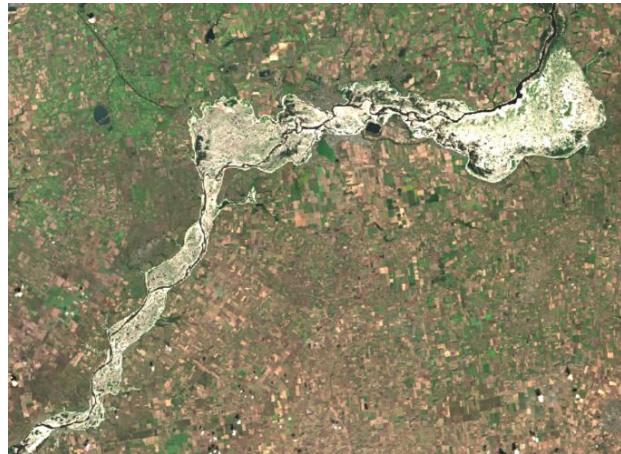
Figure 4. Color mosaic of Sentinel-2 images of the study area (August 2023).

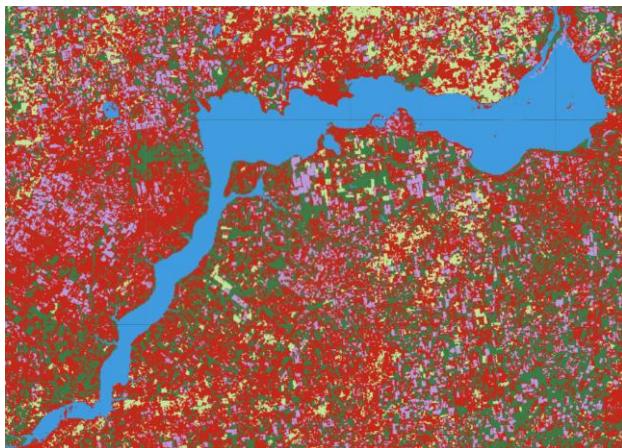
Figure 5. Area classification before the dam collapse (blue - water, green - vegetation, light green - grass, red - urban, light purple - barren)

Google Earth Engine (GEE) was used as the primary tool for classification and NDVI calculation. Different classification algorithms were tested. The classification was performed using machine learning algorithms with a sample split into training and testing subsets. The holdout percentage for train/test subsets was set to 70%. The comparison analysis showed the highest efficiency for the support vector machine (SVM) algorithm, compared to random forest and naïve Bayes. Below, the classification results with accuracy estimates are provided. The area was classified into five classes: water, vegetation, grass, urban, and barren or plowed lands. The last class was selected since the area around the reservoir is mainly used for farming. As a result, a large portion of the land is plowed or harvested during late summer. Figure 5 shows the area classification before the dam collapse.

The overall accuracy is relatively high at 0.934, and the kappa value is close to one, at 0.917. The estimated reservoir area was 2228.8 km<sup>2</sup>. The classification results for the area after the dam collapse are shown in Fig. 6.

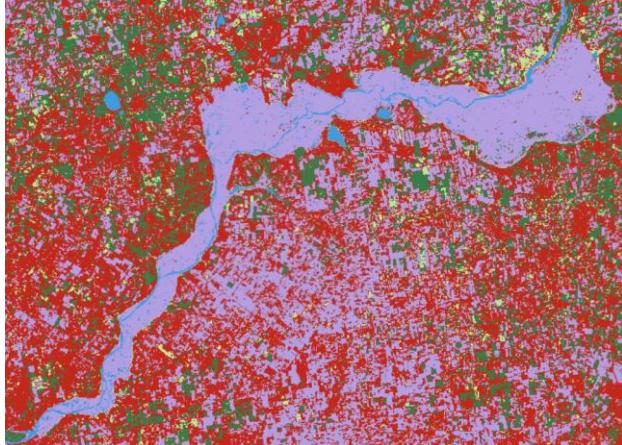
Figure 6. Area classification following the dam collapse.

Visual analysis reveals a significant change across the entire area. While some changes resulted from agricultural activity, the main difference is the dramatic reduction in the reservoir's surface area. These changes complicate classification. However, water classification still maintains very high accuracy, which is crucial for the study. The overall accuracy analysis is provided in Table 2.

The overall accuracy remains relatively high at 0.879, and the kappa value is 0.848. The lowest accuracy is found in the grass and urban classes. However, these classes occupy a tiny part of the study area, so they have no impact on the final estimate. The water surface area is 435.1 km<sup>2</sup>.

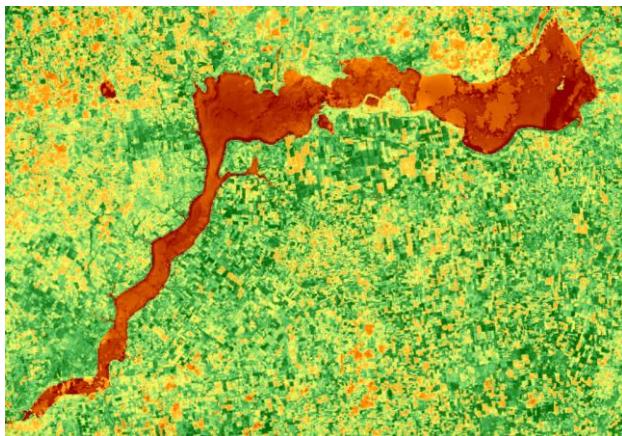
Figure 7. NDVI map of the study area (June 2023).

GEE offers quick and practical tools for NDVI analysis. To examine the changes in the study area, the first step is to create NDVI maps for the investigation period. A series of NDVI maps since the dam collapse provides the best visual understanding. These maps are shown in Figs. 7-9.

It is well-known that the NDVI value ranges from -1 to +1. Values from -1.0 to 0.0 correspond to non-vegetated areas such as water, snow, and clouds. Bare soil, sand, or urban surfaces have NDVI values between 0.0 and 0.2, while values from 0.2 to 0.5 represent grasslands, croplands, or shrubs. Dense, healthy vegetation falls within the range of 0.5 to 0.8. Based on these values, the following color palette was used for the NDVI maps: dark brown/red for very low or negative NDVI (water, urban, barren lands), yellow/light green for sparse or stressed vegetation, and green/dark green for healthy, dense vegetation. Using these color designators allows for the analysis of NDVI distribution. The NDVI map for June 2023 (Fig. 7) clearly shows the water reservoir area in brown. Over the course of a year, significant changes occurred (Fig. 8). Part of the former water reservoir became vegetated, particularly in the northeastern part.

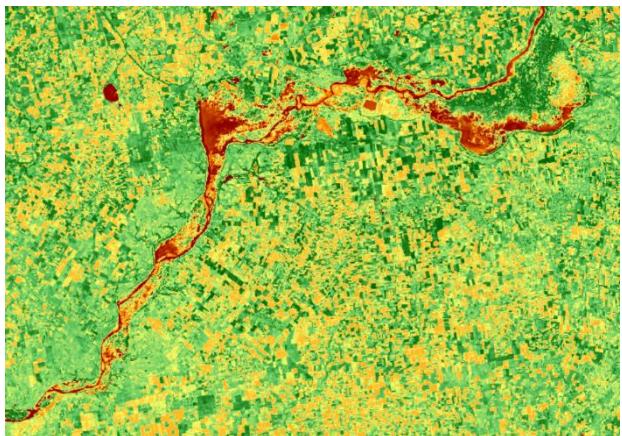
Figure 8. NDVI map of the study area (June 2024).

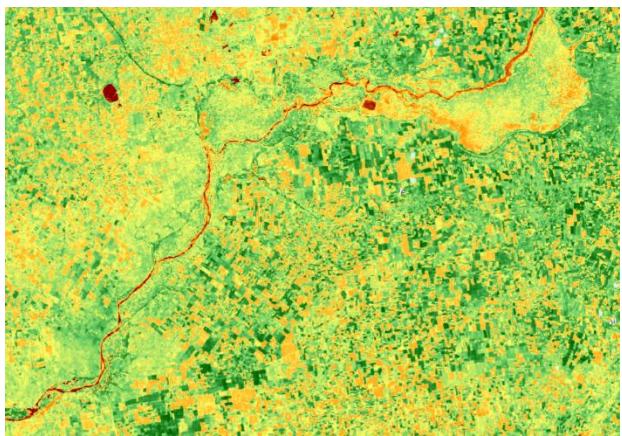
Figure 9. NDVI map of the study area (June 2025).

At the same time, other areas were covered with moderate vegetation and bogs. After another year, the changes were dramatic (Fig. 9). The brown color, indicating bare soil or vegetation-free areas, nearly disappeared everywhere except for the Dnipro riverbed. However, there is a clear trend toward transforming the former reservoir bottom into barren land in the northeastern part. Dark green areas with dense, photosynthetically active vegetation—such as forests or irrigated crops—mostly remained. Nevertheless, the dominant cover was composed of moderate vegetation or grasslands, reflected in light green to yellow colors.

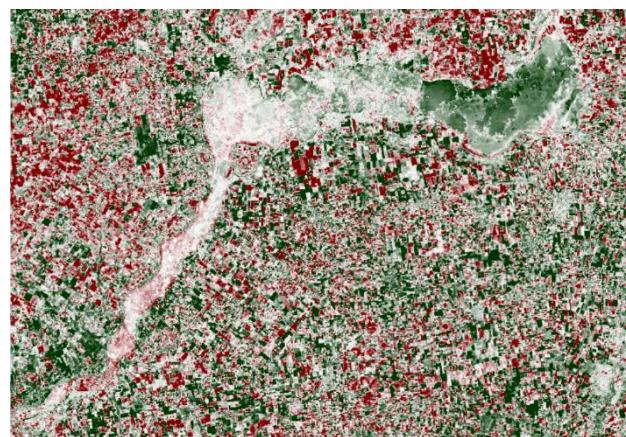
Figure 10. NDVI slope map for 2020-2023.

Figure 10 demonstrates the NDVI slope map before the dam collapse for 2020-2023.

The map in Fig. 10 displays  $\Delta$ NDVI as a continuous variable. This shows how quickly NDVI is changing, including both minor and major fluctuations. A drawback is that a slight positive slope might not be significant due to noise. A strong negative slope clearly indicates browning. For better visualization, the slope map was classified into three classes. The classification used a simple rule, assigning a threshold (T) around zero slope based on the scheme: slope  $\leq -T$  indicates browning;  $-T \leq$  slope  $\leq +T$  indicates stability; slope  $> +T$  indicates greening. The T value was set at 0.005 NDVI per year. This facilitated the creation of a clearer and visually appealing map (Fig. 11).

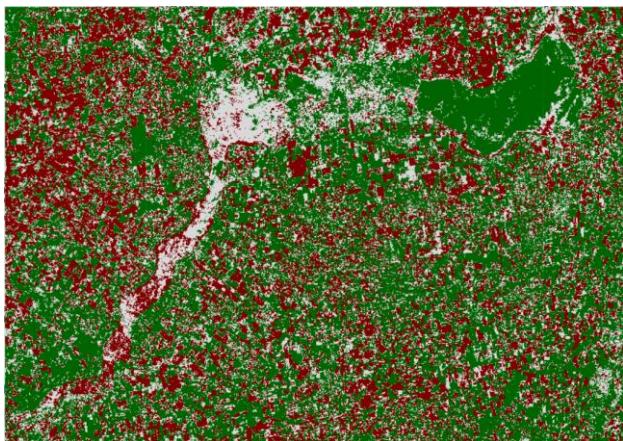
Figure 11. Classified NDVI slope trend map for 2020-2023.

The browning areas indicate where the NDVI trend slope is negative, meaning vegetation cover is decreasing over time (plants dying, deforestation, urban expansion, soil exposure, drought stress, etc.). The stable class (grey) has an NDVI trend slope close to zero, showing no significant change in vegetation. The greening class indicates a positive NDVI trend slope, signifying increasing vegetation cover (reforestation, water greening, crop expansion, improved land use, seasonal recovery, etc.). Therefore, there is no severe stress during the observation period from 2020 to 2023. Using the classified map, the areas of the different NDVI trends were calculated (Table 3).

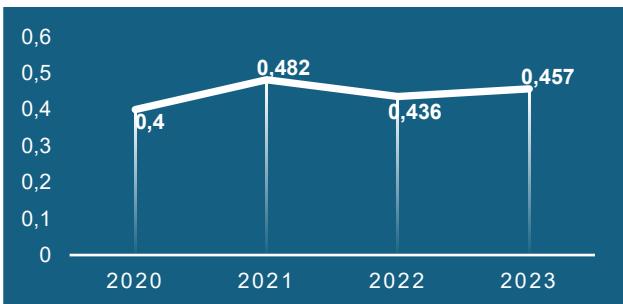
Figure 12. Mean NDVI values per observation epochs 2020-2023.

Approximately 5500 km<sup>2</sup> of land has experienced a consistent decline in NDVI over the time period. Nearly the same area shows no significant NDVI change and remains within natural variability. A larger portion of the land, 8262 km<sup>2</sup>, exhibits a positive NDVI trend, indicating healthier or denser vegetation. Additionally, the mean NDVI values for each observation epoch were calculated (Fig. 12).

The average NDVI values stay stable with minor fluctuations caused by weather variability. To compare the changes that occurred after the dam collapse, the same calculations were performed for the observation period 2023-2025 (June – July). The continuous NDVI slope map is shown in Fig. 13. This figure demonstrates how significantly the water reservoir area and the surrounding land have changed. The reservoir area has become vegetated, while the surrounding land is experiencing water scarcity. Similar to the previous case, the NDVI slope map was classified using a threshold value T (Fig. 14).

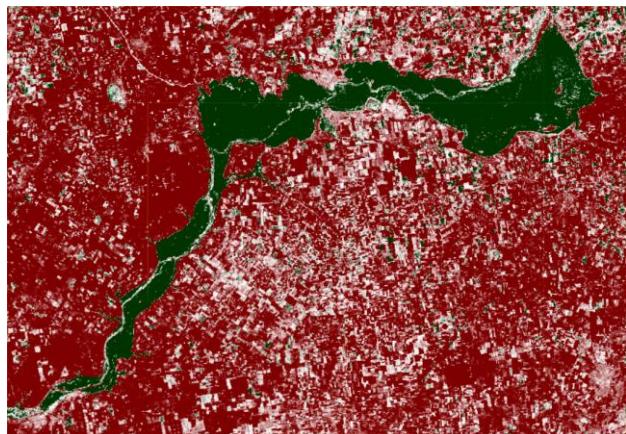
Figure 13. NDVI slope map for 2023-2025.

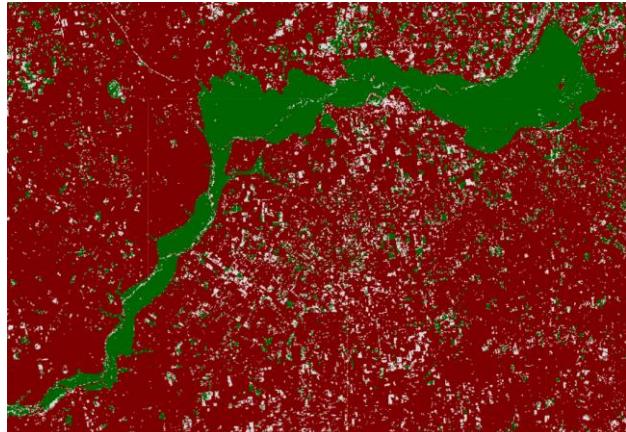
Figure 14. Classified NDVI slope trend map for 2023-2025.

Browning is the largest class ( $\approx 14,200$  km<sup>2</sup>). Greening ( $\approx 3,200$  km<sup>2</sup>) is nearly equal to stable ( $\approx 2,100$  km<sup>2</sup>) and has decreased by approximately 64% and 62%, respectively. The balance between vegetation and barren lands has been significantly disrupted. Mean NDVI values per observation epochs were also calculated (Fig. 12).

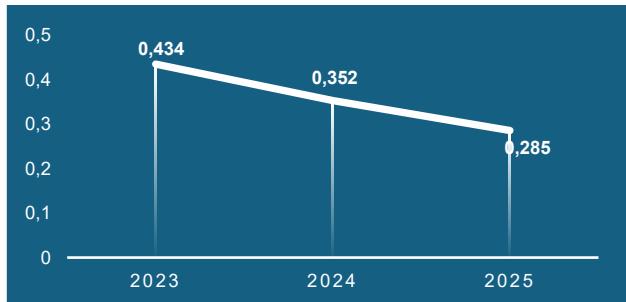
Figure 15. Mean NDVI values per observation epochs 2023-2025.

The calculated mean NDVI values also declined significantly. If the average NDVI value for 2020-2023 is 0.444, then for 2023-2025 it dropped to 0.285, or 35%, which is an unusually low value.

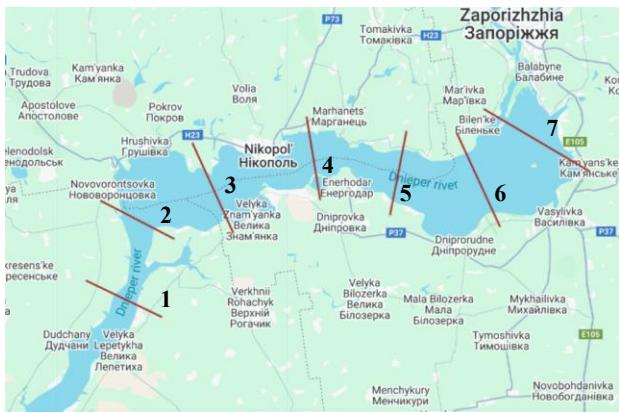
Figure 16. Cross-section distribution over the former reservoir.

The final step is to conduct a direct study of the empty water reservoir. This study will help understand the changes that occurred on the reservoir bottom. A total of seven cross-sections were drawn (Fig. 16).

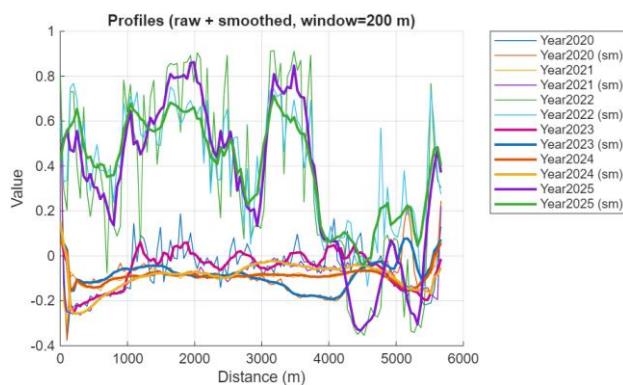
Figure 17. Cross-section 1.

For each cross-section, NDVI profiles were generated with a 100 m step. Therefore, each chart contains six profiles corresponding to yearly June-July observation periods. Examples of these charts are shown in Figs. 17 and 18. For improved interpretability, NDVI profiles were smoothed using a 200 m smoothing window.

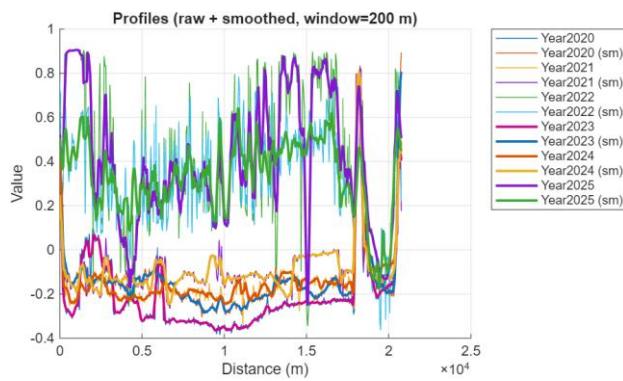
Figure 18. Cross-section 7.

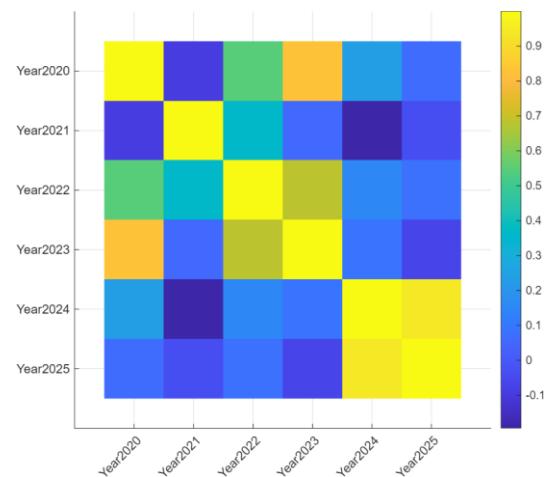
Figure 19. Pearson correlation for cross-section 1.

The analysis reveals distinct profiles divided into two datasets: 2020-2023 and 2024-2025. The correlation analysis shows an extremely high correlation (0.9-0.7) between 2020-2023 and a nearly negligible correlation (0.2-0.1) between 2020-2023 and 2024-2025 (see Figs. 19-20), with a strong correlation between 2024 and 2025. The same conclusions apply to cosine similarity, with values 0.9-1.0 for 2020-2023 and -0.4 to -0.8 for 2024-2025. The distribution of Euclidean distances and RMSEs confirms the differences between these two datasets. The charts showing changes in mean Pearson correlation over time indicate a rapid decline after the third year, which is 2023. Consequently, the analysis demonstrates significant changes in land surface coverage for the former reservoir bottom.

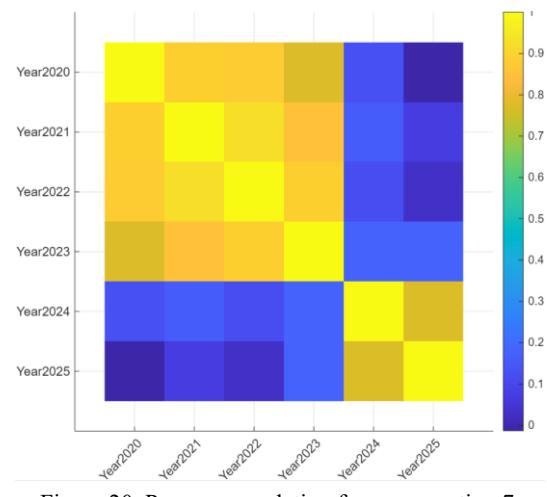
Figure 20. Pearson correlation for cross-section 7.

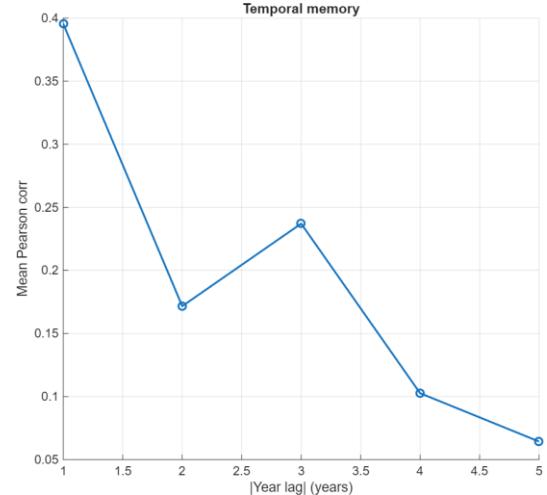
Figure 21. Temporal correlation for cross-section 1.

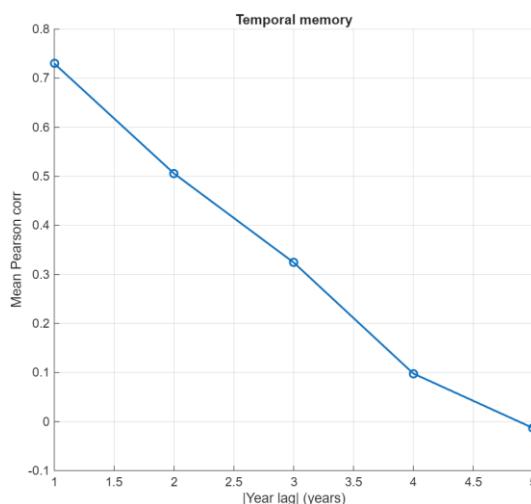
Figure 22. Temporal correlation for cross-section 7.
