## Long-Term Diagnostics of the Condition of the Choli Minaret in Erbil Using Photogrammetry and Laser Scanning

Karel Pavelka, jr.<sup>1</sup>, Lukáš Běloch<sup>1</sup>

<sup>1</sup> Czech Technical University in Prague, Faculty of Civil Engineering, department of geomatics, Czech Republic  
[karel.pavelka@cvut.cz](mailto:karel.pavelka@cvut.cz), [lukas.beloch@cvut.cz](mailto:lukas.beloch@cvut.cz)

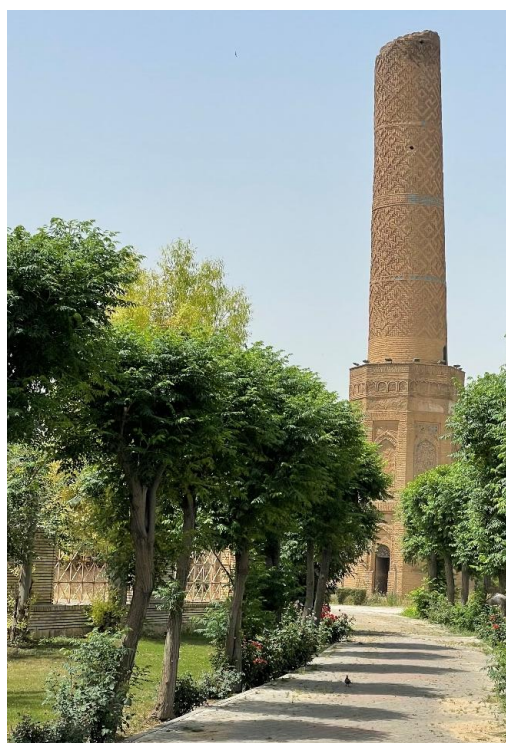
**Figure 3:** The stay of the Choli minaret in 2025

After comparing both phases of the measurements from four stable points towards the stainless-steel control points attached to the minaret shell, which are affected by temperature changes, differences in the order of millimetres (in two cases up to 16) were found. All are within the expected recording accuracy tolerance and are caused by the measuring technique and temperature changes. A comparison of the new measurements with the old measurements showed that the minaret body is stable and the deviations are within the tolerance limits of the measurement and surface roughness of the structure, where the spatial differences reach up to  $\pm 5$  cm. A comparison of the new and old measurements showed good agreement, although the old measurements have several orders of magnitude fewer detailed points due to the different measurement technology. However, the accuracy of the point measurements is similar, and the comparison of accuracy is good. Most deviations are within 2 cm, which is within the measurement accuracy and surface roughness (fig.3-5).

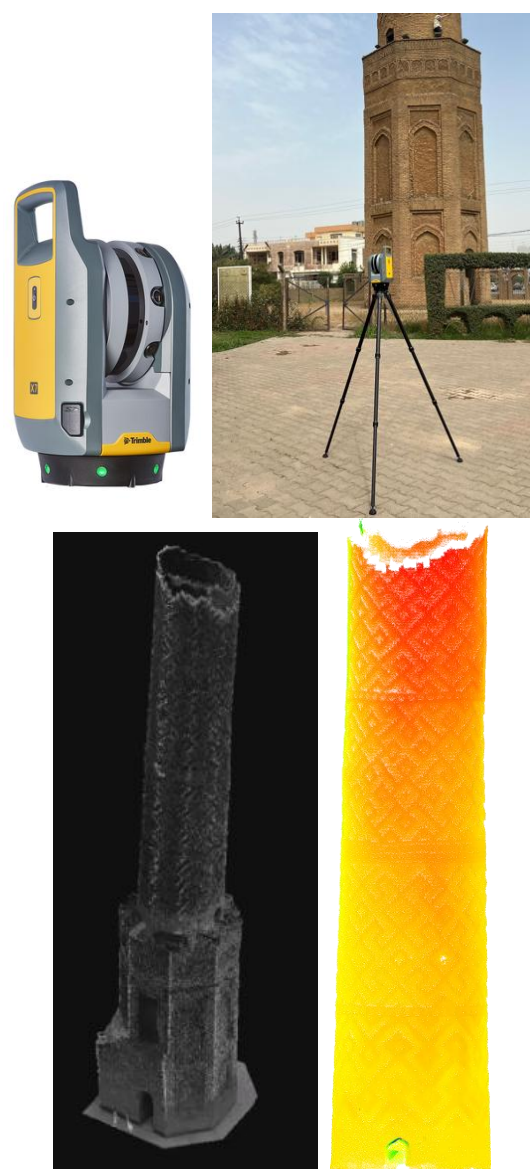
**Figure 5:** Used laser scanner Trimble X7, (upper part), point cloud from measurement, photo from one of 67 scanner position (left) and deformation of the upper part of minaret (right)

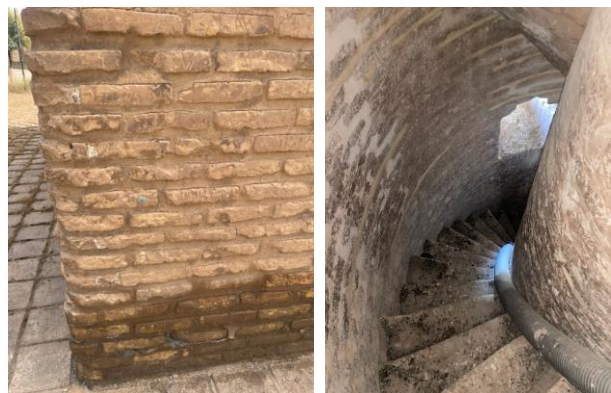
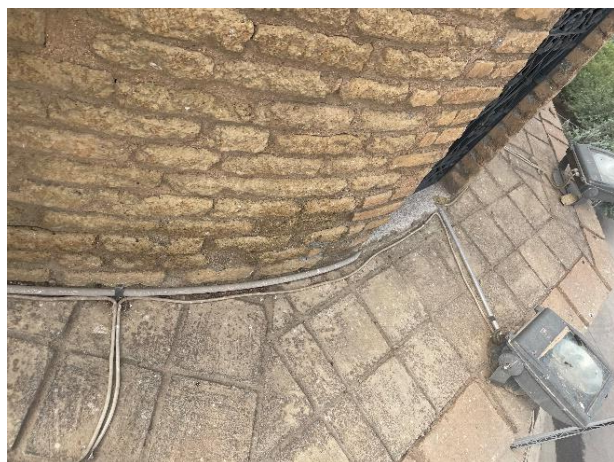
**Figure 14:** The moisture clearly visible at the base of the minaret (left up), a very good condition of minaret part, no cracks are visible

However, the moisture clearly visible at the base of the minaret is problematic and may cause certain shifts or static problems in the future. Its origin is described in the report given to the local authority (fig.14-15).

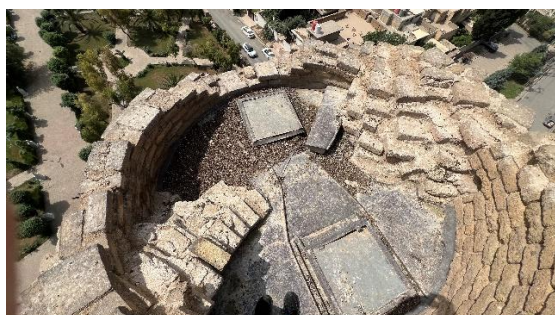
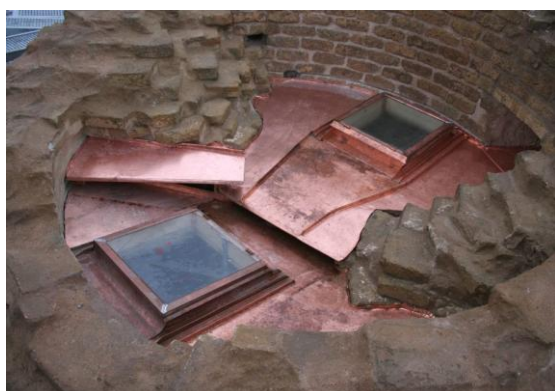
**Figure 15:** Upper part of minaret in 2025 and in 2009
