3D Reconstruction and Digital Preservation of Mandaluyong City's San Felipe Neri Parish Interior Using Close-Range Photogrammetry

Fredrik Angelo F. Francisco¹, Adrian Kristian C. Bendicio¹, Alessandra M. Tolentino¹, Janine A. Mendoza¹, Dominic C. Fargas Jr.¹

¹ Department of Geodetic Engineering, University of the Philippines Diliman, Quezon City, Philippines –
(fffrancisco, acbendicio4, amtolentino6, jamendoza16, dcfargas)@up.edu.ph

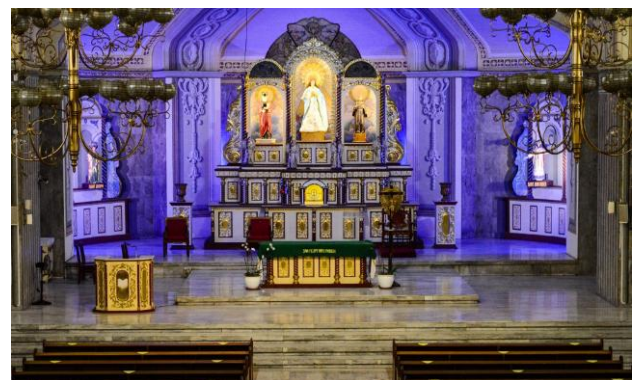
Figure 3 shows the front view of the main altar of the San Felipe Neri Parish.

Figure 3. San Felipe Neri Parish Main Altar

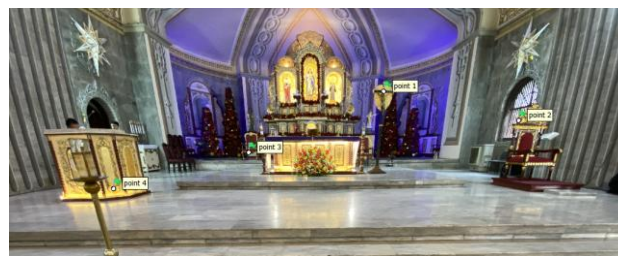
Figure 6. Natural Relative GCPs chosen.

2.3.3 Image Processing: At this stage, after compiling and importing all obtained images in Agisoft Metashape, photos were aligned with Natural Relative GCPs in overlapping images, which would help achieve better & quicker processing and results. The relative natural GCPs were chosen due to their point-like structures and spatial distribution. By denoting these GCPs as the same among multiple images, the computational process for image matching became easier and minimized distortion and mismatching, rather than if no GCPs were chosen at all. Within the overlapping images, four (4) GCPs were chosen as seen in Figure 6.

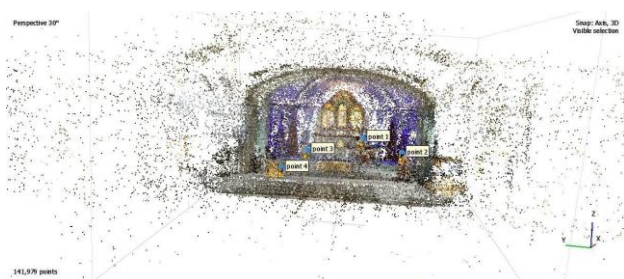
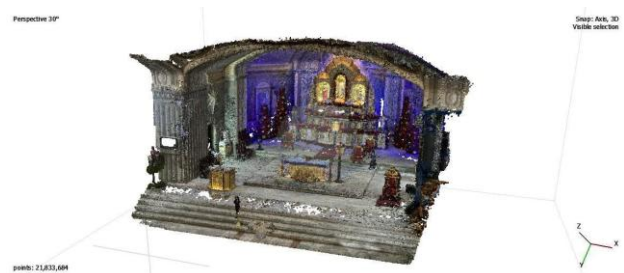
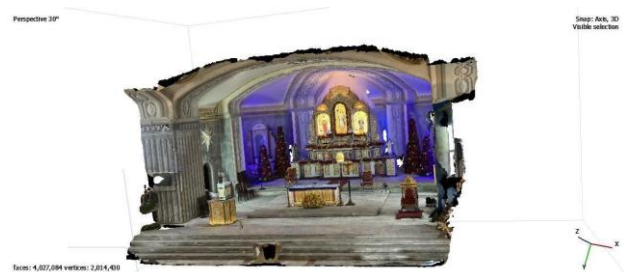
In (I) Generation of the 3D Model, after photo alignment, low confidence points in reconstruction and points outside the project area from the point cloud were removed. Each GCP was then inspected and manually adjusted in each image to optimize camera positions and photo alignment for cleanup. Afterwards, the dense cloud and mesh were generated. Figures 7, 8, and 9 all show the point cloud before cleanup, dense cloud, and mesh for visualization purposes.

Figure 7. Raw Point Cloud.

Figure 8. Dense Cloud.

Figure 9. Textured Unrefined Model or Mesh.

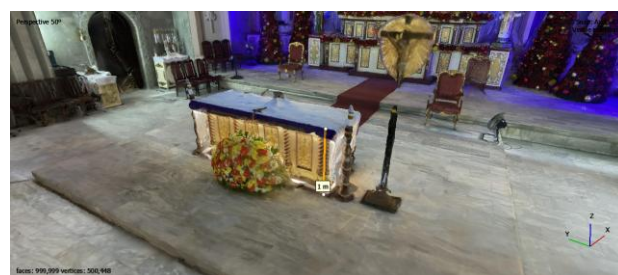
Figure 11. Measuring the altar desk in Agisoft Metashape.

2.3.4 Outputs & Accuracy Check: After creating the final model, absolute measurement differences were measured and inspected for model inconsistencies and clarity issues. Equation 2 was applied for the absolute measurement differences. Figure 11 demonstrates the measurement tool in Agisoft using the final model.

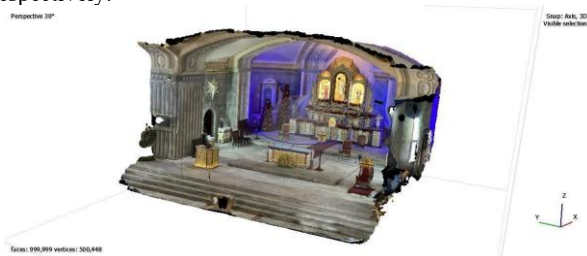
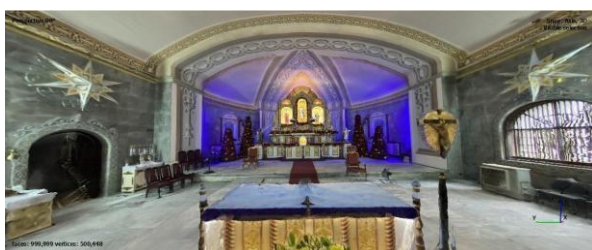
Overall, a 3D Model of the interior of San Felipe Neri Parish was successfully reconstructed using Agisoft Metashape and MeshLab. The full model can be seen in Figures 12 and 13, showing the exterior of the mesh and interior structure, respectively.

Figure 12. Exterior view of the Model

Figure 13. Interior view of the Model

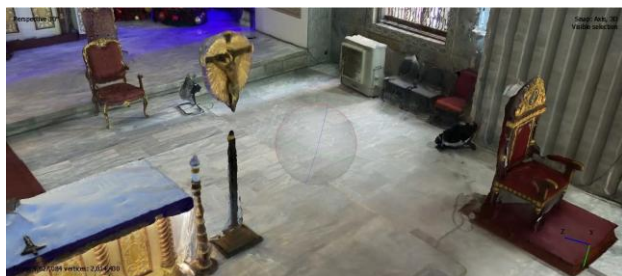
Figure 14. Broken Feature

When it came to broken features, some artifacts or objects could have been split into multiple segments or meshes during reconstruction, as seen in Figure 14. The artifact was broken into two parts rather than one full pole or cross. This issue is best fixed by adding more photos encircling the broken object to ensure precise reconstruction.

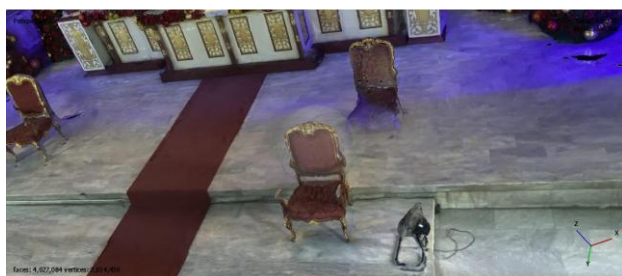
Figure 15. Ghost or Duplicate Feature

For ghost or duplicate features, some objects could have moved during the image acquisition process, causing duplicate reconstructions seen in the chair in Figure 15. The chair was duplicated as it was moved from one place to another while the researchers were capturing photos. This problem could be fixed through removal in 3D Modeling software; Usually, this issue is fixed through deletion in the point cloud during image processing. However, since the reconstructed model is indoors, the selection of duplicate points would have been more difficult and tedious than simply post-processing the 3D model in other software.

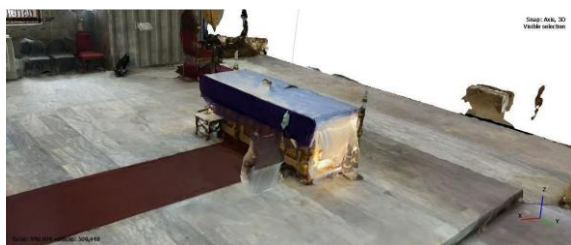
Figure 16. Inconsistent Mesh beside Altar Desk

In the case of inconsistent meshes, some thin and easily moved objects such as cloth could cause incorrect reconstructed meshes or faces, as seen beside the altar desk in Figure 16. A random floating mesh was made near the table, possibly due to the cloth around the table moving during photo capture. This problem could be fixed through removal in 3D Modeling software or affixing light objects during photo capture in the image acquisition stage.

Additionally, there are novel challenges found that were not initially expected in the study, such as strong light distorting reconstruction, moving cloth causing inconsistencies as mentioned before for Figure 16, and single color objects like rugs or TV screens causing holes in the mesh.

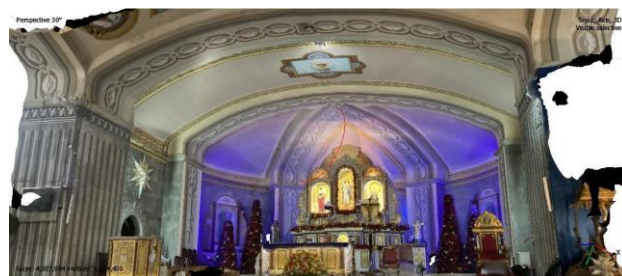
Figure 17. Main Altar Ceiling

Despite these clarity issues, overall, many features have been successfully reconstructed with great detail and clarity, including the ceiling of the interior of the main altar as seen in Figure 17. Smaller and more complex features are less detailed but still

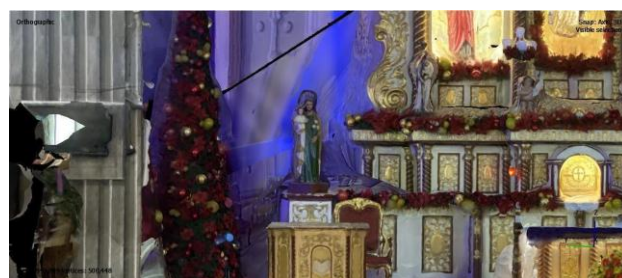
surprisingly are well-represented in the reconstructed model. Such is the case of Figures 18 and 19, where the saints' poses and larger details like color and outfits are well captured but to acquire more detail on the smaller body parts like the arms or faces require more images.

Figure 18. Left side Saint model

Figure 19. Right side Saint model

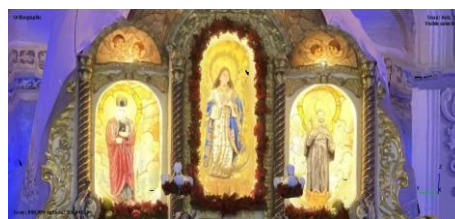
Figure 20. Main Altar Saints

In the case of strong light distorting reconstruction, this is best seen in Figure 20, where the main altar saints' faces become completely yellow or white due to the strong amount of light reflected on their faces' surface from the nearby altar frame lights. The details on their outfits are more clarified than the previous saints due to their size, but the skin and lighter features like facial shape or cheeks are distorted due to the strong light. The distortion is most pronounced in the saint's face at the left of the main altar.
