## REMOTE SENSING FOR FLOOD INUNDATION MAPPING USING VARIOUS PROCESSING METHODS WITH SENTINEL-1 AND SENTINEL-2

**KEY WORDS:** Sentinel-1, Sentinel-2, spectral indices, SAR, flood mapping, change detection

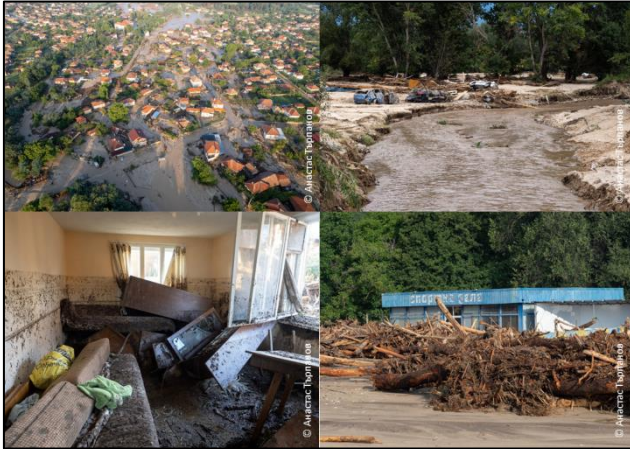
**Figure 2.** The damage caused by the flood after September 2, 2022. Karavelovo village the day after the flood (*top left*); Multiple cars swept away in affected areas (*top right*); Home in the village of Karavelovo, it can be clearly seen how far the mud has reached (*bottom left*); The stadium of the village of Karavelovo covered with trees brought down from the river (*bottom right*). © Анастас Търпанов/ Anastas Turpanov (credit:[https://www.dnevnik.bg/photos/2022/09/07/4388097\\_fotogaleriia\\_sled\\_potopa/](https://www.dnevnik.bg/photos/2022/09/07/4388097_fotogaleriia_sled_potopa/) – accessed on 21 February 2023.)

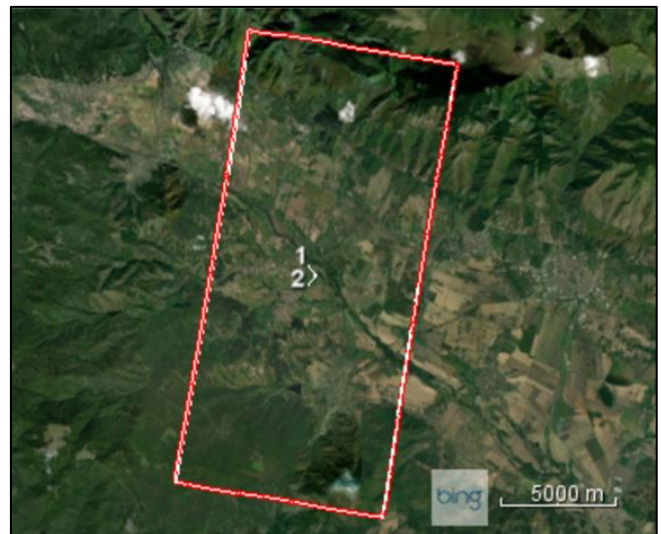
Since the Area of Interest (AOI) is quite small and there is no need to process the whole image, subsets are made. Figure 3 shows the area covered by the study. Since the orbit state vectors provided in SAR product metadata are usually not exact, a precise exact orbit is applied. The orbital file provides accurate information about the satellite's position and velocity. Based on this information, the orbit state vectors in the abstract product metadata are updated. (SNAP Help)

**Figure 3.** Area of Interest for Sentinel-1 images

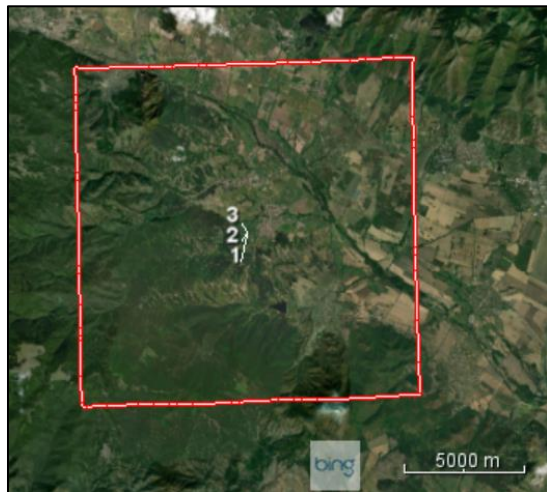
Because the same optical images from Sentinel-2 are used in both methods, the initial processing steps are identical. Processing begins with the creation of subsets, since the area of interest covers a significantly smaller area than that in the available images. This operation is applied to all three images using the same coordinate values of the endpoints of the geographic polygon (Figure 6).

Figure 6. Area of Interest for Sentinel-2 images

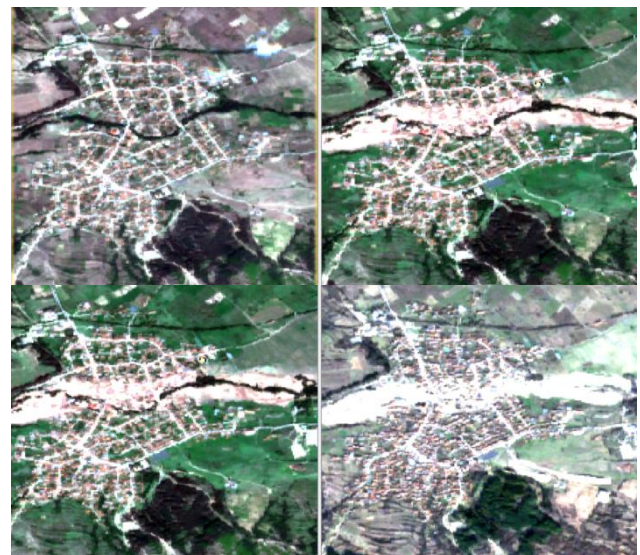
Figure 13 presents images of the village of Karavelovo before and after the flood, as well as four months after it. The mud deposits that have been brought down from the river can be clearly seen. In the second series of photos, it can be established what the situation is now. It can be seen that almost all the mud is still there and that only a small part of the centre of the village has been cleaned.

Figure 13. Karavelovo village. Photo from August 18, 2022 before the flood (top left); Photo from September 7, 2022 after the flood (top right and bottom left); photo from January 8, 2023 - 4 months after the disaster (bottom right).
