A PHOTOGRAPHIC DOCUMENTATION WORKFLOW FOR DIGITIZATION OF CULTURAL HERITAGE: THE 14 CENTURY CHURCH OF SV. NIKOLA IN KALOTINA, BULGARIA

KEY WORDS: Documentation, Photogrammetry, RTI, Architectural Heritage, 360° Photography, Medieval Bulgaria

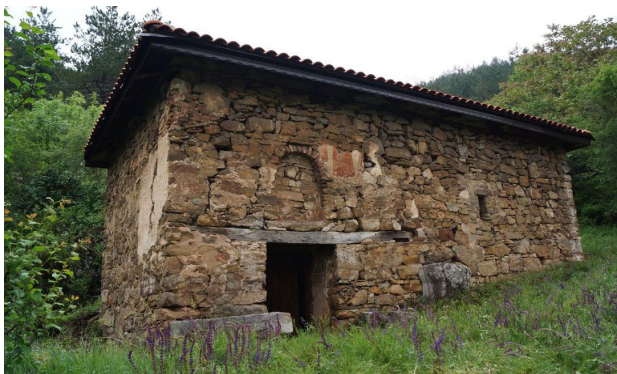
Figure 1. Modern Condition of the Church of Sv. Nikola.

Some of the wall paintings have been moved to the National Archaeological Institute with Museum - Bulgarian Academy of Sciences (NAIM-BAS) in the 1940's in order to preserve them while the ones remaining are in dire need of conservation and restoration. The church currently does not have protection status which has led to the rapid deterioration of its architecture and decoration. Stability and humidity problems arise from surface erosion, lack of drainage systems, and extended exposure to the elements in the past due to the roof having previously collapsed.

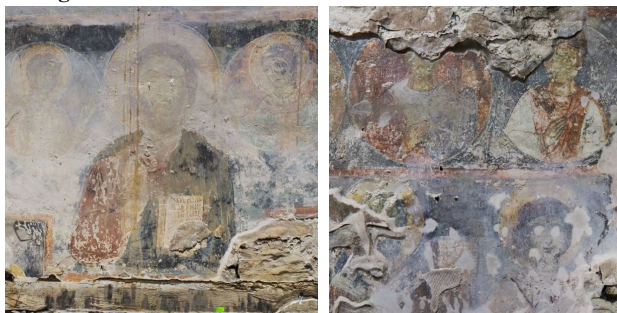
Figure 2. Wall Paintings Inside the Church.

The medieval wall paintings depict various scenes from the bible and portraits of saints (Figure 2). The depiction of aristocratic family as the donors for the church has figures of a couple with two children and the dedication inscription references the Tsar

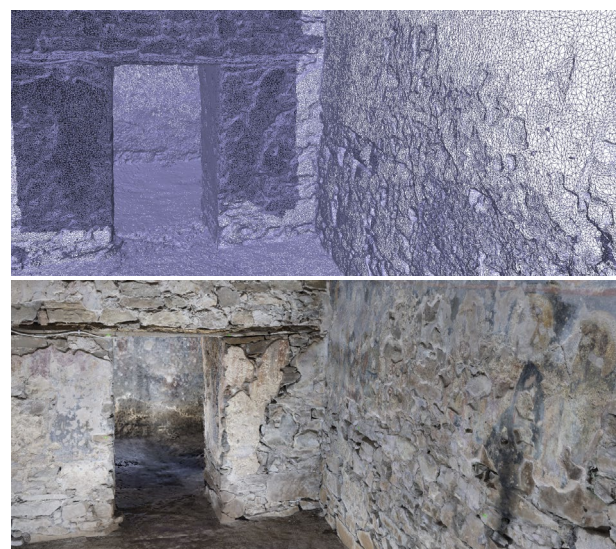
Figure 6. Interior View in the Naos of the Model (top: Wireframe; bottom: Textured Mesh).

aligned, the exterior model had an overall scaled accuracy of 1.2 cm and the interior of 1.6 cm. These values aligned with the expected accuracy of the geological measurements. The 3D textured model can be a digital alternative that can provide an interactive experience of heritage through the use of 3D glasses or by developing the model for virtual reality experiences (Figures 5-6).

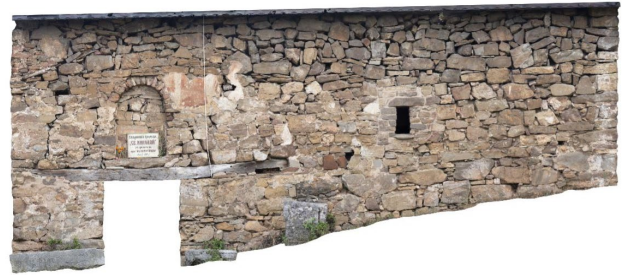
Figure 8. Orthophoto of Exterior South Façade.

The mesh of the merged 3D model was composed of over 4 million vertices and over 8 million faces. From the 3D model, georeferenced and scaled orthophotos were generated of the four exterior walls and ten interior walls of the church. This 3D model served as the base for subsequent measurements, cross sections, and digital drawings of the features and details of the construction and decoration of this important cultural monument.

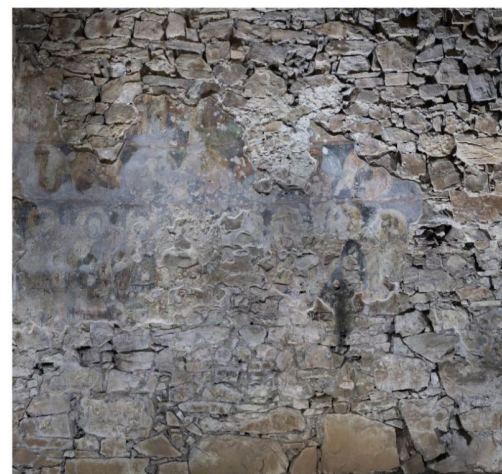
Figure 10. Orthophoto of Interior North Naos Façade.

Architectural documentation on heritage sites is mandated in Bulgaria as it gives a unique perspective to the materials, construction techniques, and existing pathologies. While manual drawing is slowly becoming more rare as we move toward fully digital forms of documentation, the resulting documentation products remain similar. Manual drawing in comparison to digital drawing is extremely time consuming and arguably less accurate than drawing digitally using the scaled and georeferenced 3D models and their exports (Jones & Bevan, 2019). Using the 3D model and resulting orthophotos, an updated top plan (Figure 7) as well as two sets of annotated digital drawings were created for all of the interior and exterior walls of the church as per the requirements of the ministry. The first set included the high resolution orthophotos with dimensions along the sides and bottom to identify the overall size of the walls themselves as well as the size of features such as windows and doors (Figures 8-9). The second set were detailed drawings showing the construction phases, building materials, and layers of frescoes (Figures 10-11).

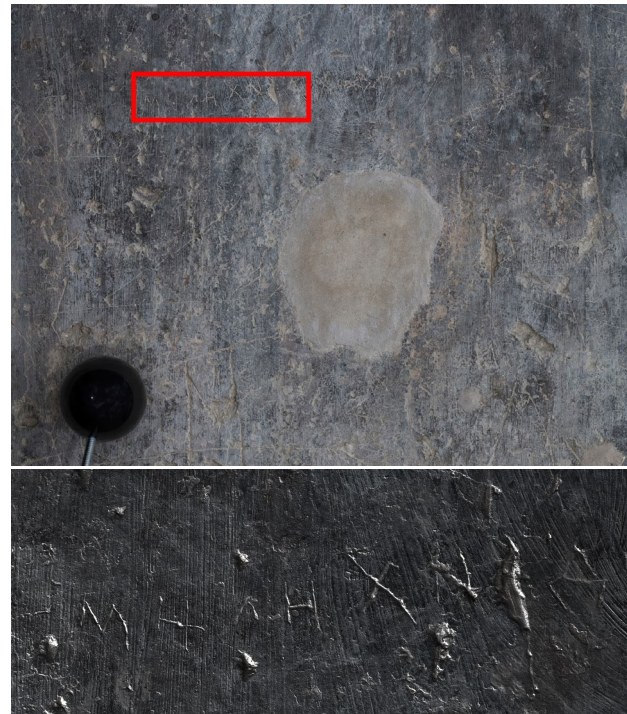
Figure 13. Interior RTI Panel 5-7. (top: colored RTI image; bottom: graffiti enhanced with the specular enhancement filter).

In total, RTI was done on nine graffiti from the interior of the narthex of the church and one from the exterior. Due to the location of the interior graffiti four RTI panels were captured and processed on site using RTIBuilder (Version 2.0.2). The four panels on the interior of the narthex represent groups of inscriptions (panels 5-7; 11; 15-16; 18-19-29) (Figure 13). The Specular Enhancement filter helps to reveal the incisions of the graffiti, but also the marks of the brushstrokes. One RTI was shot on the south exterior wall, next to the entrance to the Narthex (Figure 14). It captures a very deteriorated inscription, which was almost impossible to find, even using the detailed description of its location, published by Christo Andreev in 2004 (Андреев, 2004). The result from the RTI proves that the inscription did exist, although big parts of it are lost due to the decaying of the limestone.

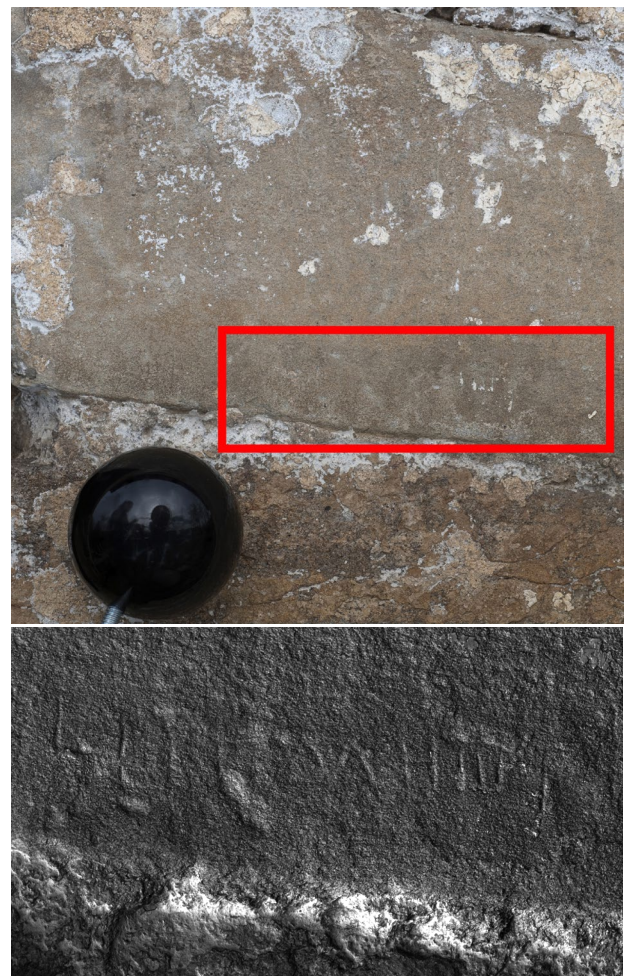
Figure 14. Exterior RTI of Inscription. (top: colored RTI image; bottom: graffiti enhanced with the specular enhancement filter).
