## MACHINE LEARNING FOR THE DOCUMENTATION, PREDICTION, AND AUGMENTATION OF HERITAGE STRUCTURE DATA

Satwant Rihal\*, Hisham Assal

Cal Poly State University, San Luis Obispo, California, USA – (srihal, hhassal)@calpoly.edu

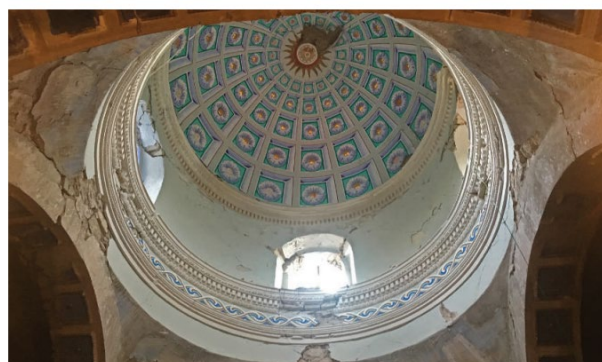
**Figure 1.** Typical damage of domes – Historical Churches September 2017 Puebla, Mexico earthquake

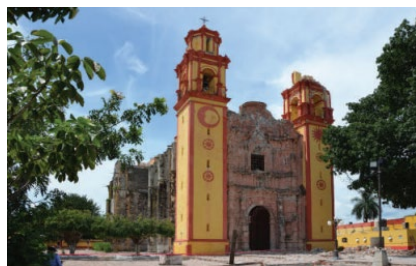
**Figure 2.** Typical damage of facade and bell towers – Historical Churches September 2017 Puebla, Mexico

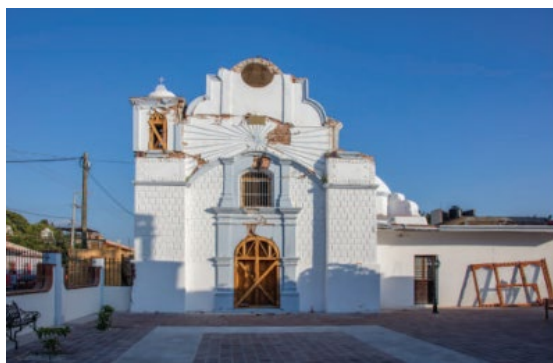
**Figure 3.** Typical damage of facade and bell towers – Historical Churches September 2017 Puebla, Mexico earthquake

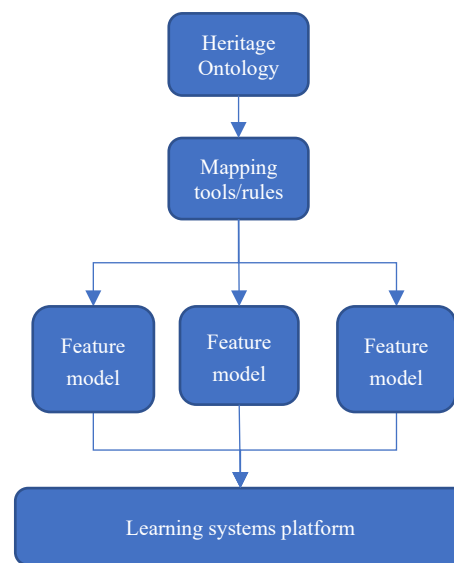
**Figure 4.** Ontology-based machine learning system Architecture

This paper proposes to develop an ontology to represent all aspects of heritage structures and their values, and use the ontology to generate machine learning (ML) models for specific types of analyses as needed. The ontology allows for the definition of rules that specify required parts of the general model to be included in each machine learning model. There are three components to this proposed development: 1) the ontology, 2) mapping tools and rules, and 3) the learning system platform. Figure 4 shows the general architecture of the proposed system.

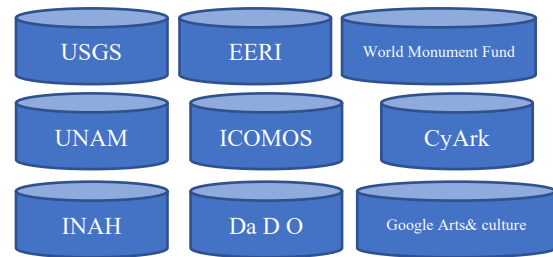
Figure 6. Earthquake data sources

Many databases exist with organizations that track and record earthquake information in different ways, ranging from general earthquake event data, such as location, epicenter, magnitude, etc. (e.g. USGS) to damage data to structures and more specifically damage to cultural heritage buildings (e.g. World Monument Fund, ICOMOS, CyArk, UNAM, INAH). Figure 6 lists some of the more prominent data sources around the world, which provide access to researchers and earthquake experts.
