SURVEY, DIAGNOSTICS, MONITORING METHODOLOGY AND DIGITAL TWIN FOR THE CONSERVATION OF THE FACADE OF THE CHURCH OF SANTA MARIA DI NAZARETH IN VENICE

I. Rocca^{1*}, I. Forti¹, G. D'Acunto¹, A. Saetta¹

¹ DCP, University IUAV of Venice, Campus Terese, Dorsoduro 2206, 30123 Venezia, Italy - (dacunto, iforti, irocca, saetta)@iuav.it

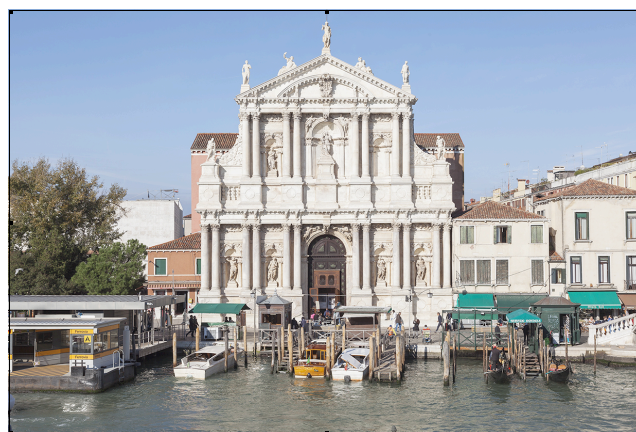
Figure 1. Facade of the church of Santa Maria di Nazareth, at the end of the restoration works in December 2018.

The baroque façade of the church of Santa Maria di Nazareth (*vulgo* degli Scalzi), a work of the late seventeenth century by Giuseppe Sardi, besides being a monument connoting the city of Venice, located at the entrance to the lagoon city, is a unicum in the context of the city, as it is entirely made of Carrara marble (Bettini and Frank, 2014), a lithotype rarely used in the Venetian environment. Over the centuries, this saccharide-based limestone has proved unsuitable, in particular given its location on the outside which subjects it to the aggressiveness of the lagoon climate, in addition to the sudden rise and fall in temperature due to both radiation and frost, Figure 1.

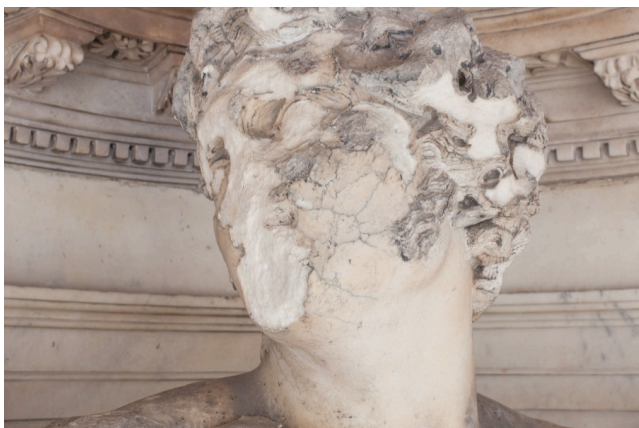
Figure 2. Detail of the degradation, 2016. -- Detail of the head of San Giovanni Battista: the Carrara marble shows different states of decay, the main ones being erosion, pulverization, widespread craquelure and chromatic alteration.

In many parts, especially in the more projecting ones, the stone surface came to detachment and pulverization by simple contact, Figure 2-3.

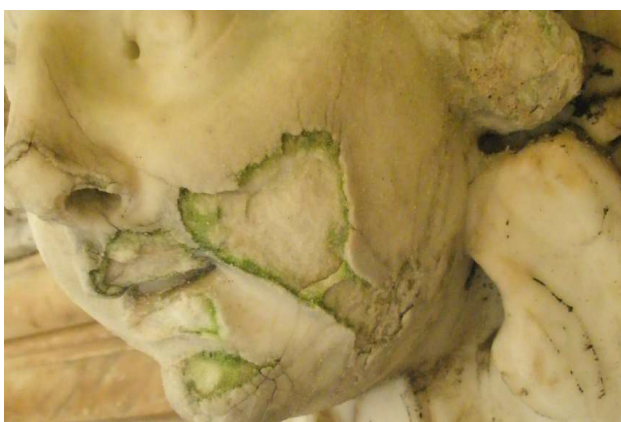
Figure 3. Detail of a cherub placed in the string course of the second order of the façade, clear example of different states of degradation of Carrara marble.

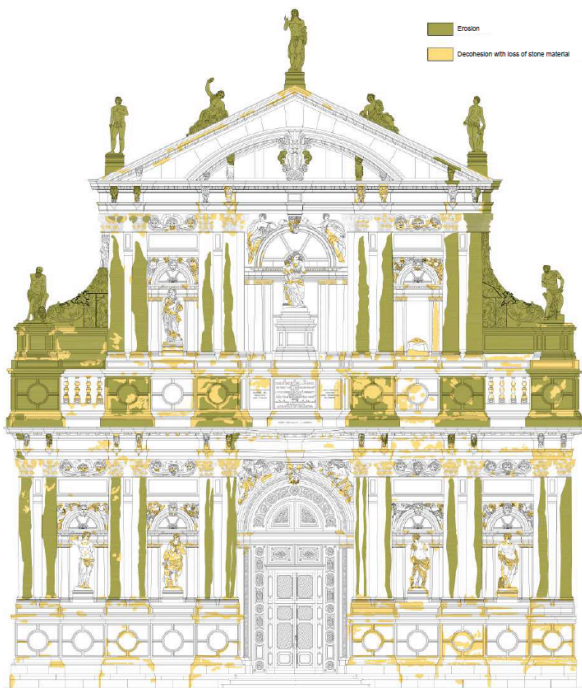
Figure 4. Mapping of degradation phenomena: erosion and decohesion

As described, the surface condensation processes of humidity and mists have proved particularly harmful for Santa Maria di Nazareth façade. Since such a dramatic condition/precarious state of conservation of the Carrara marble (made explicit via the map tool, Figure 4) did not find match in existing scientific literature, an experimental research in collaboration with the CNR/Institute of Geosciences and Earth Resources of Florence was undertaken. Thus, a fundamental partnership for choosing the consolidation agents and the method of application as well as for validating the performance was established (Forti et al., 2021).

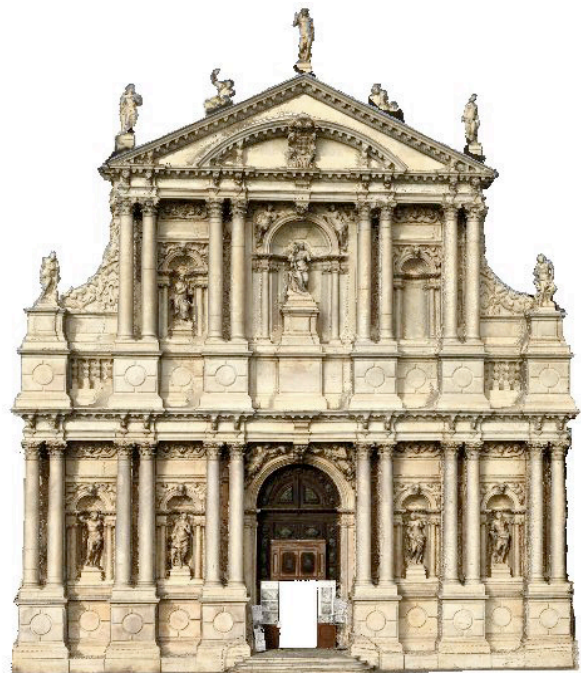
Figure 6. 3D digital model of the façade

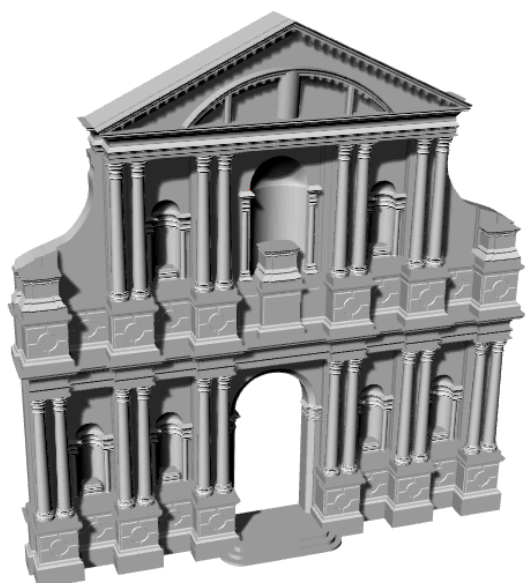
Figure 7. Digital Twin of the façade: 3D digital model representative also of the correct volumes

From the automatically oriented images a dense points cloud was obtained, which was scaled and roto-translated into the reference system, allowing integration with laser scan data. The following process of polygonal modeling occurs through creation parameters that follow a three-dimensional coordinate system and the obtained polygonal objects (meshes) return reality both as shape and as texture.

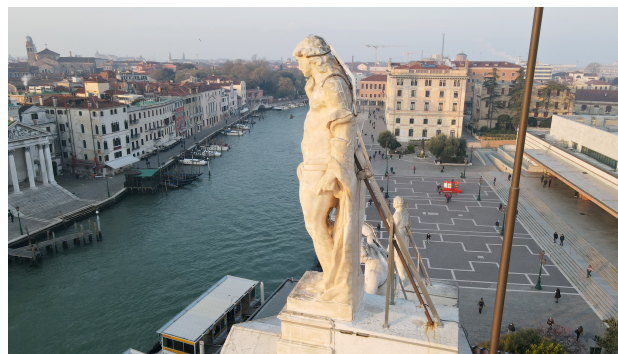
Figure 8. Close-up image from drone survey
