## RESTORATION WORKFLOWS BY MEANS OF PHOTOGRAMMETRY: THE CASE STUDY OF PASHAS BRIDGE

The restoration of cultural heritage sites is a complex and challenging process, particularly when the structure holds significant historical and cultural value. This paper refers to the first stages of the restoration study of Pashas Bridge, one of the largest stone bridges in Greece that was destroyed during World War II and further damaged by an earthquake in 1995. The project was assigned to multiple research groups from the Aristotle University of Thessaloniki (AUTH) for a period of 18 months by the Greek Ministry of Culture and Sports. To restore the bridge effectively, it is essential to accurately record, document, and assess its current condition. Through the use of photogrammetry, which creates 3D models of objects or structures using images, and unmanned aerial vehicles (UAVs) which assisted in capturing multiple shots with various angles of the bridge, a detailed 3D model of the bridge's current condition was generated. In addition to these technical approaches, historical research and documentation were utilized to understand the bridge's cultural heritage value. The process included

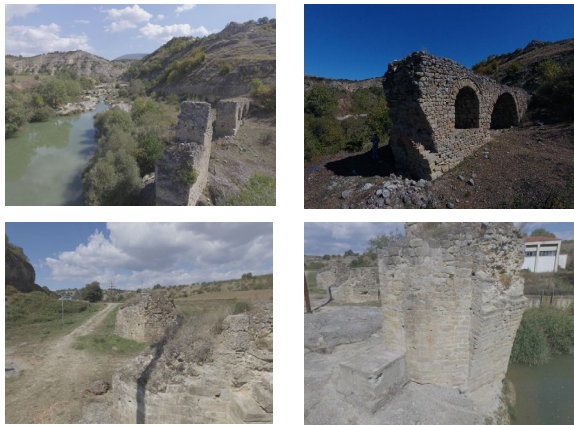
**Figure 3.** Bridge's current remains.  
(source: Photos from field survey)

The remnants have also been heavily impacted by the 6.6 magnitude earthquake that hit the nearby town of Kozani in 1995 (Papanastassiou et al., 1998) and have remained in a state of deterioration ever since (Figure 3).

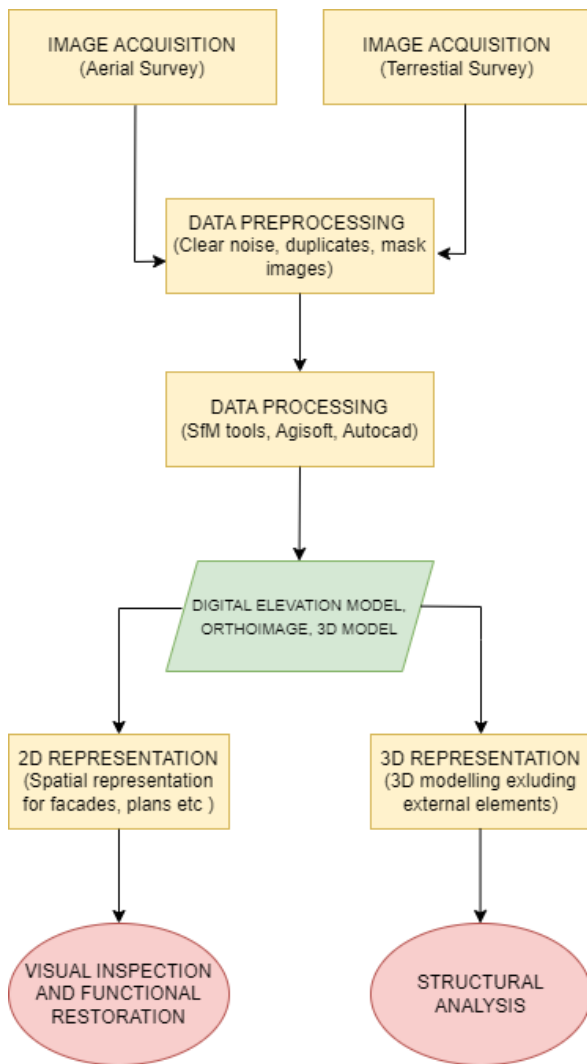
**Figure 4.** Workflow of the SfM approach and further possible structure and functional analysis

The pipeline which outlines the primary steps of the team's restoration project is depicted in Figure 4.

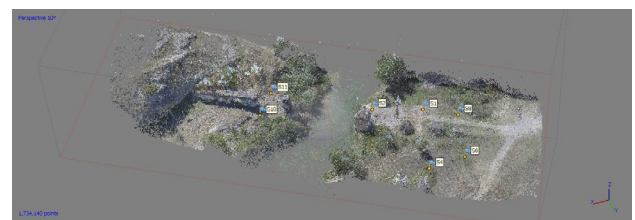
**Figure 7.** Point Cloud (source: Agisoft Metashape Pro)

The collected data was processed using the Agisoft Metashape Pro (Agisoft, 2021). Out of the 1350 captured images, a total of 1160 images were finally imported and used for alignment. The point cloud generated contained 37,993,185 data points, including noise and water data. GCPs from a txt file were inserted, with control points having an accuracy of 6 cm both horizontally and vertically (Table 1). This level of accuracy is considered good, and it ensures that the resulting 3D model is reliable and can be used for accurate measurements and further analysis.
