# STONE WALLS, CHARACTERS, MOSS AND TREES – MULTILEVEL DOCUMENTATION OF INSCRIPTIONS AND GRAFFITI FROM DIFFERENT CENTURIES IN A FORMER SANDSTONE QUARRY

The Fingalshöhle near Illesheim, Germany, is today both an archaeological and a cultural heritage site. This paper will show the application and analysis of the combination of terrestrial laser scanning (TLS) and high resolution structured-light-scanning (SLS) as a multilevel documentation approach to help preserve this unique location with its graffiti and inscriptions from the past 300 years. The site is a decommissioned sandstone quarry which has been gradually taken over by nature. The quarry served as field quarters for troops during several wars, with soldiers carving inscriptions into the sandstone walls. In the later 18th and 19th centuries, the site attracted visitors, who also immortalised themselves. These witnesses to the site's diverse history are threatened by the ever-increasing overgrowth of the quarry, and above all by weathering processes impacting the unprotected stone. Photographs show that over periods as short as the last 15 years, climatic effects have completely obliterated some inscriptions. The characters

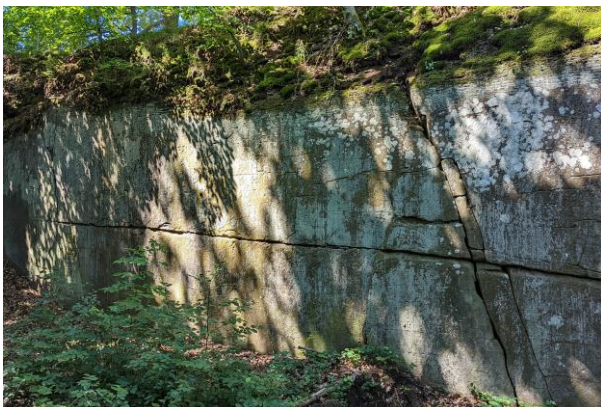
**Figure 1.** One of the sandstone walls of the quarry in July 2022, illustrating the challenge of moss and lichen.

The site is a decommissioned sandstone quarry, which has over the past several centuries, been gradually taken over by nature and the surrounding woods (Fig. 1 and 2). According to basic historical research, it is known that the site was still in use after the stone mining ceased: During the Thirty Years' War (1618-1648), and later from 1806 on during the Napoleonic Wars (1804-1815), the quarry served as field quarters for troops. There the soldiers carved many inscriptions and dates into the sandstone walls in both French and German. In the later 18th and 19th centuries, the site attracted visitors from the nearby castle, who found in this place an example of the wild landscape which was popular with the Romanticism movement at that time (Schultheiß 1986).

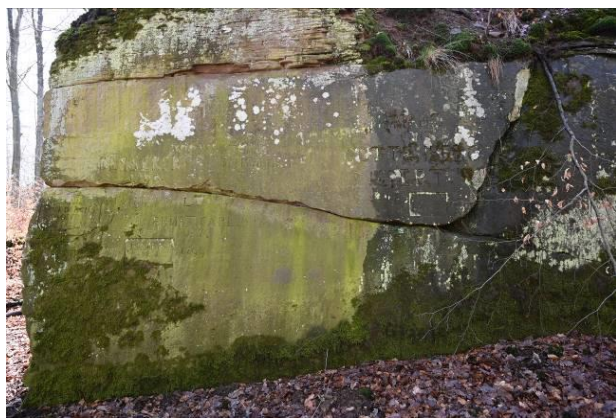
**Figure 3.** A stone wall of the quarry with graffiti and biological coating (moss, lichen, small tree) and water drainage traces especially on the right side.

While the TLS-data serves as an overall documentation of the complex site, it is also a basis to geo-reference the high resolution structured light scanning data of the more delicate inscriptions and graffiti that are barely readable or threatened due to their exposition and location. As discussed by Valente et al (Valente et al 2019), graffiti can be extremely difficult to document. In the case of the quarry these difficulties are not caused by poor visibility due to outdoor lighting conditions (shade, sunshine), bad stone surface conditions, moisture, minimal scratch depth, multiple layers of writing and particularly in this case, the growth of lichen and moss and natural erosion (Fig. 3.4, 6).

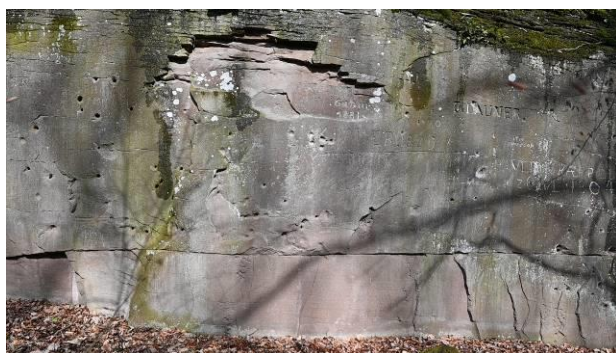
**Figure 4.** Stone wall with graffiti, bullet holes and a big spalled of part.

The main problems of the stone walls in the former quarry are erosion, mechanical damage and biological colonization, as well as moist areas due to water drainage as categorised in the ICOMOS glossary on stone deterioration patterns (ICOMOS 2010). Some bigger parts have even spalled off in the last few years (Fig. 4). Therefore the inscriptions and graffiti in the area of the former quarry are thus slowly but steadily being erased.

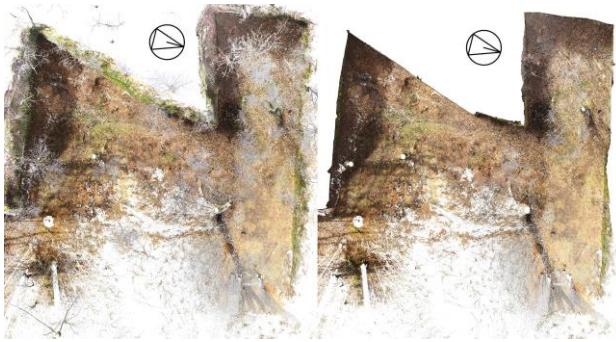
**Figure 5.** Overview of the quarry; point cloud from the TLS-data (left), ground floor-section of the point cloud at the level of the stone walls (right).

The positions for scanning were selected to cover all parts of the five stone walls. To minimize the obstruction of the laser beam due to leaves and branches of the bushes and trees the work was done in the wintertime when the vegetation is less abundant. The 20 individual scans were registered in Faro Scene software (Version 2020.0.7) using the point cloud registration algorithm, and colour was applied using the images taken by the scanner's built-in HDR-camera. To increase the quality of the resulting point cloud, the scanning data was cleaned manually afterwards: Trees and bushes were removed in the areas next to

the stone walls (Fig. 5). In addition, points recorded at a sharp angle to the walls were erased, to reduce noise on the surface and to improve the visibility and clarity of the inscriptions and graffiti. Afterwards an overall project point cloud was computed, with filtering to provide an even point density and to remove less accurate points recorded over a certain distance from the scanner. This point cloud is used to generate orthophotos of the stone walls.

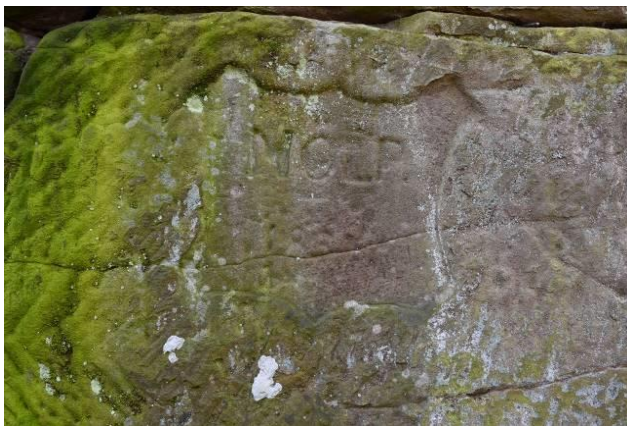
**Figure 6.** Almost illegible graffiti due to biological coating.

The high resolution scanning was carried out with an Artec EVA scanning device using Artec studio 15 software. The settings ensure a 3D point distance up to 0.5 mm. The resolution was chosen to ensure that even filigree scratchings are properly recorded. The recording was performed either while the area of interest was in shadow, or using an umbrella to shield the surface from bright sunlight. The filigree and organic structures on parts of the inscriptions and graffiti covered with moss and moist areas were difficult to capture (Fig. 6). Approximately 30 vulnerable inscriptions and graffiti have been documented using

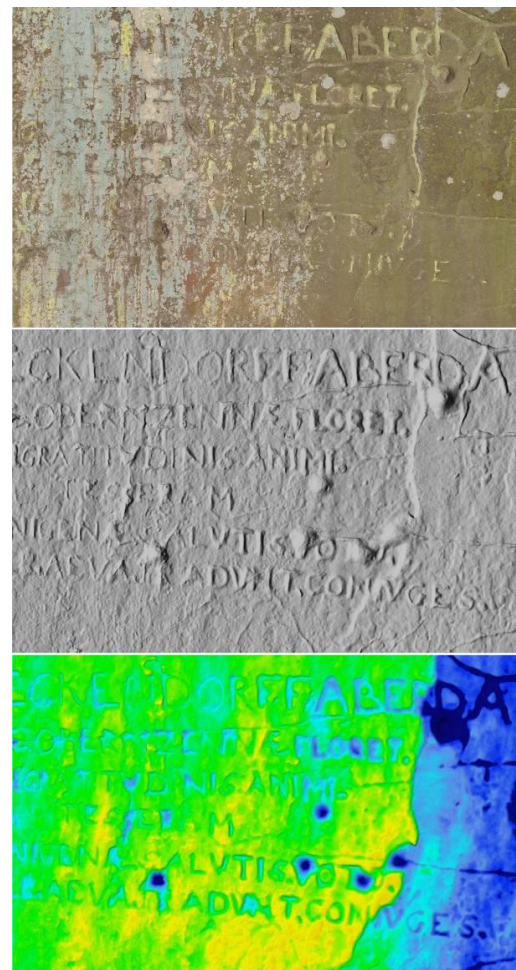
**Figure 9.** Detail orthophotos of the SLS-data of a memorial inscription on the western wall (wall 2) to enhance the readability of the inscriptions (from top to bottom): textured 3D model, textureless 3D model with raking light, depth map from a 3D comparison to a base-level (also usable for future monitoring).

Another way to better visualise the inscriptions and graffiti is a 3D-surface comparison to a plane surface that is displayed in a false colour image. The 3D comparisons were created using GOM Inspect 2022 (Zeiss Quality Suite 2022) (Fig. 9). This methodology could also be used in the future, to monitor the decay process of the site.

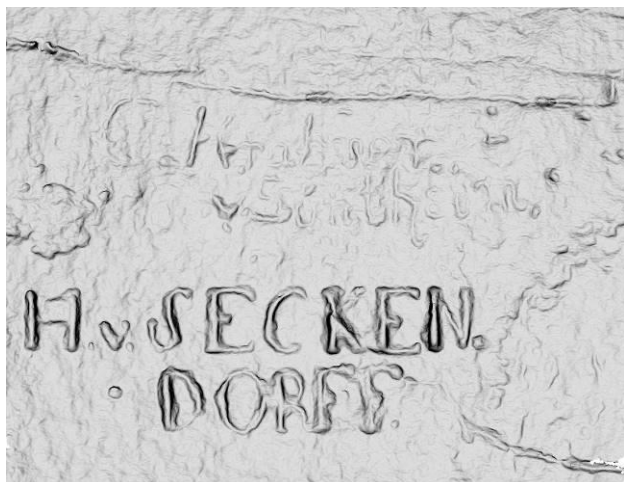
**Figure 11.** Deeply scratched graffiti mentioning "H. v. Seckendorff", with a more delicate example above "G. Krahiser v. Sontheim"

As mentioned above, three of the stone walls show different kinds of inscriptions and graffiti. The size, arrangement and depth of the carvings differ widely. Some of them are scratched into the sandstone walls very deeply, some are well arranged with small sketches or drawings, some are dated, and some are quite delicate and filigree (Fig. 11).

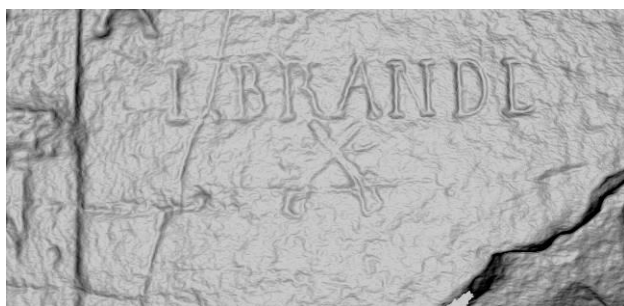
**Figure 14.** Graffiti showing name “I.Brandl” and a drawing of two crossed sabres(?).

Some inscriptions – mainly the ones with a military background – also include small sketches or drawings, like weapons or other tools (Fig. 14).

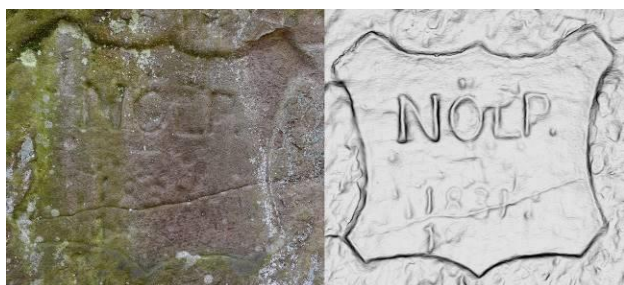
**Figure 15.** Comparison of almost illegible graffiti on the left (photograph) and, on the right, virtually illuminated 3D surface model.

An example of graffiti and inscriptions with nearly unreadable characters and dates is located on wall 2 and engraved in an emblem: the characters in the first line are NÖLP, which can be identified in the photograph, but the date below is indecipherable. Using the textureless 3D surface model it can easily be read as 1831 (Fig. 15).
