# AUTOMATED LARGE-SCALE DAMAGE DETECTION ON HISTORIC BUILDINGS IN POST-DISASTER AREAS USING IMAGE SEGMENTATION

J. Kallas, R. Napolitano\*

Pennsylvania State University, United States of America - (jkallas, nap)@psu.edu

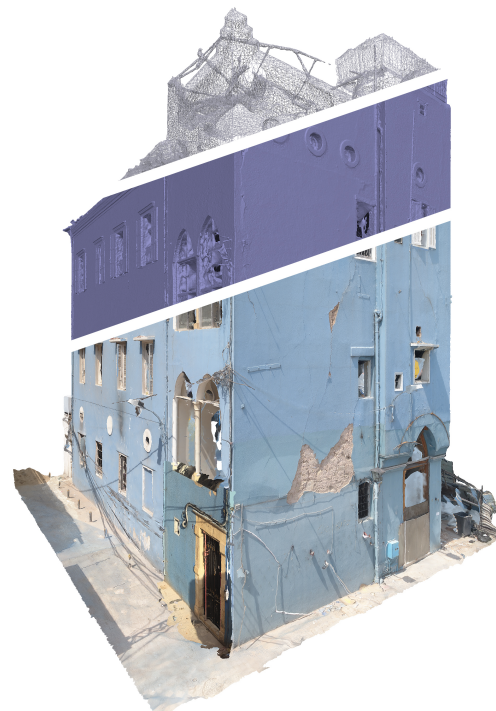
**Figure 1.** 3D photogrammetric model conducted by the author of one of the damaged historic buildings in Beirut following the explosion of August 4th, 2020.

The use of digital technologies has been shown to significantly enhance the speed and efficacy of disaster recovery processes. This was demonstrated in the aftermath of the August 4th, 2020 explosion in Beirut, where the author conducted a comprehensive digitization project of damaged historic buildings using photogrammetry (UNESCO, 2022); (J. Kallas, M. Silver, O. Vileikis, 2020). This generated detailed 3D models of the structures, allowing for rapid implementation of emergency interventions and restoration planning (Figure 1). The application of computer vision techniques, such as image segmentation, can also play a crucial role in disaster relief efforts. Image segmentation, a key aspect of image processing and computer vision, has numerous applications such as object detection, face recognition, and satellite image analysis (Shervin Minaee, Yuri Boykov, et al., 2020). Other successful applications of image segmentation include the automated detection of cracks in roads and bridges,

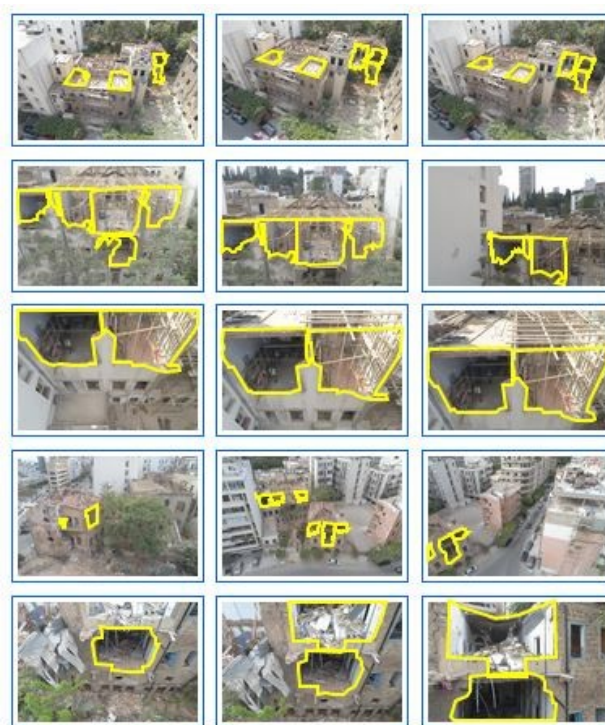
**Figure 2.** Labeling of the images using the VGG Image Annotator (VIA) tool.

The creation of a thoroughly labeled and annotated image dataset is crucial for training a supervised computer vision model. In this experiment, the VGG Image Annotator (VIA) (A. Dutta et al., 2018), an open-source, web-based tool developed by researchers at Oxford University, was utilized to manually create detailed and precise annotations of the wall collapse damage present in all images of the dataset, including both the training and validation sets. This process involved outlining the damaged areas of each image with precise polygons and assigning appropriate labels, resulting in a comprehensive dataset for training and supervising the computer vision model (Figure 2). The annotations were then exported and saved in ".json" file format (json, 2001), enabling seamless integration with the training process.

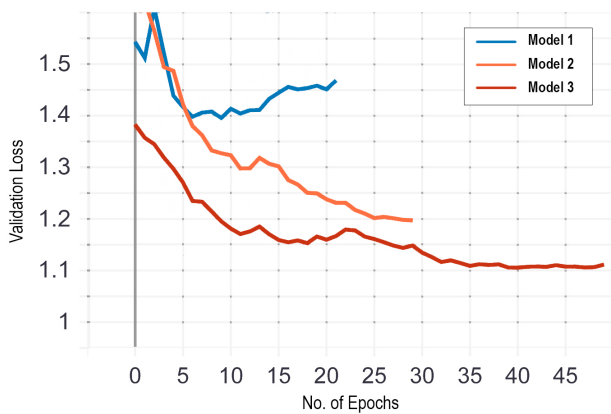
**Figure 3.** Validation Loss curve

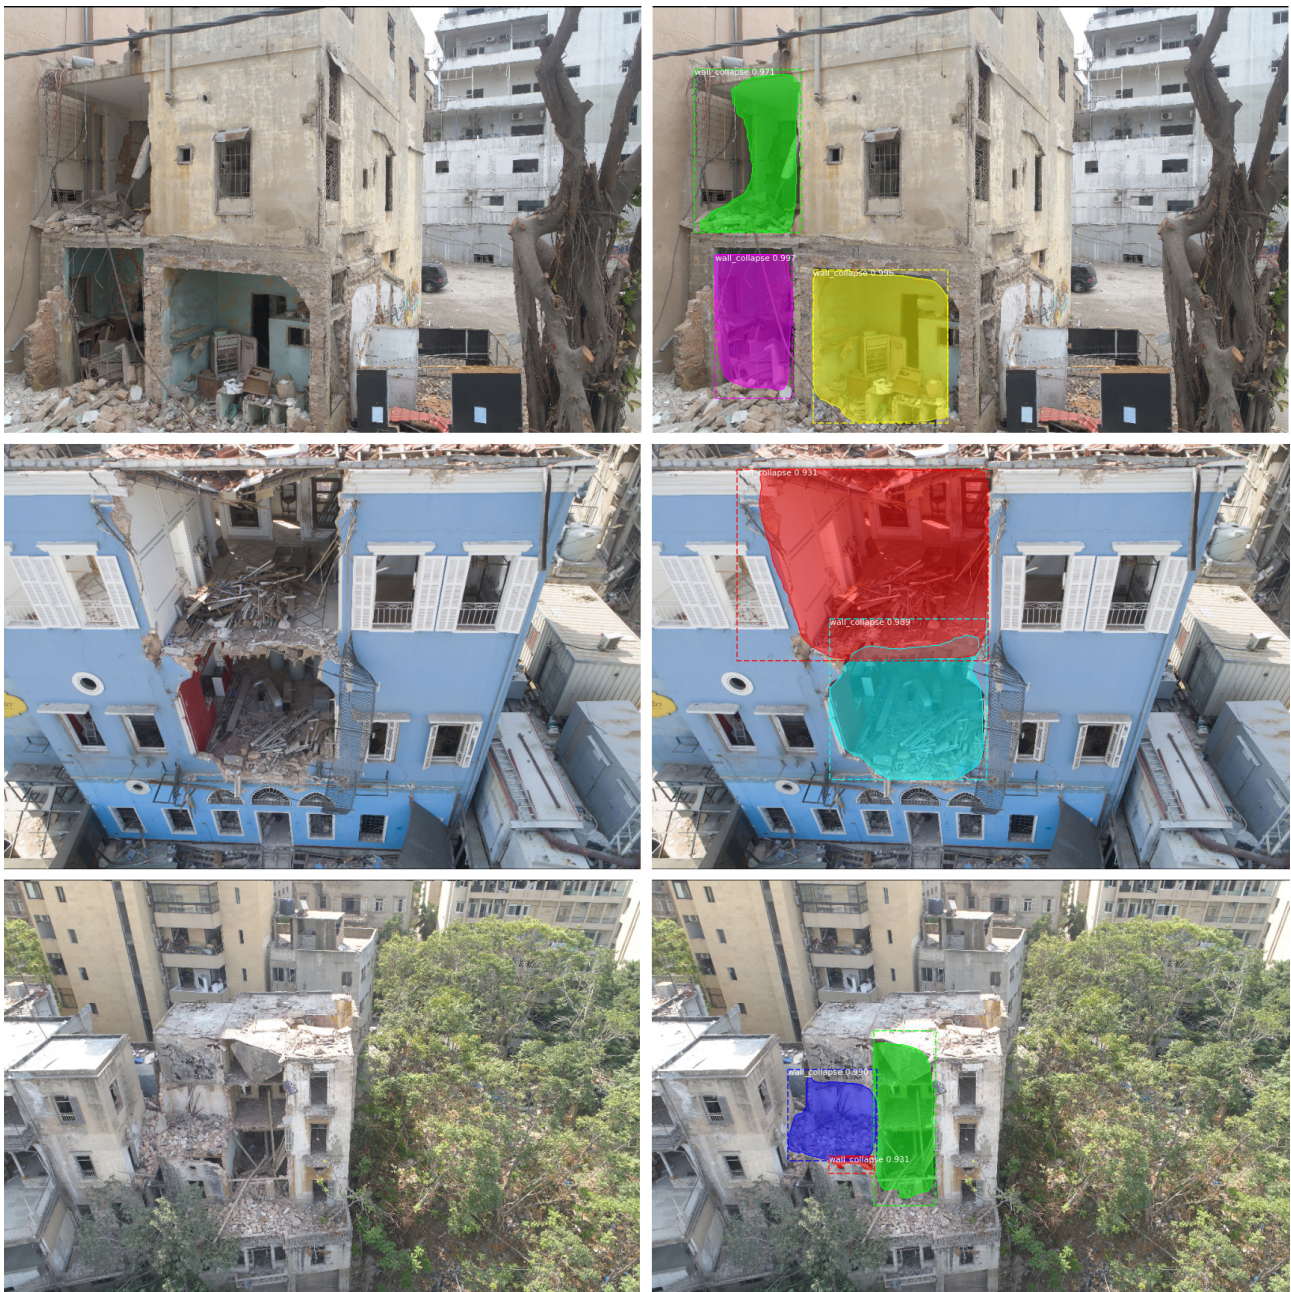
**Figure 5.** Photos showing the wall collapse damage detection results on random photos taken after the Beirut explosion of August 4th, 2020.

The predictions made using the results of model 3 are presented in this section. The wall collapse damage detection accuracy achieved by the model was 72.38% for the training set and 71.81% for the validation set, indicating that the model was able to correctly identify the majority of wall collapse damages in the dataset (Figure 5). The precision of wall collapse detection was found to be 83.17% for the training set and 86.81% for the validation set. Similarly, the recall of wall collapse damage detection reached 84.80% and 80.61% for the training set and the validation set, respectively. The F1 score of model 3 was found to be 83.96% for the training set and 83.59% for the validation set, indicating that the model had a balanced performance in terms of precision and recall. However, misdetections were observed in some cases due to the presence of trees that were partially covering the wall collapse damage or the presence of wooden and metallic scaffolding inside the space where a wall damage occurred. In some cases, wrong detections were also made due to the similarity of demolished windows with actual wall collapse damage. These issues can be addressed in the future by increasing the size of the training dataset and improving the model's ability to learn the relevant features. Visual examples of the misdetections and wrong detections are presented in Figure 6 and Figure 7, respectively.

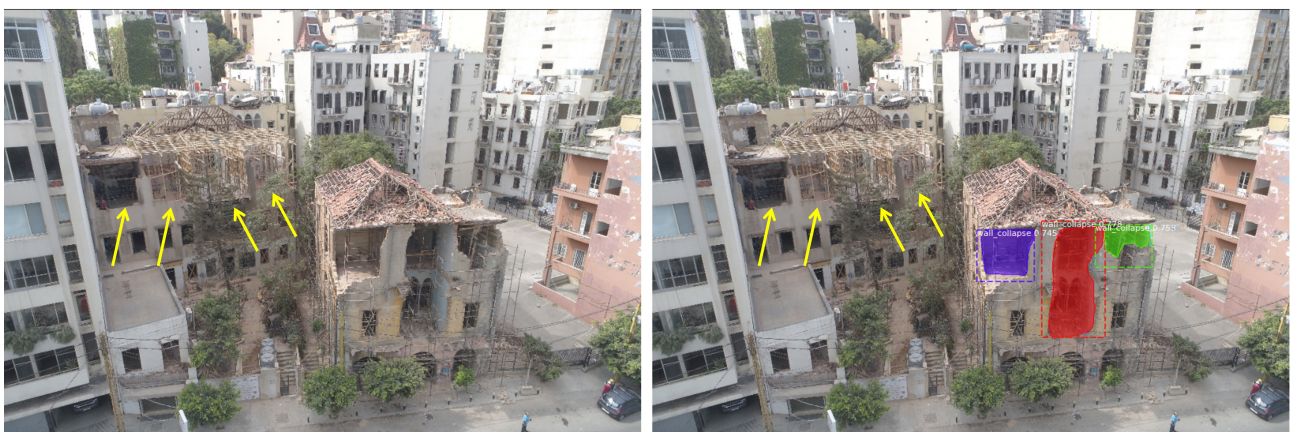
**Figure 6.** Photos showing the misdetection of some of the wall collapse damage in areas partially covered by trees or by wooden and metallic scaffolding on the inside.

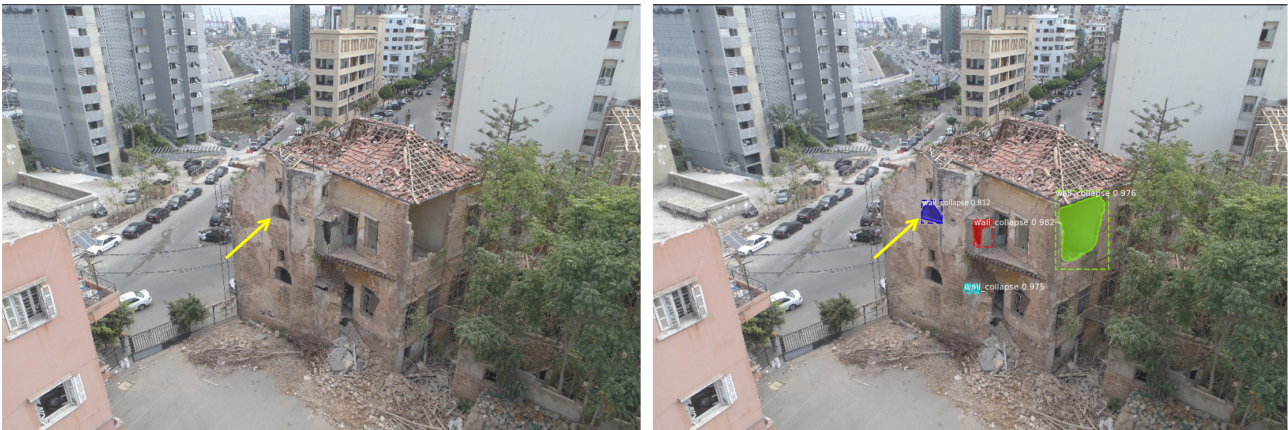
**Figure 7.** Photos showing the wrong detection of the wall collapse damage due to the similarity of demolished windows with actual wall collapse damage.

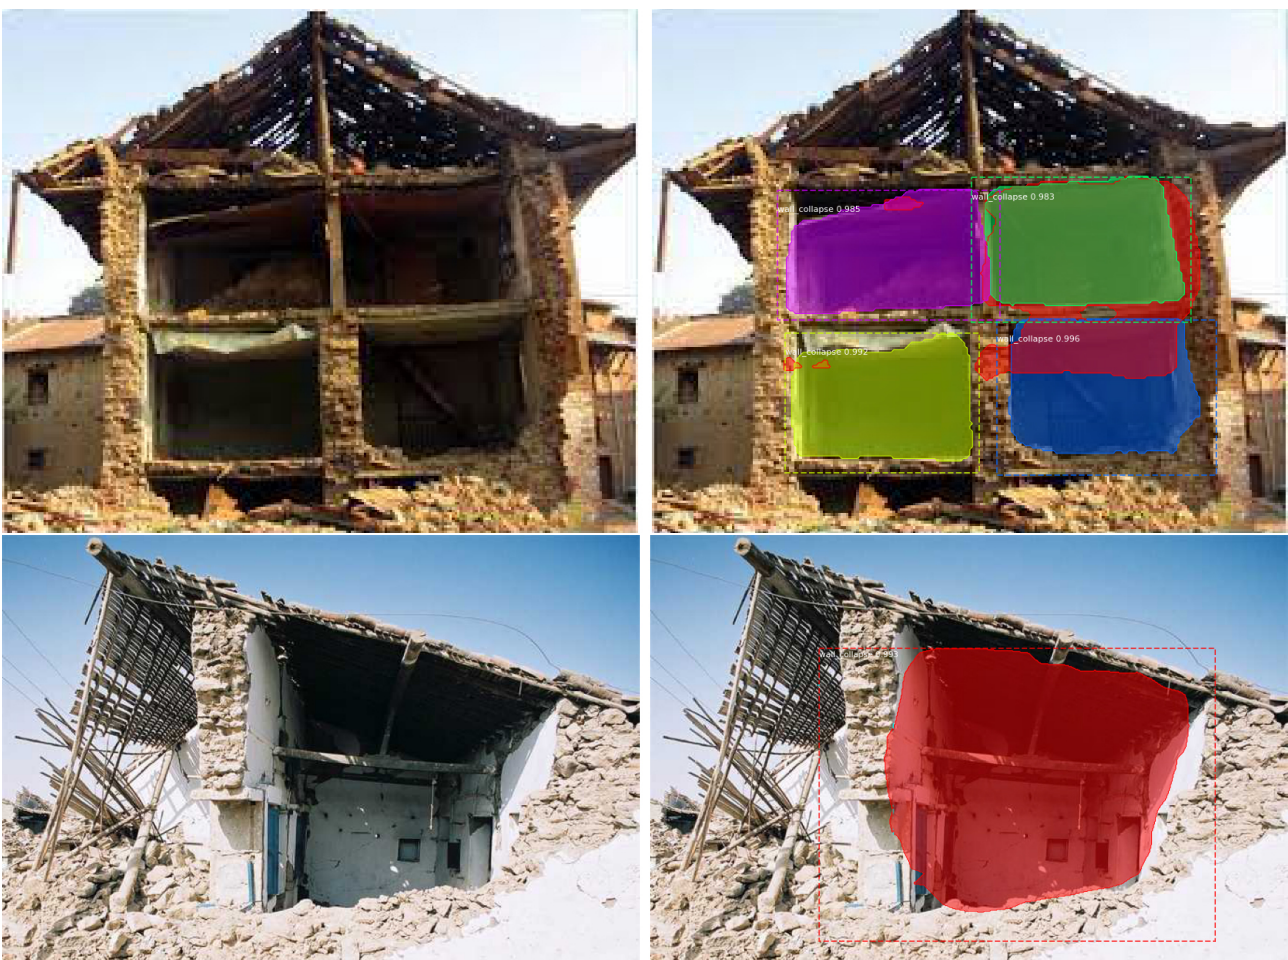
**Figure 8.** Photos showing the wall collapse damage detection results on random photos of damaged buildings taken from the internet.

To verify the efficacy of our proposed method, we conducted experiments on a diverse set of wall collapse images, which were randomly downloaded from the internet. Our evaluation demonstrated that the method yields satisfactory results in detecting wall collapses, indicating its effectiveness in a real-world setting (Figure 8). Moreover, the good detection results we achieved in the experiments validates the transferability of the proposed approach to different datasets, highlighting its potential for a wide range of applications. In summary, our findings suggest that the proposed method holds promise for the efficient detection of wall collapses, paving the way for its application in various domains such as structural health monitoring, and disaster response.
