## STRUCTURAL ASSESSMENT OF STONE-ARCH BRIDGES THROUGH PHOTOGRAMMETRY

The present study examines the structural assessment of Pashas bridge, located at the Western Makedonia, in Greece. This stone arched bridge, which is declared cultural heritage monument, was built during the end of 17<sup>th</sup> century and it was destructed during the 2<sup>nd</sup> civil war, in 1941 by British and New Zealander soldiers aiming to end the German invasion to the South of Greece. It was considered the largest bridge in Macedonia, with a length of more than 100 meters, 6 arches, the biggest one of which was almost 15 meters high. In its current form it is partially collapsed.

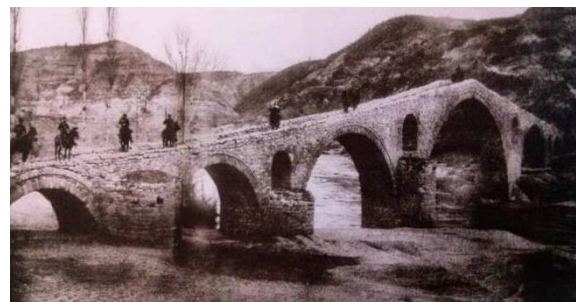
**Figure 2.** North view of the bridge before its collapse

Figure 2 and 3 depicts some of the found photographic material that was utilized in order to approach the actual geometry. A key aspect of the restoration process is the need to properly record, document and assess the current state of the stone bridge. Photogrammetry, using images to create accurate 3D models of objects or structures, can be a particularly useful tool. By combining the use of unmanned aerial vehicles (UAVs) that support the acquisition of a huge number of images from many angles, and specialized software, a detailed 3D model of the stone bridge in its existing state can be created. Thus, the 3-D model of the bridge was measured and created, on which the study of its repair-restoration and reconstruction will be based.

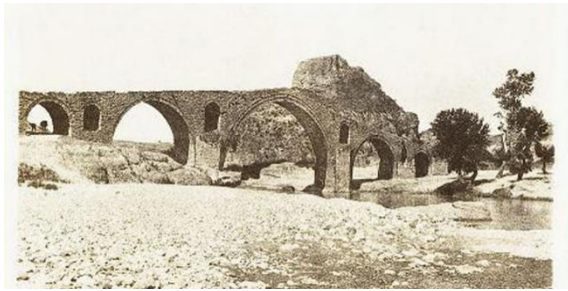
**Figure 3.** South view of the bridge before its collapse

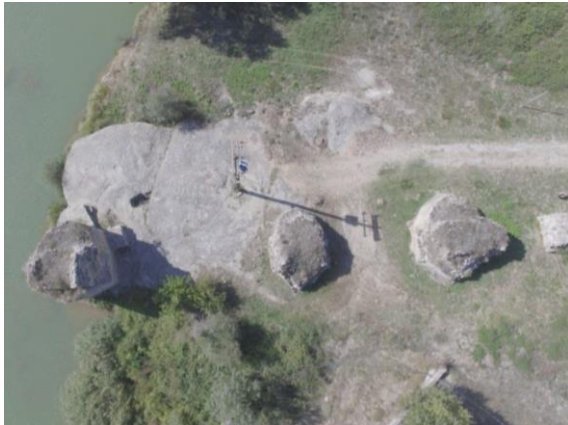
**Figure 4.** Top view of existing parts of the piers

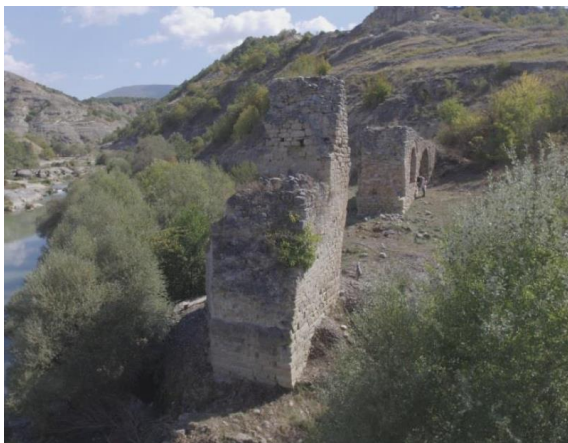
**Figure 5.** Side view of existing parts of the piers

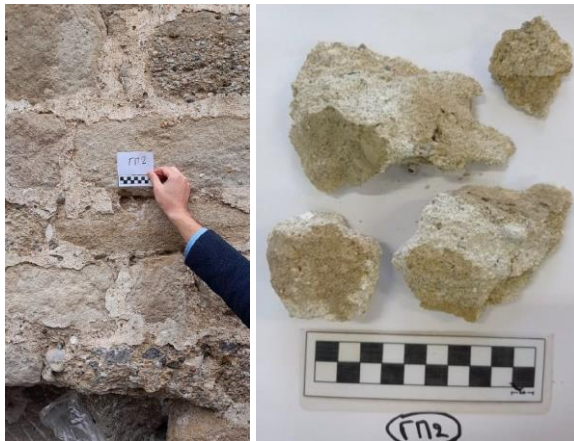
Figure 9. Sample of mortar taken from existing pier

Pasha's bridge structural system is constructed with stone masonry parts. In order to identify the mechanical and physico-chemical properties of the used materials, a number of samples were taken from the existing parts, figure 9.

The obtained results were used to understand the existing material and suggest compatible restoration materials. The composition of the mortars is calcite with the use of soil material with pozzolanic action. The aggregates used are natural and predominately fine-grained in an even distribution and in a powder/aggregate ratio of the order of 1/2.5. The maximum grain size of the aggregates is 8mm. The compressive strength is 4.0-4.9MPa while the porosity ranges from 18-20%. From the evaluation of the analysis results of the mortars, based on its composition and structure, compositions for the reconstruction of the collapsed parts will be defined, compatible with the old materials, which preserve the physico-chemical characteristics of the original mortar with the necessary adjustments to make it workable and obtain strength compatible with the existing ones. The high presence of salts in the materials indicates the requirement of high porosity for the structure to "breathe".

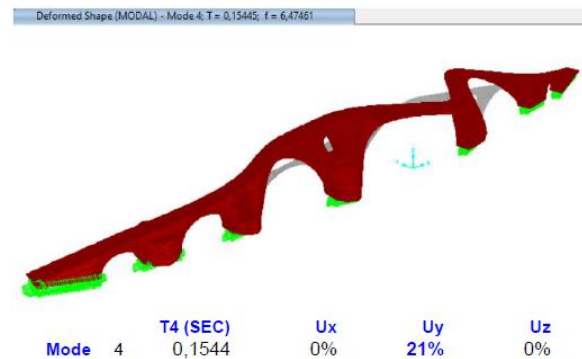
Figure 11. Mode 4 - deformed shape, T=0.154sec

described in section 2. Following, the appropriate thickness was assigned to the shell elements according to the measured and predicted thickness of each structural member as it is described in section 3. A number of load combinations were formed to evaluate the bearing capacity of the structure. These load combinations include gravity loads, live loads, seismic type loads and hydraulic pressure imposed by the flow of the river. The seismic type loads are simulated through response spectrum analysis, which is based on the modal analysis of the structure. The following figures depict the dominant modes derived from the modal analysis. Mode 1 is the dominant mode in the out of plane direction with mass participation factor 24%, while mode 4 has mass participation factor 21%, figures 10-11. Mode 1 is the dominant mode in the in plane direction with mass participation factor 33%, while mode 9 has mass participation factor 21%, figures 12-13.
