Evaluating Flood Damages using Land Cover Changes Detection

Paulina Raeva, Silviya Katsarska-Filipova, Dobromir Filipov

UACEG, Faculty of Geodesy, Laboratory of Remote Sensing and Spatial Data Processing, Sofia, Bulgaria -
paulina.raeva@gmail.com, filipova_fgs@uacg.bg, filipov_fgs@uacg.bg

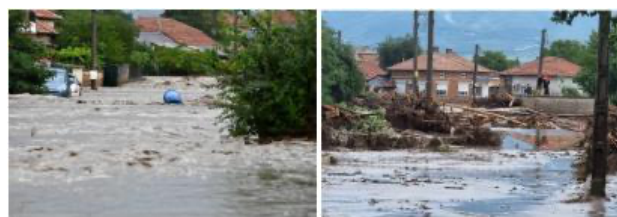
Figure 2. Disastrous flood impacts in Karlovo Region (photo credits: Bulgarian Red Cross)

According to reports from the Directorate General Fire Safety and Civil Protection of Bulgaria, the village of Bogdan was entirely submerged at one point following the failure of an embankment along the Stryama River (Floodlist, 2022). The floods caused severe damage or destruction to at least 200 homes across the region. Critical infrastructure, including bridges and roads, was destroyed, leaving several villages temporarily isolated. Damage to power supply systems and water infrastructure resulted in prolonged outages of electricity and drinking water services.

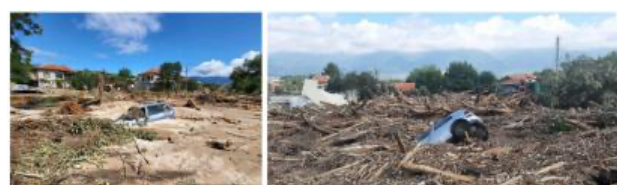
Figure 3. Disastrous flood impacts in Karlovo Region (photo credits: Bulgarian Red Cross)
