# Evaluating Rapid Data Acquisition Methods for Structural Analysis of a Church at Risk from Climate Change Induced Subsidence

Oriel Prizeman<sup>1</sup>, Sharham Sharifi<sup>2</sup>, Yichang Dai<sup>1</sup>, Brunella Balzano<sup>3</sup>

<sup>1</sup> Centre for Sustainable Building Conservation, Welsh School of Architecture, Cardiff University, King Edward VII Avenue, Cardiff CF10 3NB – (prizemano, DaiY34)@cardiff.ac.uk

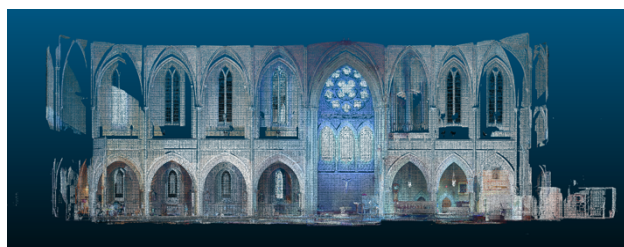
Figure 1. St John the Evangelist, Norwood Long section (N) from FARO TLS

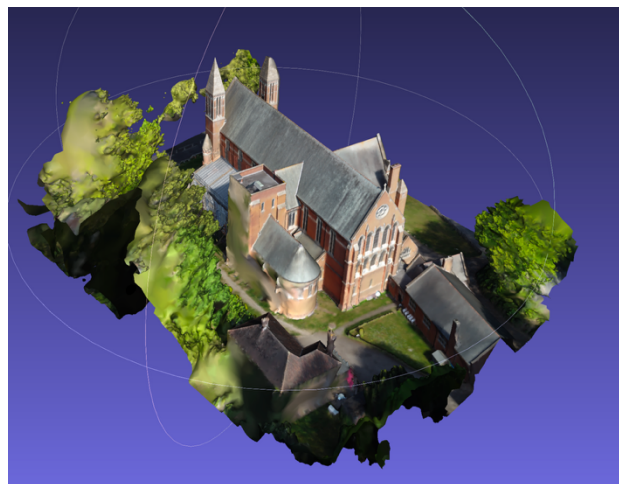
Figure 2. St John the Evangelist, Norwood Aerial mesh from drone photogrammetry

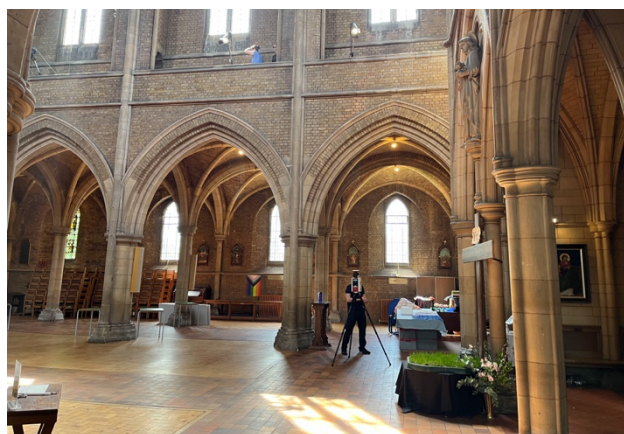
Figure 3. St John the Evangelist, Norwood RIEGL VZ600i in use

The RIEGL VZ-600i, a state-of-the-art terrestrial laser scanner designed for rapid and high-precision data acquisition. Capable of capturing up to 2.2 million points per second with a range of up to 1000 meters, it is well-suited for both large-scale and detailed architectural documentation (RIEGL USA, 2025a). In tandem a FARO Focus 3D scanner (FARO Technologies, 2010) and a handheld LEICA BLK2go (Leica Geosystems, 2019) were also used to gather terrestrial data. Due to the considerable height of the church building, a photogrammetric model was simultaneously used to achieve a complete model, using a modest DJI Mavic mini 3 drone (DJI, 2022) to complete the envelope of

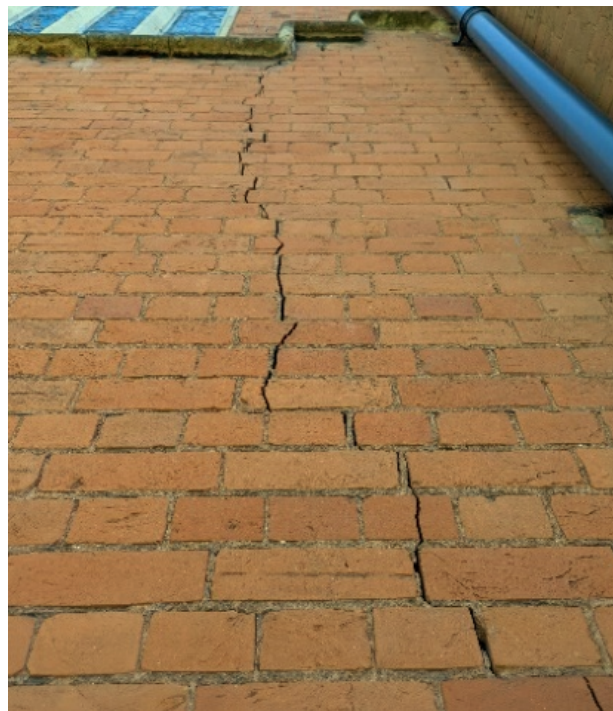
Figure 4. St John the Evangelist, Norwood Vertical crack in the south wall indicating possible settlement

3d data. In addition to these advanced methods, classical survey techniques were also applied by photographing visible cracks and surface damage. A reference object, such as a coin, was placed next to the cracks to estimate their size and monitor changes over time. Although less comprehensive than laser scanning, this approach remains valuable for basic structural assessment, particularly in areas with limited access or where equipment use is constrained.

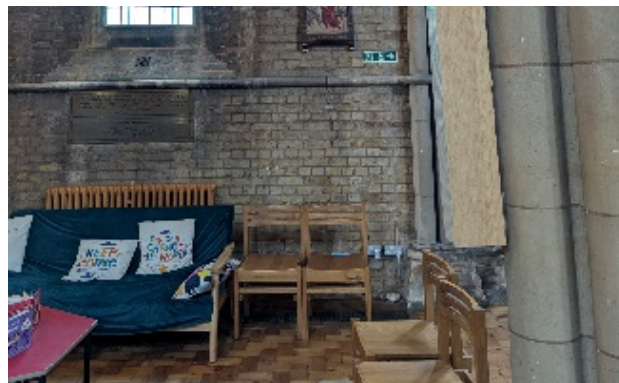
Figure 5. Furniture and fixed elements that limited full scan visibility and access

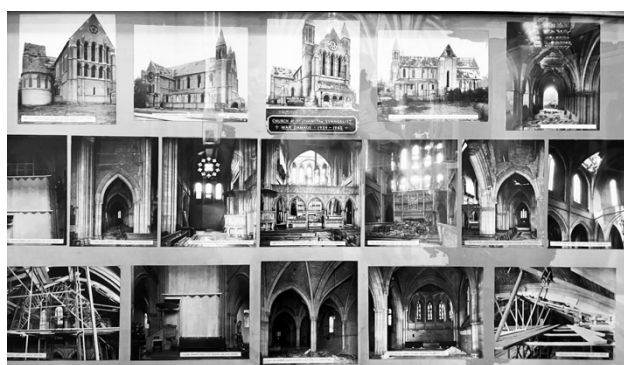
Figure 6. Photomontage of war damage in church

A framed photo-montage in the entrance to the church illustrates the extent of aerial bomb damage in 1944. The church was repaired and restored between 1946 and 1951 unlike the more catastrophically damaged St John the Evangelist in Red Lion Square (1878) also designed by Pearson, which was demolished following severe bombardment in 1941 (Ashby, 2016).

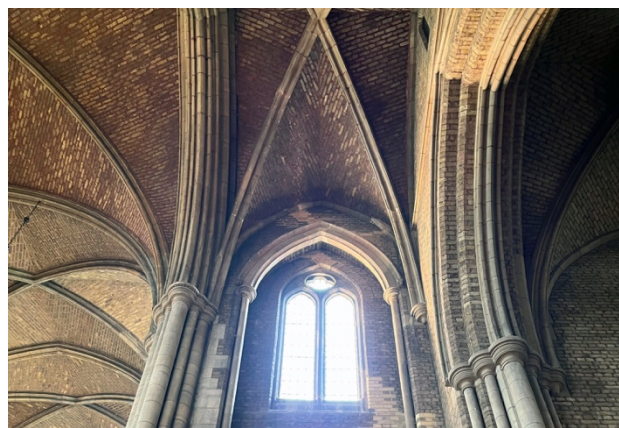
Figure 7. Visible repairs

Evidence of this rebuilding is visible in the contrasting brick repairs in vaults. In 2016, further damage was incurred where large cracks emerged between the main body of the church and the South aisle. These were underpinned in 2017 with work funded by the Heritage Lottery Fund and timber propping remains externally (National Churches Trust, 2025). In addition, a set of nine signed architect's original drawings of the church dated 1878 are on display in the vestry area. A history of the church written in 1937 (Bateman, 1937) and another available online through the church's website provide further accounts of iterative change (Ashby, 2016).

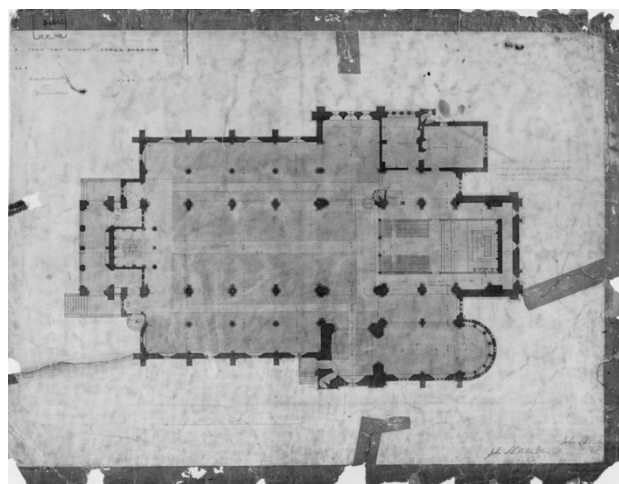
Figure 8. St John the Evangelist, Norwood, Architect's signed plan 1878 (onsite)

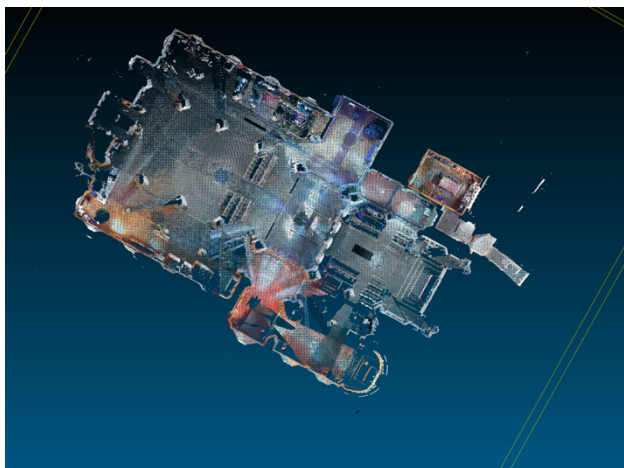
Figure 9. St John the Evangelist, Norwood cutaway through RIEGL pointcloud to show undulating floor

Quiney observes that the church is exceptionally wide – he observes that “the nave bays are twice as long, and wide as they are high up to the springing of the vaulting arches - a much lower proportion than the Golden Section” (Quiney, 1979). It is possible that this disproportionate breadth may also provide a vulnerability in terms of subsidence – indeed the undulations in the pavement are clearly visible. The provision of access to measurable 3d modelling particularly in grayscale and depth map renditions of the detailed scan data make this immediately obvious and also provide an opportunity for monitoring change over time.

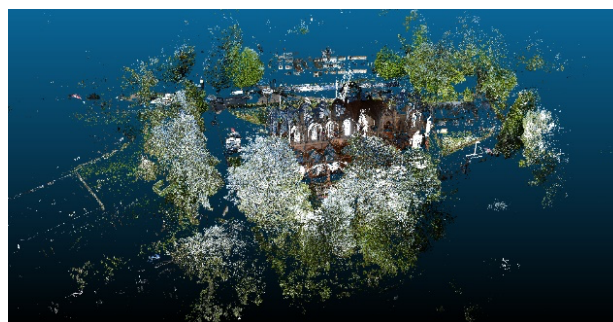
Figure 10. Point cloud data captured using the RIEGL VZ-600i terrestrial laser scanner, providing high-resolution structural details

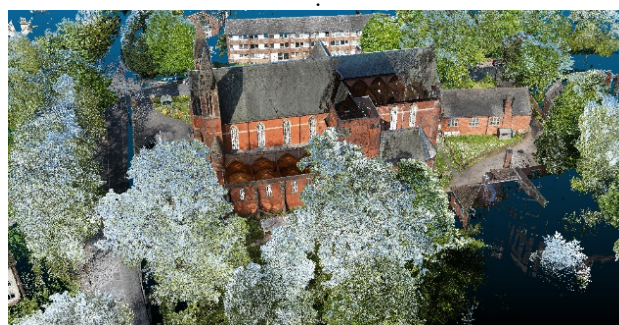
Figure 11: Combined and integrated .e57 point cloud generated from RIEGL, LEICA BLK, FARO Scene and drone datasets, forming the basis for unified modelling

The generation of a working plan became a prerequisite for further structural analysis. The E57 data from the FARO X1303D, Photogrammetric model from the drone imagery, and RIEGL terrestrial laser scans (Figure 10) were first combined to produce an integrated point cloud for optimal results (Figure 11).

This consolidated dataset was generated in CloudCompare, where non-architectural elements—such as surrounding vegetation and peripheral site features—were removed (CloudCompare Development Team, 2025). This filtering process allowed the church structure to be isolated, enabling more focused and efficient modelling efforts. Also in RiPANO some orthogonal elevations were swiftly generated (RIEGL USA, 2020) (Figure 13). These can be compared with the original design drawings showing the incomplete proposed tower (Figure 12).

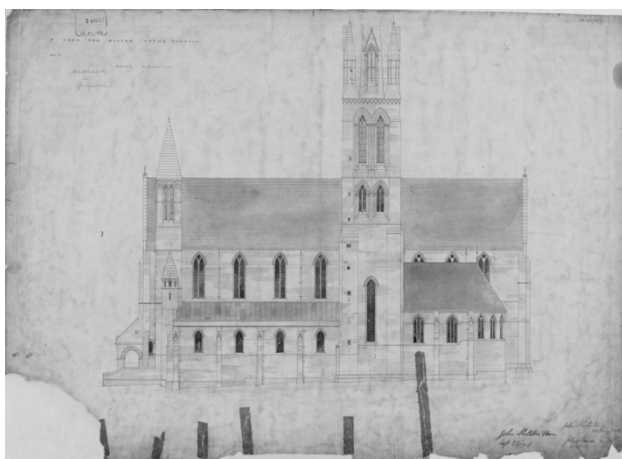
Figure 12: St John the Evangelist, Norwood, Architect's signed South Elevation (Featuring unbuilt complete tower) 1878 (onsite)

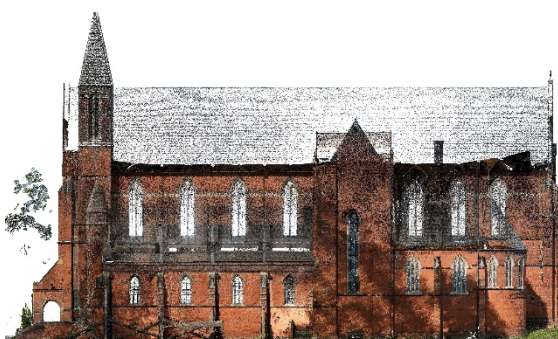
Figure 13: South elevation of St. John the Evangelist generated from point cloud data in RiPANO (RIEGL USA, 2020)

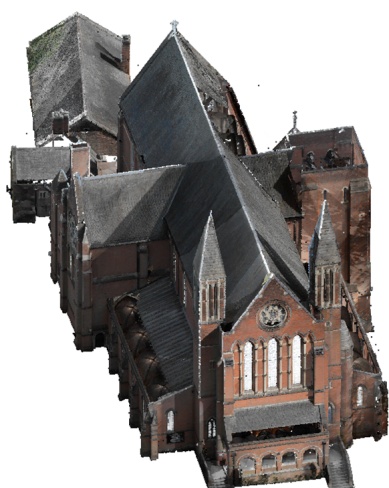
Figure 14: 3D model of St. John the Evangelist created in Revit

The cleaned dataset was then exported and opened in ReCap, where it was converted into a format suitable for Revit integration (Autodesk, 2025). Once imported into Revit, the model was saved in .rvt format and used as a foundation for analytical tasks (Figure 14).

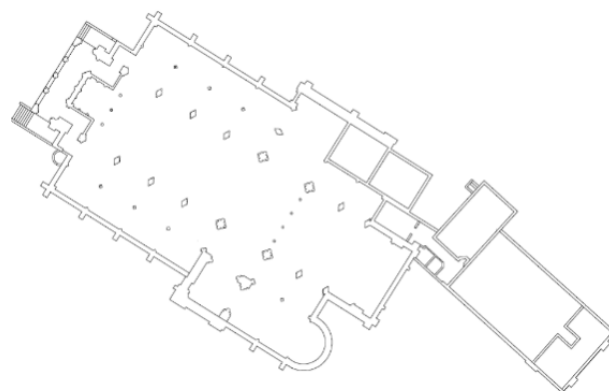
Figure 15: Optimised 2d plan of St. John the Evangelist generated in AutoCAD from cleaned section data (Autodesk, 2025)

Horizontal section cuts were generated at 0.0 m, 0.5 m, and 1.0 m above ground level, each with a slice thickness of 20 cm, to reduce visual noise introduced by furniture and equipment

(Error! Reference source not found.20). These section views facilitated the creation of accurate plan drawings in AutoCAD, which were then optimized to produce a refined architectural plan (Figure 21) This plan served as a spatial reference for mapping the crack locations.

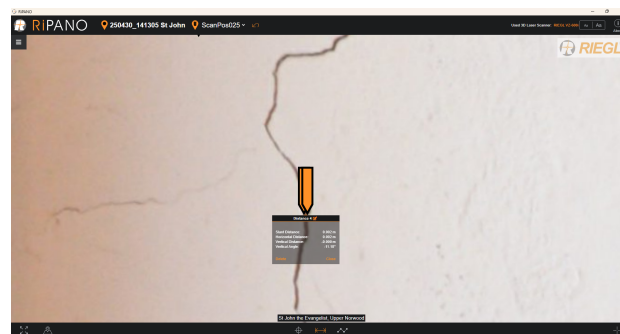
Figure 16: Corresponding crack visualised and georeferenced in RiPANO, enabling spatial linking between 3D point cloud data and site damage records (RIEGL USA, 2020)

documented by the structural engineering team. As part of the assessment process, each crack was visually identified, photographed, and digitally measured to support diagnostic analysis. The combined use of RiPANO's point cloud viewer (RIEGL USA, 2020) and AutoCAD (Autodesk, 2025) allowed for spatial correlation between real-world damage and the 3D model, enabling targeted interpretation of structural behaviour and deterioration patterns. (Figures 16-17)

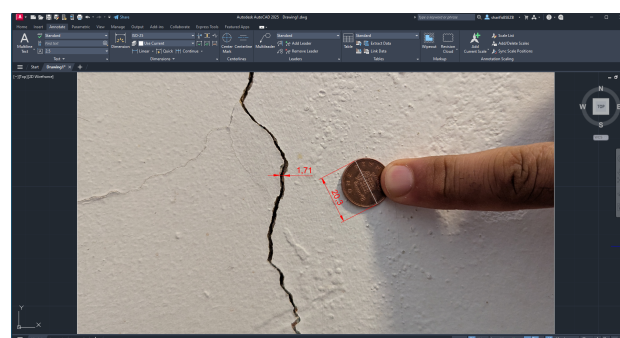
Figure 17: Crack width measurement performed in AutoCAD using scaled reference from a UK 1p coin (Autodesk, 2025)
