Applied Imaging in Architectural Conservation practice: Insights from the case studies

Maniyarasan Rajendran¹, Akhila Udayashankar²

Keywords: Visual Documentation, Architectural Conservation, Photography, Photogrammetry, Applied Imaging.

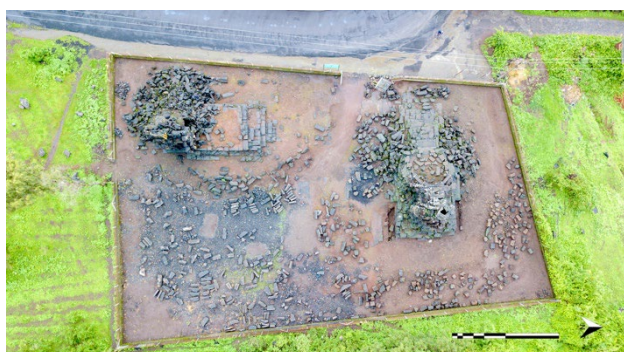
To achieve effective documentation with higher accuracy, a combination of technologies was used to complete the documentation. (i) Total station survey was undertaken to locate the temples exactly on the site and to identify some key markers for each of the temples. (ii) Manual documentation was undertaken to the maximum possible extent with intensive use of triangulation and tube levels to have high levels of accuracy (iii) orthographic aerial imagery was taken using a drone (DJI Mavic Pro). This was used to document the inaccessible part of the temple (owing to the fragile structural stability of the temples) –the roof, the fallen members, stones and surrounding rocks to complete the documentation. The aerial imagery played a significant role in completing the documentation.

Figure 1. Aerial Image. Anjaneri Temple No.6 & 7, Nashik, Maharashtra, India, 2017. Source: Author

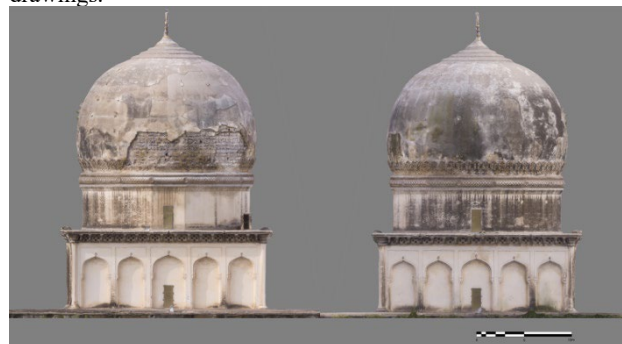
Instead, a combination of measured drawing and aerial photogrammetry was used to develop the plans and profile of the dome. This made it possible to quantify the surface area of the dome comprehensively. Around 250 images were shot using a combination of an aerial drone with a camera and a full frame DSLR (Canon 5D Mark III with 100 mm macro telephoto lens). Photos were captured from multiple angles, exposing the maximum surface. These were used to build the complete volume of the dome. The 3D photogrammetry (Agisoft Photoscan software) model was built on the software. Ortho & scale rectified views in elevations and plan were acquired from

it. This also gave the profile in section, in ascertaining the accurate measurements, after superimposing with the available drawings.

Figure 2. Ortho photos, Hazrath Shah Raju Mosque Dome, Hyderabad. Source: Author

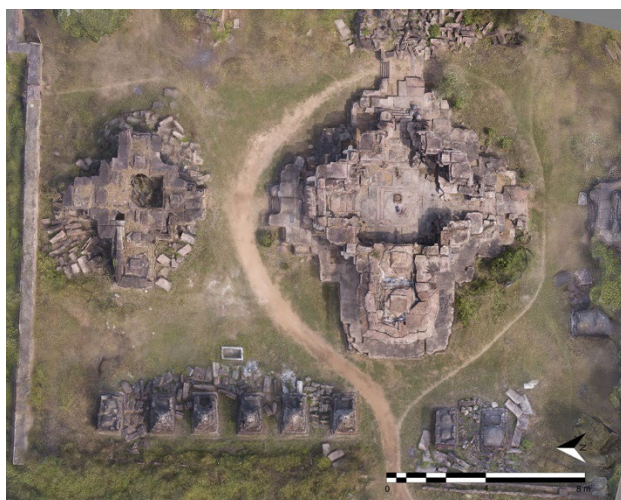
Figure 4. Aerial Image of Ghanpur group of temples, Ghanpur.
 Source: Author

As a result, these temples today are in various stages of decay; some of them have partial areas of collapse, while others have been dismantled. As a result, there are many stone members lying on the ground around the structures. The condition of the decay was extensive with dense vegetation on the ground. This reduced physical access, to undertaking manual documentation; it would have required an intensive and time-consuming, without sufficient accuracy to work with. To add to the constraints, some areas within the site were inaccessible. To achieve comprehensive documentation with better accuracy, a combination of technologies was used. Apart from manual documentation, orthographic aerial imagery and photogrammetry were used to document the roofs, the structurally fragile sections of the temple and physically inaccessible areas. Gigapixel7 Photogrammetry using a full frame DSLR (Canon 5D Mark 3) was done to understand more detailed information of the surface, texture and the context.

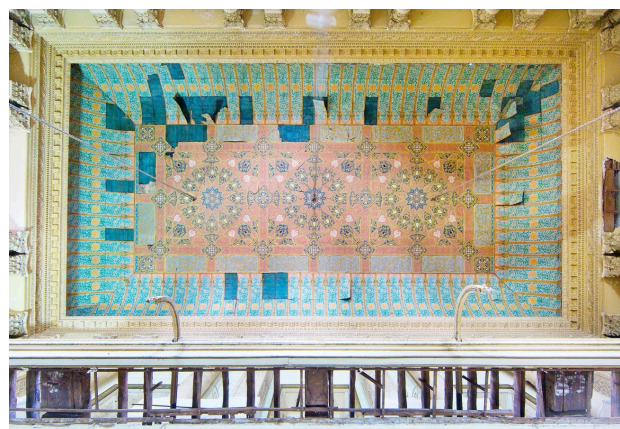
The former British Residency in Hyderabad is one of the largest Palladian villas built in India. Constructed in 1803-06, it has large spaces with many decorative features. One of the distinct features of this building is the decorative pressed paper ceiling that is fixed to a vaulted wooden ceiling in the central room of the building – the Durbar Hall. Made of a total of 651 panels in 18 typologies and located at a height of 18 metres above the ground, it would have been an enormous task to undertake an accurately measured drawing of this 180sqm of the ceiling and would have involved erecting scaffolding for the whole area for several months. To achieve a base map of the ceiling which would be high on accuracy and low of time and budget, different techniques were used to capture the ceiling. Initially, a Canon super wide-angle lens on a full-frame DSLR camera was taken to capture the whole ceiling in a single shot. While this gave a complete picture of the ceiling, it was not orthographically accurate. Next, the ceiling was captured in parts (8 rows and 5 columns), using a telephoto (Canon EF 100 mm Macro) lens. A total of 40 images were stitched in a photo editing software. The accuracy was around 90%, with some issues in merging junction.

Figure 5. Wide angle image of the Papier Mache Ceiling, British Residency, Hyderabad. Source: Author

The same images were then utilized to build a photogrammetric model using the Agisoft Photoscan software. In addition to the surface plane, the software provided the contours and smaller changes. This ensured the ceiling was documented with the highest resolution and accuracy, in its current state. Besides, it gave the art conservators a greater advantage in making decisions without any gaps in information on the condition. Using this as a base mapping, the team identified the types of panels, the numbers, map the condition of the ceiling, and prepared a strategy for its conservation. The restoration process got over after 3 years of work, that heavily relied on the technical imaging for important decisions. Some of the vital junctures where the imaging tools were used were,

For example, in case study 5, it should be noted that the same camera was used in all the three stages. It is critical to understand how different techniques and processes can be used to capture the same details and achieve different results. This is the crucial part of good photographic documentation – application of the right technology to achieve desired results at highest accuracy. Another example can be documentation of colour of spaces – colour could be in terms of finishes of elements (walls, doors, windows etc), or of architectural ornament. It becomes imperative that for these spaces, that along with size scales, the images are captured with colour targets to ensure that the accurate colour temperatures are recorded. In addition to using a colour target, the digital camera should also be set to ensure that image captured represents the most accurate colour reproduction. There are various colour calibration softwares that can assist the conservators to record the exact details.
