Comprehensive Advanced Heritage Building Defect Assessment and Procedures Using LiDAR and Photogrammetry Towards the Sustainability of Cultural Heritage

Shahrul Yani Said ^{1,2}, Muhammad Shahrir Shahrin ²

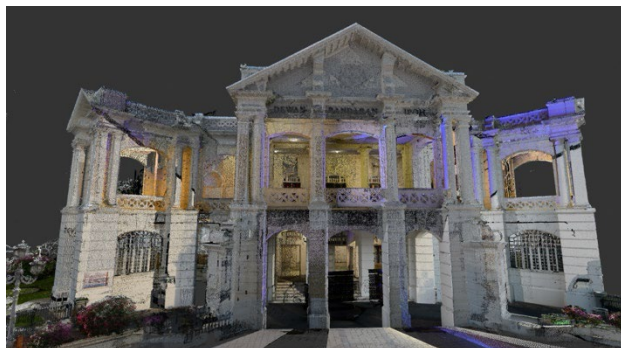
Figure 1. Ipoh Town Hall LiDAR scan.

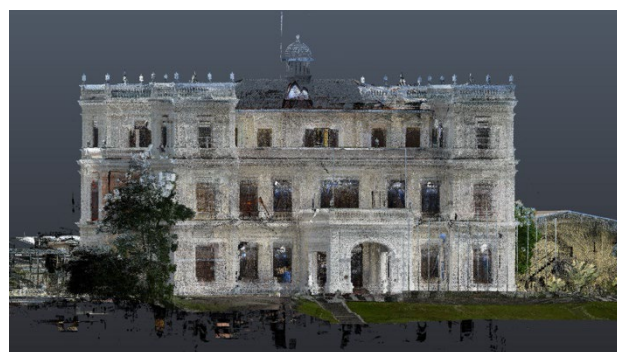
Figure 3. Bangunan Dato Jaafar LiDAR scan.

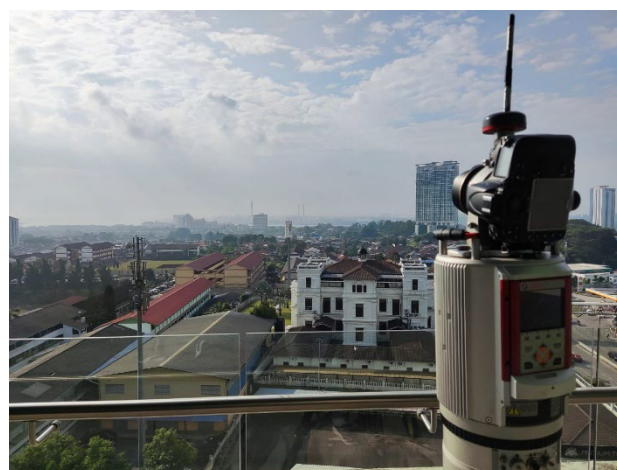
Figure 4. VZ-400 TLS unit scanning the roof of Dato' Jaafar Building, Johor Bahru.

LIDAR scan is conducted using TLS unit VZ-400 from Riegl for the whole building in order to produce a dilapidation survey and measured drawing for the heritage restoration project. A tripod is used for mounting the TLS unit, and a triangle ground spreader for attaching the tripod on very slick surfaces such as tiled flooring, marble flooring and smooth concrete finishes.

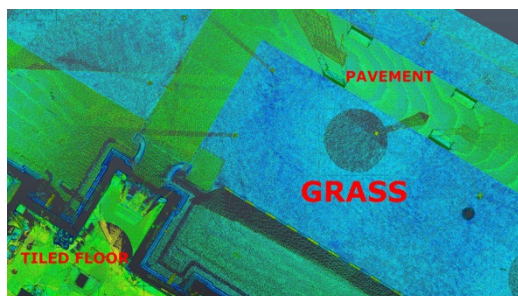
In using point cloud data, an intensity visual mode is used to better roughly classify each building elements to differentiate surfaces and materials when producing measured drawings.

Figure 7. Differentiation of various surfaces using intensity view mode.

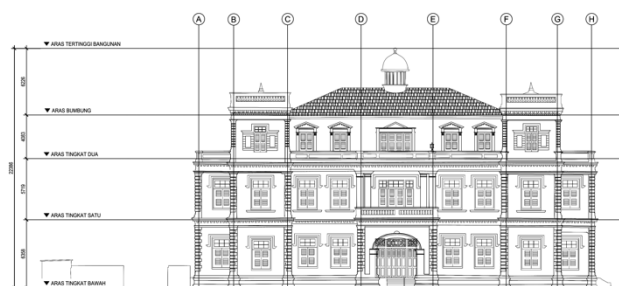
Figure 10. Measured drawing of Bangunan Dato' Jaafar front façade.

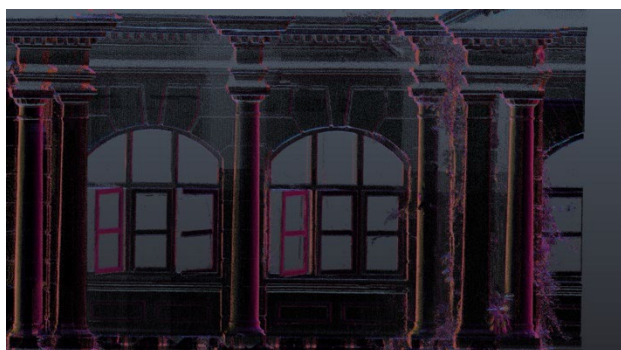
Figure 13. Normal view for row of windows at Galeri Kraftangan Seremban front façade.

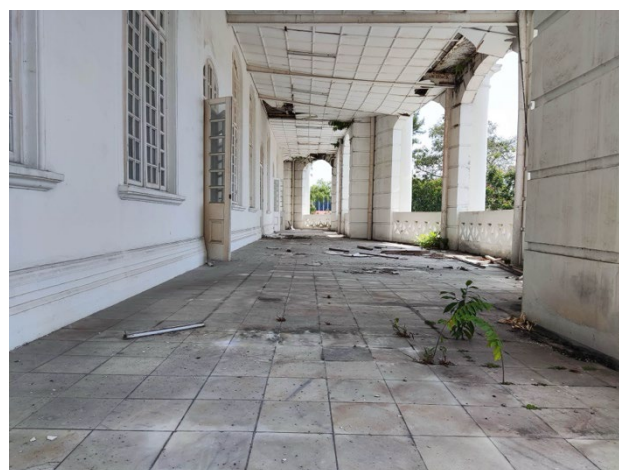
Figure 17. Sloping floor of verandah in Ipoh Town Hall and Post Office on site.

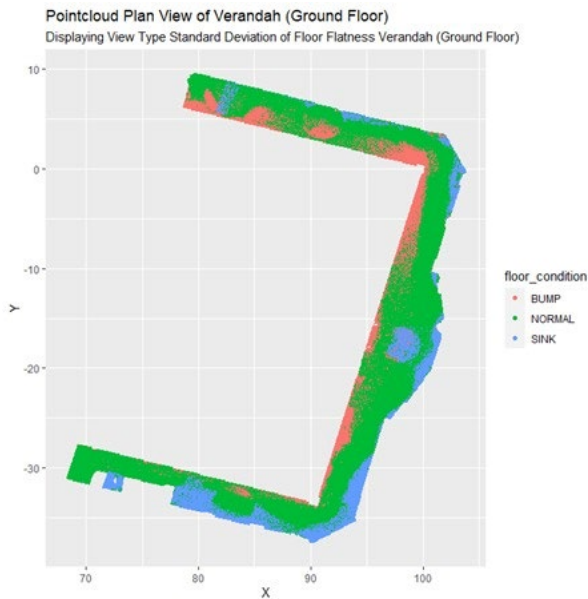
Figure 19. Classifying point cloud data to identify bumping, normal and sinking surfaces of affected sloping floor.

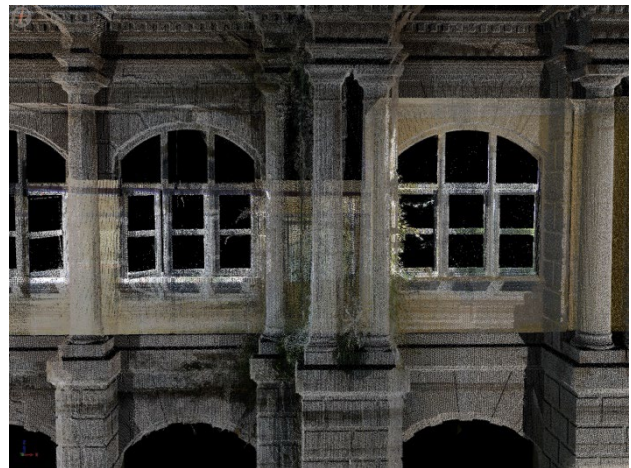
Harmful growth and surface defects are common defect in cultural heritage buildings. This is due to their exposure in the elements without any preventative care for the buildings. By using point cloud, the surface area can be identified easily by using intensity analysis. In this example of Galeri Kraftangan Seremban, harmful growth can be identified by filtering the affected intensity through the software Cloud Compare.

Figure 22. RGB data for on the façade of Galeri Kraftangan Seremban.
