Advanced 3D Documentation and Capacity Building for Post-Conflict Damage Assessment: The Case of the Taras Shevchenko Chernihiv Regional Academic Music and Drama Theatre, Ukraine

Margarita Skamantzari¹, Pieter-Jan De Vos², Serhii Revenko³, Victor Mota Ferreira¹

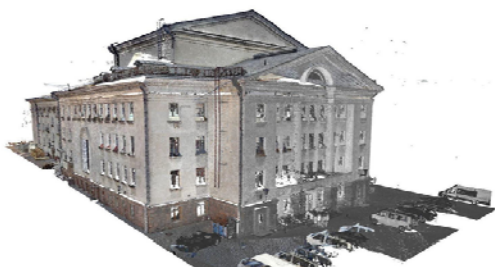
Figure 4. Overview of the combined point clouds produced by the laser scanning process. (©UNESCO/ICOMOS)

In total, 836 TLS scans were collected throughout multiple floors, with HDR imagery selectively applied to enhance visual analysis in critical areas (Fig. 3). For registration and data integration, LaserControl 9.3 was used to process the Z+F datasets by performing target-based and cloud-to-cloud alignment, achieving a registration deviation of 2–4 mm across the cloud data. Cyclone Register 360 Plus handled the BLK360 datasets, organizing scans by floor while integrating Z+F datasets as reference points for precise connection and alignment. The final registration was confirmed against the control network established through the total station targets (Fig. 4).

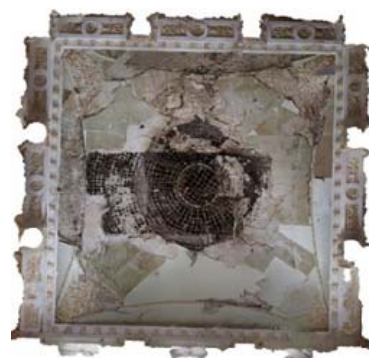
Figure 5. The orthomosaic of the damaged atrium produced using the photogrammetric method. (©UNESCO/ICOMOS)

The processing involved a Structure-from-Motion (SfM) technique for camera alignment and the generation of a sparse point cloud. Following this, Multi-View Stereo (MVS) methods were employed for the reconstruction of a dense point cloud. Precision in georeferencing was achieved at sub-centimeter accuracy (≤ 1.2 cm) through the integration of Ground Control Points (GCPs). The outputs included high-resolution orthomosaics depicting collapsed roof sections and ornate wall surfaces, along with 3D mesh models of critical interior areas (Fig. 5).

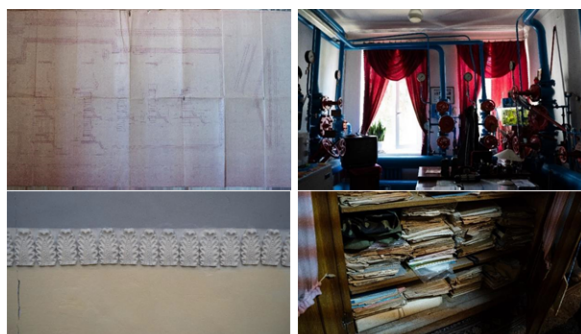
Figure 6. Examples of record photography (top left to bottom right: construction plans, control room on F3, detail in room 85, archives in F1, ©UNESCO/ICOMOS)
