A Holistic Documentation and Restoration Framework for Heritage Structures: The Case of the Metropolitan Church of Saint Minas, Heraklion, Crete

Margarita Skamantzari¹, Evanthia Ioannatou², Orfeas Kountouroglou², Apostolos Mylonas², Christos Sofianos²

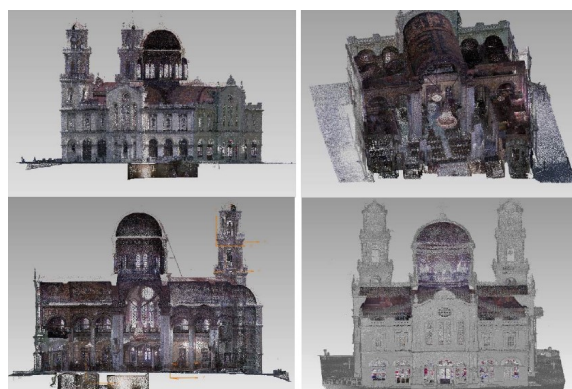
The geometric documentation was carried out using a hybrid acquisition strategy that combined high-resolution terrestrial laser scanning with terrestrial and aerial photogrammetry. The laser scanner that was used was a Leica BLK360, known for its portability and accuracy. The scanning process attained a spatial resolution of roughly 6 mm at a distance of 10 meters and 8 mm at 20 meters, capturing the intricate architectural geometry of the dome, nave, bell towers, underground cistern, adjoining chambers and the outdoors. This comprehensive documentation was facilitated by a total of 205 individual scans. The point clouds were registered using Leica Cyclone REGISTER 360, maintaining sub-centimeter alignment errors while it was referenced using the coordinates of the measured control points (Fig. 4).

Figure 4: Different views and representations of the unified point cloud of the Metropolitan Church of Saint Minas

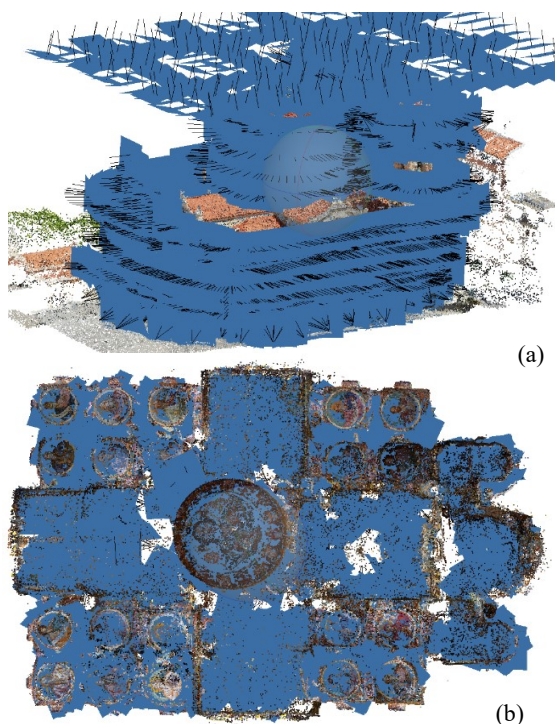
The resulting datasets were processed using Agisoft Metashape for the orientation via the automated Structure from Motion (SfM) process (Fig. 5). The dense cloud generation using the Multi-View Stereo (MVS) reconstruction algorithms, and finally the mesh reconstruction and orthophoto production concluded the photogrammetric processing. The point clouds from both TLS and photogrammetry were integrated and optimized using CloudCompare, where noise filtering and deviation analysis were conducted. The integrated point cloud formed the basis for advanced analyses such as deformation monitoring, material condition evaluations, and the creation of orthogonal projections. The high geometric fidelity of the documentation allows for accurate longitudinal monitoring of structural movements and conservation interventions, ensuring the project complies with international principles of reliability and long-term reproducibility.

Figure 5: Snapshots from the oriented digital images of the church's exterior (a) and interior (b).

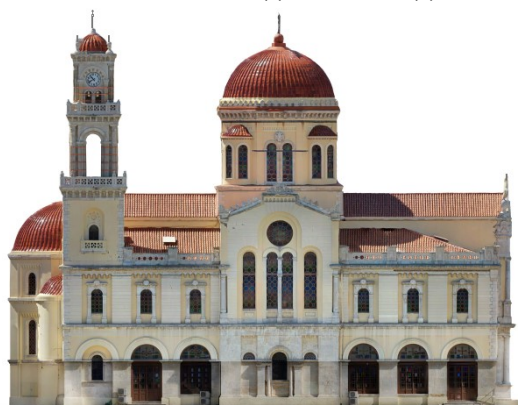
Figure 6: The orthophoto of the North Façade of the Metropolitan Church of Saint Minas.

For the production of the orthophotos, a ground sampling distance (GSD) of 2 mm was selected in order to preserve all the recorded information from the original digital images (Fig. 6). The orthophotos were geometrically verified using the measured points that were not included in the bundle adjustment process for image orientation in order to be used as check points. The unified 3D point cloud and the high-resolution orthophotos served as the foundational dataset for generating all necessary architectural drawings. These included detailed plans, sections, elevations, and façade drawings (Fig. 7 & 8). The integration of both 2D and 3D outputs ensured the production of geometrically accurate and visually comprehensive documentation, suitable for conservation planning and further analysis.
