Innovation Scenarios in Digital Documentation of Complex Heritage Buildings for Seismic Risk Mitigation

Martina Suppa¹, Federica Maietti¹, Luca Rossato¹, Marida Paternò²

Keywords: Digital Documentation, Integrated Workflow, Seismic Damage, Historic Theatres, Risk Mitigation.

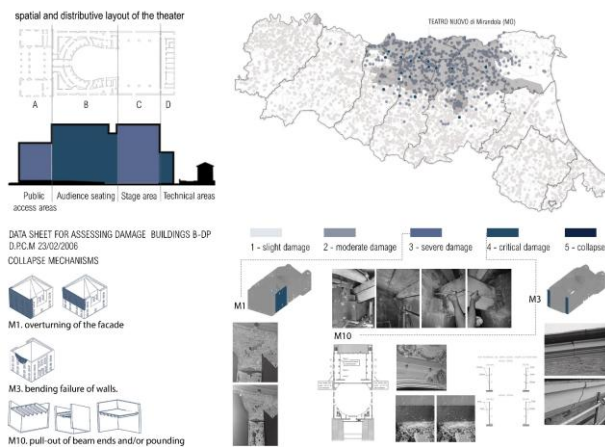
Figure 1. The overall methodological framework, including a macro-schematisation approach for structural behaviour analysis, applied to the Teatro Nuovo in Mirandola (graphic elaboration by the authors).

structural features to be considered to improve survey procedures for damage assessments and seismic risk mitigation (Fig. 1).

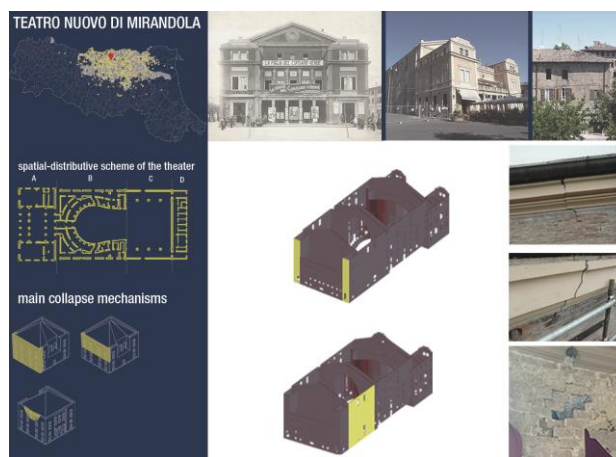
Figure 4. Analysis of the Teatro Nuovo in Mirandola (graphic elaboration by the authors).

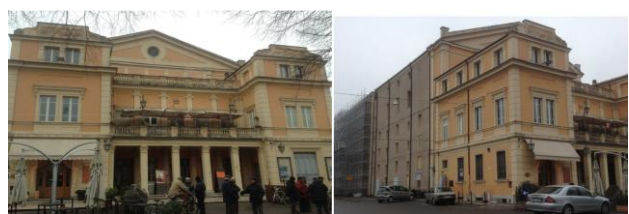
Figure 6. Pictures of the main façade and south side of the Teatro Nuovo in Mirandola (Sisma 2012 Agency).

Its facade features a portico with composite capitals, while a tympanum crowns its main auditorium. In the late 1960s, the conversion into a cinema led to a significant change in the building, closing the original openings. Morphologically, the theatre has a classic horseshoe-shaped auditorium with a significant rake, originally seating 224, and includes a recessed orchestra pit with an inverted vaulted "harmonic box" for sound amplification. The current seating arrangement reflects a shift from its original operatic focus. The auditorium features three tiers of boxes and an amphitheatre-style loggia, topped by a broad, shallow vault with a central skylight (now veiled) and rich decorations. Box balconies are adorned with gilded stucco, composers' insignia, and painted medallions. The proscenium

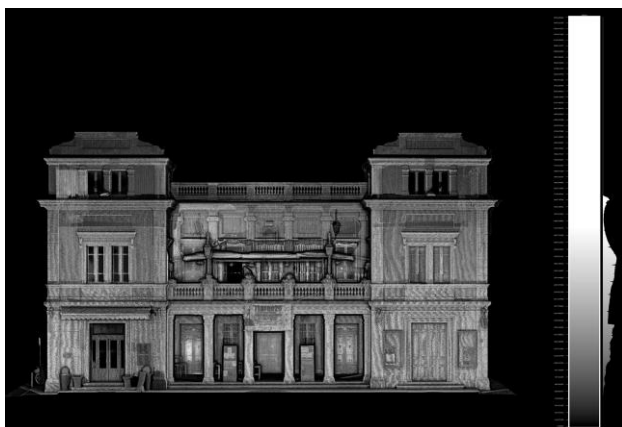
Figure 7. View of the main façade of the Teatro Nuovo in Mirandola extracted from the point cloud during the data assessment phases (graphic elaboration by the authors).

The second level (L2) advanced the investigation through the application of integrated digital technologies, such as laser scanning, for metric-geometric surveying and advanced diagnostics. In the case of the Teatro Nuovo in Mirandola, a 3D laser scanner survey has been performed, applying Leica C10 and Faro Focus 3D X130 tools (Figg. 7-10).

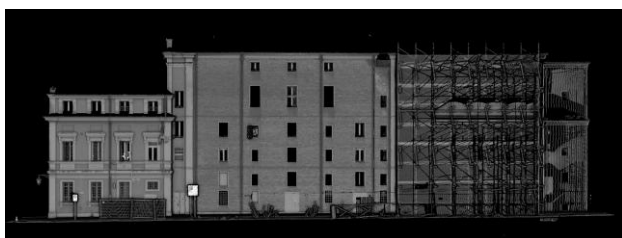
Figure 8. Point cloud view of the north elevation (graphic elaboration by the authors).

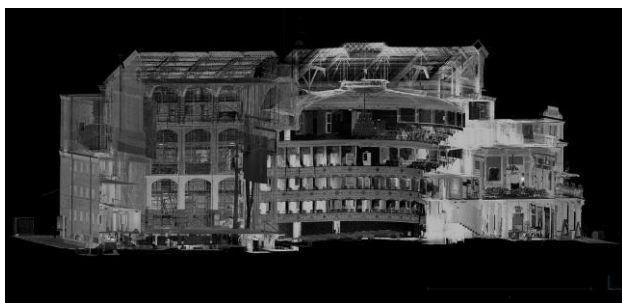
Figure 9. Axonometric section extracted from the point cloud (graphic elaboration by the authors).
