Heritage Conservation in Crisis: A Case Study on Post-Earthquake Church Restoration in Samos Island, Greece

This paper details the methodology for recording, documenting, and restoring six historic Orthodox churches on the island of Samos, Greece, severely damaged by 2020 Aegean Sea earthquake, occurred on October 30. An interdisciplinary team from the Faculty of Engineering from Aristotle University of Thessaloniki led this 12-month project, funded by the Greek Ministry of Culture. The restoration process began with a thorough on-site data collection, employing advanced 3D surveying techniques like Terrestrial Laser Scanning (TLS), photogrammetry, Unmanned Aerial Vehicles (UAVs), and traditional topographic methods including GNSS. This was complemented by historical documentation. The collected data included images, videos, measurements, and reports and were processed to create detailed 3D models of each church's interior and exterior, along with 2D CAD orthoimages for precise measurements and architectural documentation. Structural assessment utilized these 3D models and on-site identification of the load-bearing stone masonry systems. Bearing capacity under seismic loads was ev

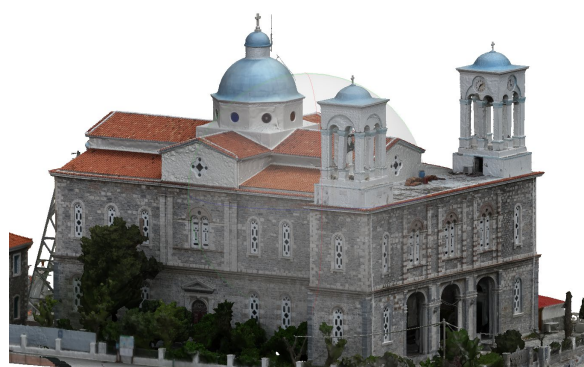
Figure 4. 3D model of St. Nicholas Kekkari

The outputs were representative models (Figure 4), textured models (Figure 5), point clouds (Figure 6), elevation point clouds (Figure 7) orthoimages (Figure 8) and extracted architectural drawings from this endeavour.

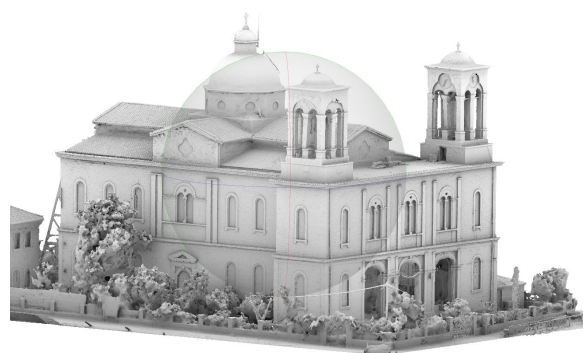
Figure 5. 3D textured model of St. Nicholas Kekkari

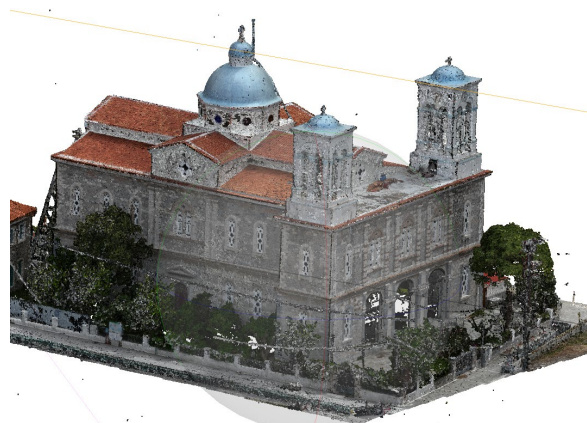
Figure 6. Point cloud of St. Nicholas Kekkari

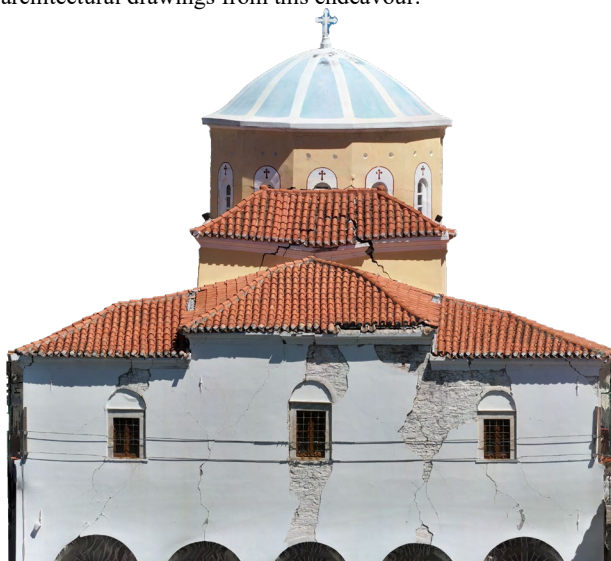
Figure 9. East View facade ortho-image depicting damages in Dormition of the Virgin Mary in Ano Bathy

The baseline 3D models serve as critical references for long-term monitoring of the monument's condition and the evaluation of restoration efforts. It consists of a thorough and quantifiable assessment of disaster-related damage.

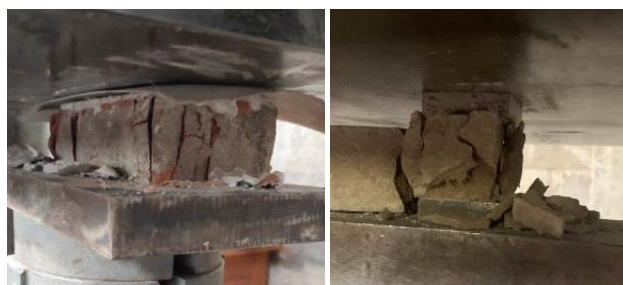
Figure 12. Compression test on a clay solid unit (left) and on a stone unit (right)

The determination of the mechanical characteristics of the masonry elements is based on the compressive strength of the masonry units and the used mortar. The normalized compressive strength of the clay masonry units was measured at the Laboratory between 16MPa and 20MPa and that of the stone units between 45MPa and over 100MPa, figure 3. Subsequently, the mechanical characteristics of masonry walls are determined using analytical models adopted by KADET. The calculated compressive strength of stone or clay masonry elements is 1.0-2.0MPa and 4.0-5.0MPa respectively. The corresponding Young's Modulus was estimated 1.0GPa-1.50GPa and 2.0-3.0GPa.
