Ground Sampling Distance as a Key Parameter for Automatic Crack Detection in Built Heritage: A Practical Framework With YOLOv5

Simon Boutet¹, Pierre Hallot²

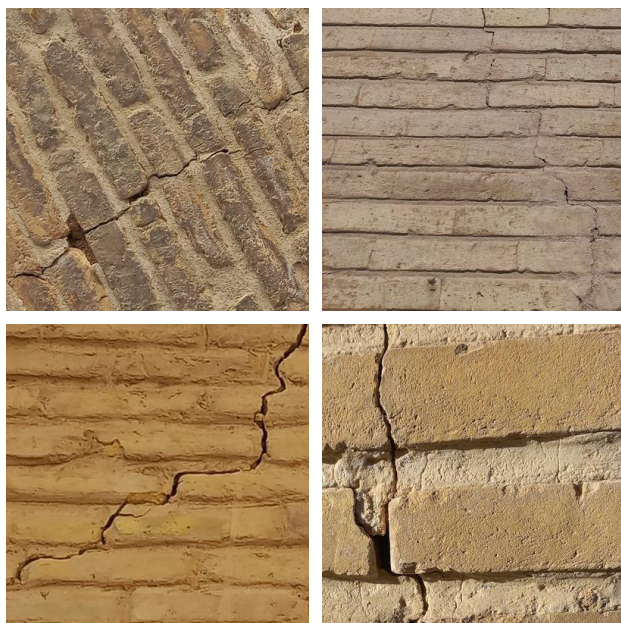
To realistically evaluate the model's robustness in a context different from its original training environment, we employed a dataset created and annotated by Karimi et al. (2024), which is publicly available on Kaggle (<https://www.kaggle.com/datasets/nargeskarimii/various-materials-from-historic-buildings>). It features different types of cracks under varying lighting conditions and masonry textures from historical bridges in Isfahan, Iran (fig. 1).

Figure 1. Brick dataset sample from Karimi et al. (2024).

To create the brick dataset, Karimi et al. (2024) acquired high-resolution images using a Samsung Galaxy A32 (64 MP), under diverse weather and lighting conditions. After manually filtering these images to remove non-relevant or low-quality data, brightness and contrast processing were applied to improve damage visibility. Also, 45° image rotation was employed as a data augmentation technique to prevent the model from confusing cracks and mortar joints and to enhance the model's robustness.

Images were then downsampled from 3456×3456 pixels to 416×416 pixels to match the input requirements of the YOLOv5 architecture and to optimize GPU resource usage during training. This resolution adjustment was not related to ground sampling distance (GSD) evaluation but rather meant to comply with the model's standardized input format. Finally, the dataset was partitioned into training (70%), validation (20%), and testing (10%) subsets, resulting in a total of 861 annotated images available for training.

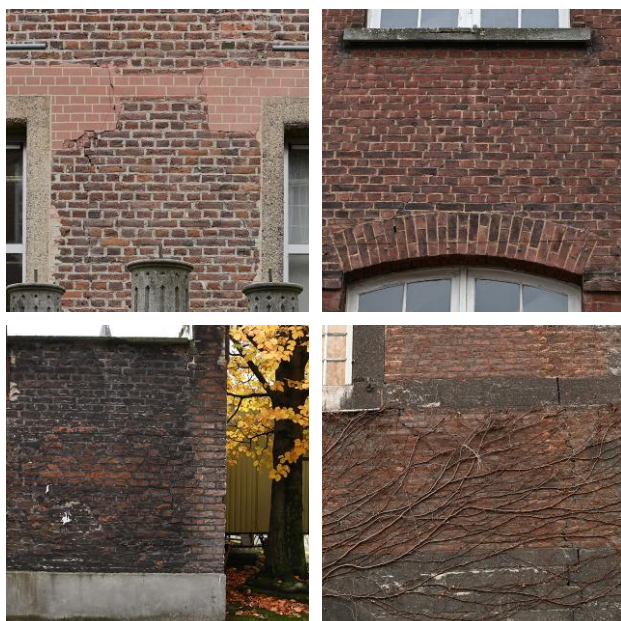
All other images presented in this study were used to evaluate YOLOv5's performance and were captured using a Nikon Z6 camera with a native resolution of 6048×4024 pixels in various masonry facades in the city of Liège, Belgium (fig. 3). A Nikon Speedlight SB-700 flash was employed for nighttime photography and a Vanguard tripod was used to mark and replicate camera positions across day-and-night sessions, allowing for consistent framing and enabling the comparison of lighting conditions under near-identical setups.

Figure 3. Masonry façades used for testing YOLOv5's robustness in the Faculty of Architecture of the University of Liège, Belgium.

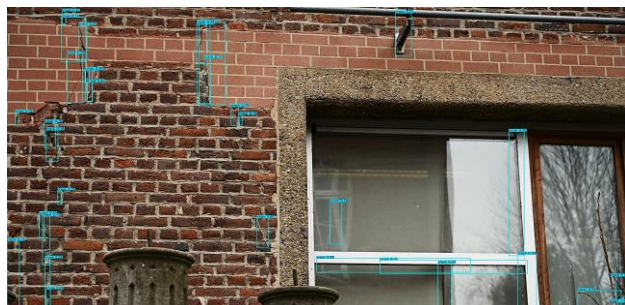
To further explore spatial sensitivity, peripheral pathologies were introduced by capturing scenes where target cracks appeared near the image edges instead of being centered (fig. 5). This aimed to test whether the position of defects within the image affected detection accuracy. In accordance with the graph shown in fig. 2a, results indicated that defect location had no significant impact on performance.

Figure 5. Predictions on peripheral pathologies

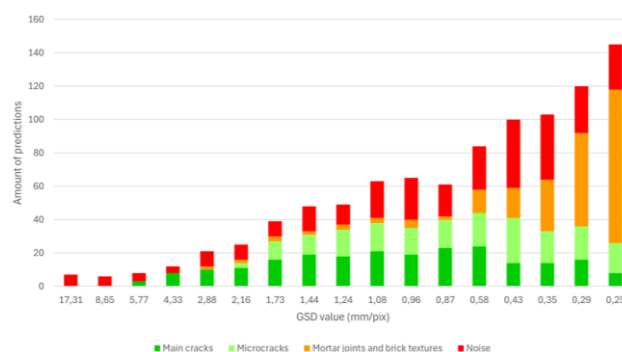
Figure 8. Visual graph of predictions for specific GSD values

Beyond this point, however, detection quality began to degrade. At very high resolutions such as 4160, 6240 pixels, and above, the confidence scores for the main cracks decreased, and although the model identified a greater number of microcracks, the volume of predictions and false positives rose sharply. This increase hindered the image output's readability and interpretability, making it more challenging for human operators to distinguish relevant defects. Table 2 shows a quantitative analysis of those results, while figure 8 allows for better visual representation. True positive predictions were subdivided into *main cracks* and *microcracks*, representing respectively the primary targeted defects and smaller, less critical cracks. False positives were categorized into *mortar joints and brick textures* and *noise*. The first category reflects cases where the model confuses background patterns with actual cracks, while the second is due to unexpected architectural elements which are absent from the training data.
