Digital Damage Measurement and Analysis of Masonry Heritage Based on Degradation Measurement Method (MMD)

This study selects the Jixi Building within the Puppet Manchurian Palace Museum in Changchun, China, as the practical case. Originally constructed in 1908 and reconstructed in 1928, the building comprises two above-ground stories and one basement level. It is currently designated as a national-level cultural heritage site in China. The structural system is brick-wood, and the envelope material consists of exposed blue brick masonry. The facade is symmetrically arranged, with both wings projecting approximately 1.25 meters from the central mass. The central entrance of the south facade is designed with a gable facing south, above which a circular brick-arched window is set at the apex of the triangular gable, serving both decorative and ventilation purposes. The building has undergone six different degrees of renovation since 1964, the most recent of which was in 2017. However, in recent years, the facade materials of buildings have been gradually exposed to varying degrees of material damage, driven by harsh climatic environments and improper maintenance.

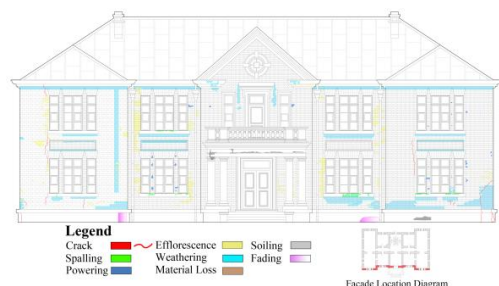
Figure 5. Damage Atlas of the South Facade

The damage atlases for the south, north, east, and west facades of the Jixi Building were generated, as shown in Figures 5–8, with the corresponding damage extents presented in Tables 1–4.

Based on the damage data from each facade, it can be observed that variations in physical conditions and patterns of human use have led to different dominant pathological manifestations across facades, and notably, significant differences also exist between the upper and lower portions of the same facade. The occurrence rate of cracks in the Interstory Transition Zones across facades is relatively low, suggesting that changes in the

South Facade	Facade Area (m ²)		187.307	
Pathological Type	Indicated Area in Damage Atlas (m ²)	Number of Instances	Damage Coverage Rate (%)	Total Damage Coverage Rate (%)
Crack	0.025	15	0.013	9.158 (excluding Fading)
Weathering	12.861	45	6.866	
Powdering	0.147	26	0.078	
Spalling	0.28	19	0.149	
Soiling	0.4	7	0.214	
Fading	0.535	2	0.286	
Material Loss	0.07	5	0.037	
Efflorescence	3.37	165	1.799

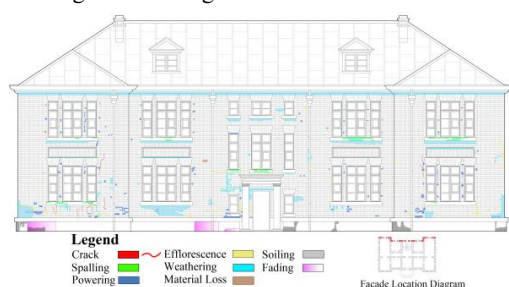
Figure 6. Damage Atlas of the North Facade

internal structure are not the main cause of material-related cracks in the external wall. As the prevailing wind direction in Changchun is northwesterly throughout the year, the north facade experiences the most severe deterioration, with more pronounced powdering and efflorescence. Overall, soiling is primarily concentrated on the wall sections below windows. Apart from improper human use, this phenomenon can be interpreted — according to Professor Sousa of the Technical University of Lisbon — as being related to moisture sources (Sousa et al., 2011). Since the wall beneath the window is close to the ground, moisture is drawn upward by capillary action and carries with it a large amount of ground dust. As moisture evaporates under sunlight while the dust remains, long-term accumulation leads to the buildup of surface soiling. Of course, the occurrence of soiling on the shaded sides of the building involves more than just this process. Capillary action facilitates moisture transport, and the limited exposure to direct sunlight creates favorable conditions for the growth of mold and bacteria, resulting in the accumulation of stains.

North Facade	Facade Area (m ²)		177.329	
Pathological Type	Indicated Area in Damage Atlas (m ²)	Number of Instances	Damage Coverage Rate (%)	Total Damage Coverage Rate (%)
Crack	0.015	18	0.008	7.478 (excluding Fading)
Weathering	9.636	69	5.434	
Powdering	0.89	124	0.502	
Spalling	0.723	29	0.408	
Soiling	1.251	7	0.705	
Fading	1.669	4	0.941	
Material Loss	0.066	10	0.037	
Efflorescence	0.68	301	0.383

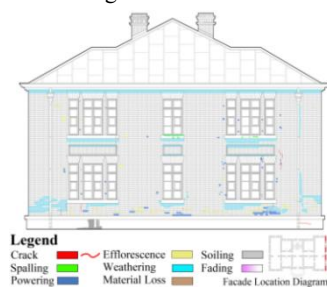
Figure 7. Damage Atlas of the East Facade

East Facade	Facade Area (m ²)		111.719	
Pathological Type	Indicated Area in Damage Atlas (m ²)	Number of Instances	Damage Coverage Rate (%)	Total Damage Coverage Rate (%)
Crack	0.01	14	0.009	7.576 (excluding Fading)
Weathering	7.045	32	6.306	
Powdering	0.452	46	0.405	
Spalling	0.074	5	0.066	
Soiling	0.329	1	0.294	
Fading	0	0	0.000	
Material Loss	0.02	11	0.018	
Efflorescence	0.534	136	0.478

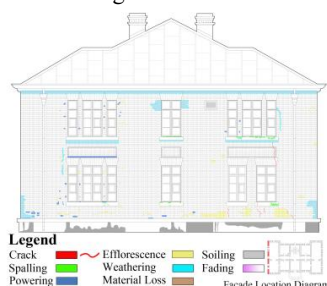
Figure 8. Damage Atlas of the West Facade

West Facade	Facade Area (m ²)		111.92	
Pathological Type	Indicated Area in Damage Atlas (m ²)	Number of Instances	Damage Coverage Rate (%)	Total Damage Coverage Rate (%)
Crack	0.007	8	0.006	9.196 (excluding Fading)
Weathering	4.792	15	4.282

Powdering	0.399	39	0.357	g Fading)
Spalling	0.151	38	0.135	
Soiling	3.609	8	3.225	
Fading	0	0	0.000	
Material Loss	0.02	9	0.018	
Efflorescence	1.314	172	1.174

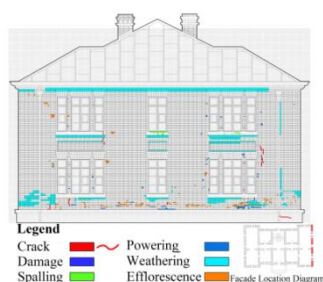
Figure 11. MMD Damage Map of the East Facade

The damage maps were drawn using the MMD method based on the defined grid system, as shown in Figures 9–12. As soiling, fading, and vegetation intrusion have relatively minor effects on the material pathological conditions of built heritage and are relatively easy to repair, soiling and fading were excluded from the classification in this phase of measurement. Therefore, six types of damage were measured using the MMD method: cracks, weathering, powdering, spalling, damage, and efflorescence. It is evident that when using a grid, the measured values of small-scale damage

East Facade	Facade Area (m ²)		111.72	
Pathological Manifestation	Indicated Area in Damage Map (m ²)	Indicated Area in MMD Damage Map (m ²)	FD (%)	FDt (%)
Crack	0.161	0.248	0.222	
Efflorescence	1.735	0.840	0.752	
Weathering	0.000	7.785	6.968	8.95
Spalling	0.319	0.110	0.099	2
Powdering	0.000	0.488	0.437	
Damage	0.563	0.530	0.474

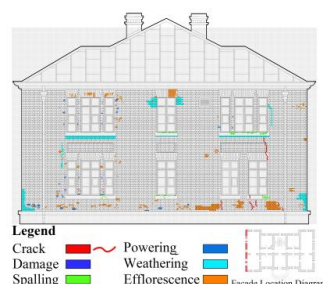
Figure 12. MMD Damage Map of the West Facade

West Facade	Facade Area (m ²)		111.92	
Pathological Manifestation	Indicated Area in Damage Map (m ²)	Indicated Area in MMD Damage Map (m ²)	FD (%)	FDt (%)
Crack	0.161	0.178	0.159	
Efflorescence	1.735	2.124	1.898	
Weathering	0.000	2.165	1.934	4.55
Spalling	0.319	0.255	0.228	1
Powdering	0.000	0.333	0.298	
Damage	0.563	0.038	0.034

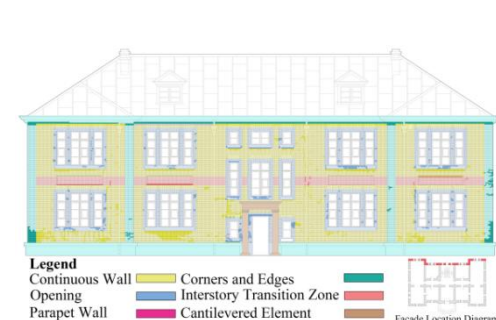
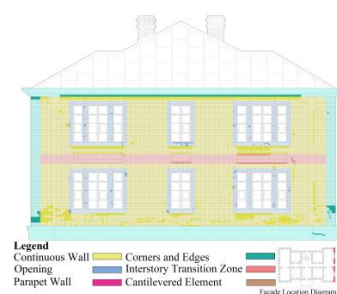
As shown in Figures 13–16 and Table 9, it is evident that the results of the FDr are directly influenced by the size of the region. The findings at this stage indicate that the region with the most frequent damage occurrence is the Continuous Wall: 6.289% on the south facade, 4.489% on the north facade, 6.245% on the east facade, and 2.899% on the west facade. The results demonstrate that FDr is directly affected by the size of the region; if the area is too large or too small, it can distort the actual severity of the damage in that region, with larger areas showing a higher degradation rate compared to smaller ones. To

Total Area of South Facade (m ²)	187.31	Total Area of North Facade (m ²)	177.33
Region	Damage Coverage Area in Region (m ²)	FDr (%)	Damage Coverage Area in Region (m ²)	FDr (%)
Continuous Wall	11.780	6.289	7.961	4.489
Opening	2.560	1.367	2.285	1.289
Interstory Transition Zone	1.190	0.635	0.605	0.341
Corners and Edges	4.643	2.479	5.539	3.127
Cantilevered Element	0.000	0.000	0.000	0.000
	Total Area of East Facade (m ²)	111.72	Total Area of West Facade (m ²)	111.92
Region	Damage Coverage Area in Region (m ²)	FDr (%)	Damage Coverage Area in Region (m ²)	FDr (%)
Continuous Wall	6.977	6.245	3.245	2.899
Opening	0.338	0.303	1.065	0.952
Interstory Transition Zone	0.307	0.275	0.103	0.092
Corners and Edges	1.732	1.550	0.695	0.621
Cantilevered Element	0.000	0.000	0.000	0.000

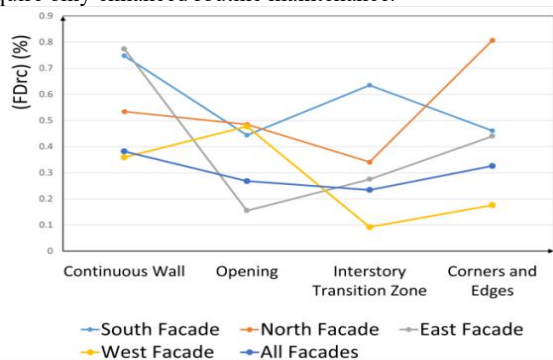
Figure 17. FDrC across Facades

Figure 17 illustrates the comparative analysis of overall It can be observed that the extent of damage varies among different regions of each facade. damage severity across all facades. For

example, the Continuous Wall on the east facade suffers the most severe damage; the areas around the Openings and the Interstory Transition Zone on the north facade, as well as the Corners and Edges on the east facade, also exhibit significant degradation. These areas should be prioritized for further intervention and preventive measures to avoid continued deterioration. Except for the Opening area, the other regions on the west facade show relatively low damage severity and require only enhanced routine maintenance.

As shown in Tables 10 to 13, the most severely damaged area on the south facade is the Continuous Wall, with an FDrc of 0.748%, while the Continuous Wall on the east facade is even more severely damaged, with an FDrc of 0.774%, requiring urgent intervention to prevent further deterioration. On the west facade, the most severely damaged area is around the Openings, with an FDrc of 0.477%, which warrants heightened attention.
