A Deep Learning Approach to Intelligent Detection of Shedthin Tile Pathology in Suzhou Classical Gardens

Keywords: Deep Learning, Architectural heritage Conservation, YOLO11-seg, Suzhou Classical Gardens, Shedthin tiles.

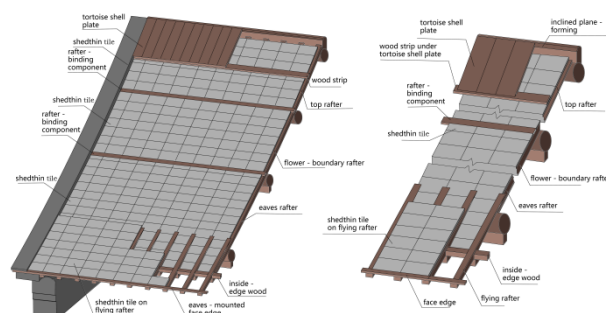
Figure 1. Laying steps and detail drawings of shedthin tiles.

Shedthin tiles, also known as "brick sheathing" or "wangba (望芭)", are important components of the roof structure in ancient Chinese architecture. In practical applications, shedthin tiles primarily serve to carry the finish roof tiles, block rainwater infiltration and act as an interior wind- and dust-screen while lending the ceiling a refined, rhythmic appearance (Figs. 1, 2). According to *Yingzao Fayuan* (《营造法原》, The Craft of Architectural Construction), the laying process of shedthin tiles must adhere to strict standards: "When laying shedthin tiles, a face edge (mian-yan, 面檐) should first be set at the eaves, and shedthin tiles should be laid on wooden rafters. A primary bedding (le-wang, 勒望) is set on each purlin to prevent the shedthin tiles from sliding and ensure neat horizontal alignment. For shedthin tiles with insufficient width, narrow infill pieces called "zhao-wang" (找望) should be inserted at the upper end of each bay. If the roof has "flying rafters"(fei-chuan, 飞椽) an additional layer of shedthin tiles should be laid on the flying rafters. To protect shedthin tiles from the heavy pressure of the upper roof, wooden strips are typically laid between the shedthin tiles and the turtle-shell plates to buffer the load" (Hou and Hou, 2014).

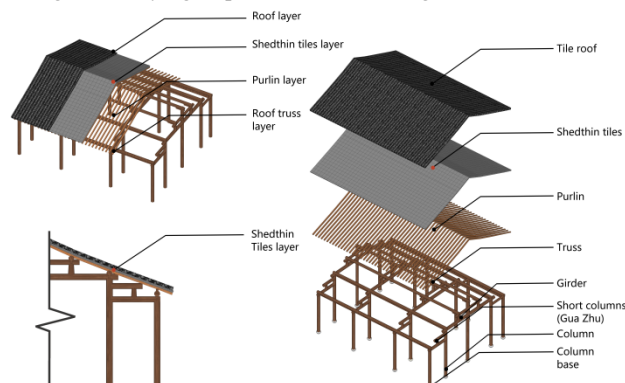
Figure 2. Structural position of shedthin tiles in garden architecture.

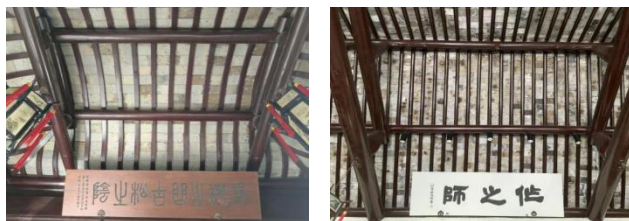
Figure 3. Extensive application of shedthin tiles in Suzhou garden architecture.

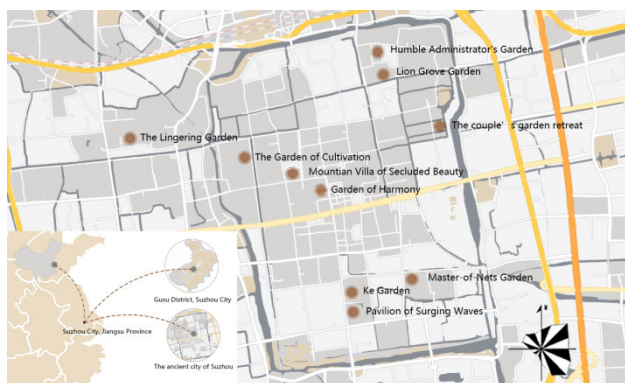
Figure 4. Data collection locations.

In this study, a total of 1,283 high-resolution pathology photos covering various pathology types were collected from multiple classical gardens in Suzhou (Fig. 4). To ensure data diversity, the shooting locations were selected from different pavilions, terraces, and halls, which are representative and have different pathology conditions. During data acquisition, the team used a mobile-phone camera to photograph the tiles under diverse weather conditions—clear, overcast, and immediately after rainfall—to bolster the model's robustness against environmental and lighting variations.

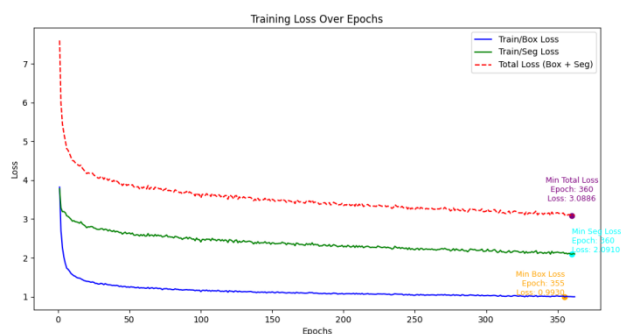
After 362 epochs of training, the loss-curve analysis (Fig. 6) revealed that the network reached its minimum object-detection loss at epoch 355, while the instance-segmentation loss bottomed out at epoch 360. Considering both tasks jointly, the aggregate loss was lowest at epoch 360. Accordingly, the weights from epoch 360 were selected for subsequent performance evaluation and quantitative pathology analysis. During testing, the IoU threshold was fixed at 0.5. On the validation set, the model achieved a mean average precision of 51.7 % for object detection (mAP50) and 49.8 % for instance segmentation (Fig. 7). The detection accuracies of different pathologies varied significantly. For example, in the instance segmentation task, the accuracy of excessive gaps (EG) was 69.5%, while that of surface scaling (SS) was only 30.9%. Further analysis of the confusion matrix showed that surface scaling (SS) was easily confused with color aberration (CA) and water stains (WS), which may be due to the diverse and overlapping morphologies of shedthin tile pathologies, thereby increasing the difficulty of model recognition. For example, surface scaling varies in morphology, size, color, and texture, and exists in various forms, some of which are large-area scaling, while others present punctate scaling. This diversity undoubtedly increases the difficulty for the model to accurately recognize pathology features.

Figure 6. Training loss gradient diagram of YOLO11-seg model.

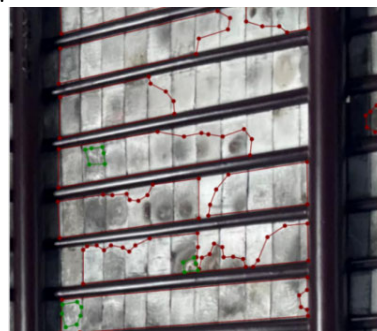
Subsequent analysis revealed that shedthin tiles frequently exhibit overlapping deterioration types: for instance, water staining (WS) often coincides with surface scaling (SS). Because YOLO treats every bounding box independently, overlapping annotations cannot be recognised simultaneously; annotators therefore marked only the most visually dominant defect, inevitably depressing detection accuracy. To mitigate this limitation, we introduced the notion of “compound pathologies” (Fig. 8), explicitly labelling overlap zones as combined classes (e.g., WS + SS). This strategy reduces annotation bias and improves model sensitivity to complex, co-occurring damage. Although the current detection performance

Figure 8. Schematic diagram of compound pathology annotation.

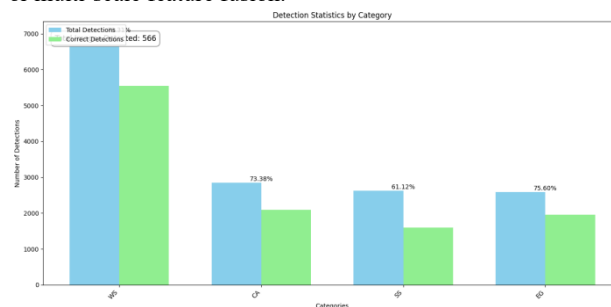
Subsequently, we manually validated the model using a separate set of 566 photographs. The detection standard was that a detection box was considered correctly detected if it overlapped with the annotated box by more than 50% (Table 2). The results showed that the detection accuracies of water stains (WS), color aberration (CA), surface scaling (SS), and excessive gaps (EG) were 79.31%, 73.38%, 61.12%, and 75.60%, respectively, with an average accuracy of 74.38% (Fig. 9). Among them, the detection performance of surface scaling (SS) was relatively weak, providing a clear direction for model optimization. Subsequent model improvements will enhance its robustness through data augmentation, attention mechanism improvements, or multi-scale feature fusion.

Figure 9. Model detection accuracy chart.

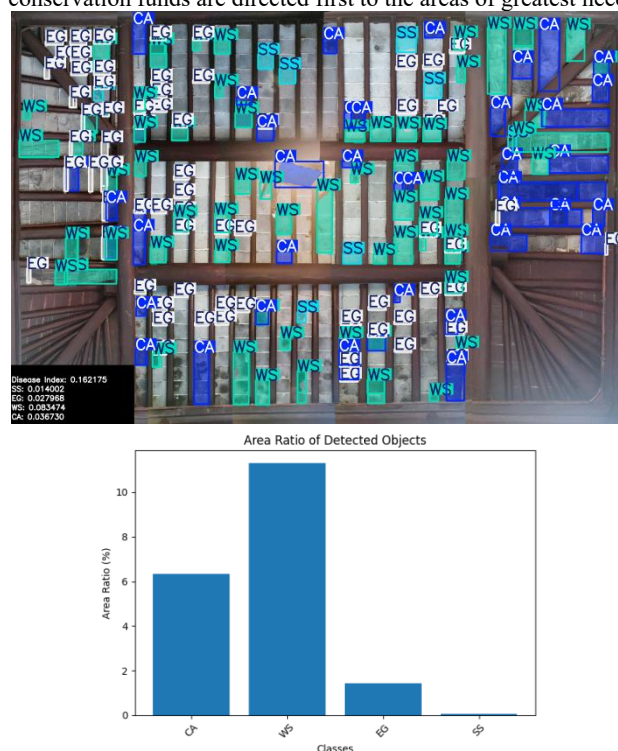
Quantitative assessment was carried out on two garden-roof elevations. The resulting Shedthin-Tile Pathology Index values were 0.162175 for Roof 1 and 0.093364 for Roof 2 (Fig. 12,13). Because Roof 1 exceeds the 0.15 threshold, it ranks as the higher-priority candidate for intervention, whereas Roof 2, with a markedly lower index, can be scheduled for subsequent treatment. Incorporating these index scores into the repair timetable supports rational resource allocation and ensures that conservation funds are directed first to the areas of greatest need.

Figure 12. Quantitative detection results and pathology area ratio of roof 1.

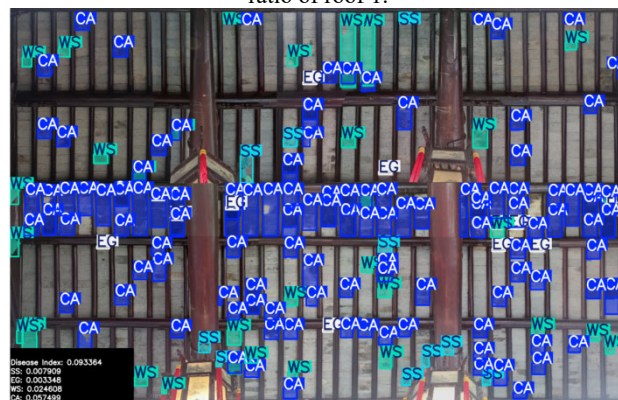
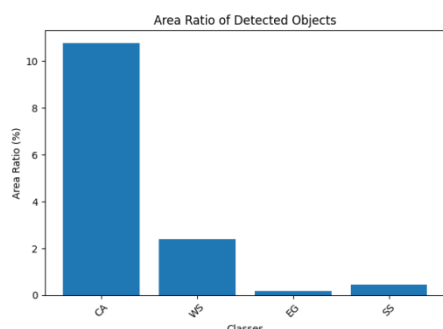
Figure 13. Quantitative detection results and pathology area ratio of roof 2.

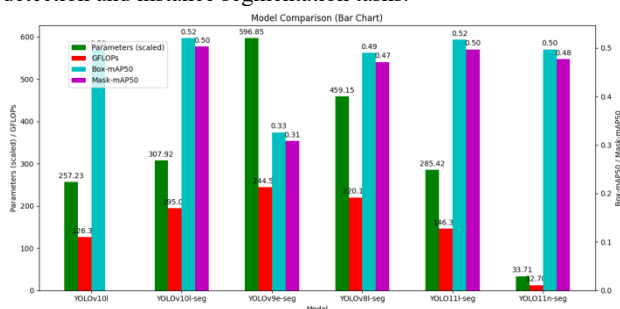
A head-to-head evaluation was conducted on four segmentation-enabled YOLO variants: YOLOv8-seg, YOLOv9-seg, YOLOv10-seg, and YOLO11-seg. Validation-set results (Fig. 14) reveal that, aside from YOLOv9-seg model, which had significantly lower detection accuracy due to technical problems during training, the other four models showed relatively close detection accuracies, with the difference in Box-mAP50 and Mask-mAP50 indicators within 3%, indicating that each model has high performance consistency in object detection and instance segmentation tasks.

Figure 14. Comparison of detection results of different models.

Among them, the YOLO11n-seg model stands out particularly in terms of parameter quantity and computational efficiency. Experimental data showed that the number of parameters and floating-point operations (GFLOPs) of this model were both less than 1/10 of other models, significantly lower than other models. This characteristic enables YOLO11n-seg to ensure faster inference speed, lower hardware requirements, and make subsequent integration with real-time terminal devices such as drones possible, thereby significantly expanding its application potential.
