## GIS-based Analysis for Seismic Vulnerability Assessment of Strengthened Masonry Churches: The Case of Parma (Italy)

**Keywords:** Cultural Heritage Protection, Emilia Masonry Churches, Seismic Damage, Post-earthquake Reinforcements Effectiveness, Historical Documentation, GIS Database.

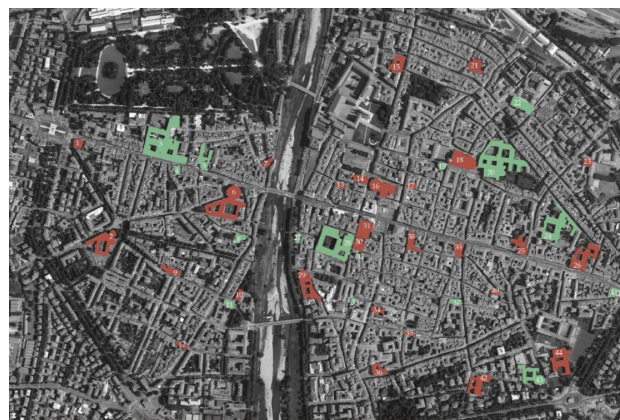
Figure 1. Masonry churches located in the historical centre of Parma and identification of damaged structures (in red) after the 1983 earthquake (Privitera, 2025).

To assess the seismic vulnerability of these religious buildings, archival research and GIS-based spatial analysis were conducted on the 44 churches located in the city centre of Parma (Figure 1), considering aspects such as historical damage, architectural characteristics, and previous seismic reinforcement.

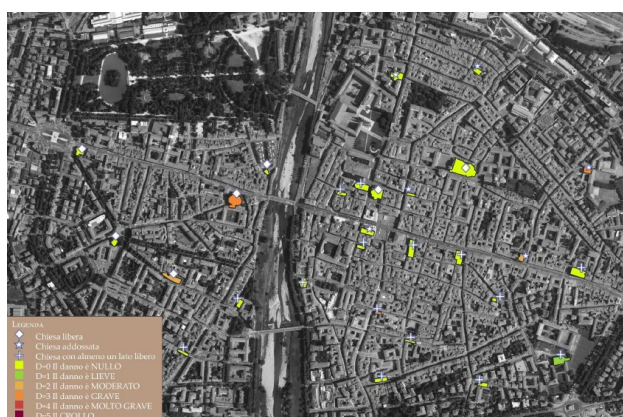
Figure 3. Example of GIS analysis investigating the correlation between the constructive features of Parma masonry churches and the level of damage for out-of-plane mechanisms caused by 1983 earthquake (Privitera, 2025).

Information on the damage was catalogued by assigning a damage level on a scale from 0 (no visible damage) to 5 (complete collapse of the macro-element), according to EMS1998 (Grünthal, 1998) to each of the 28 mechanisms defined by national guidelines (D.P.C.M. 23/02/2006). These levels were derived from technical documentation and photographic evidence retrieved from the SABAP-PR archives (Figure 3).

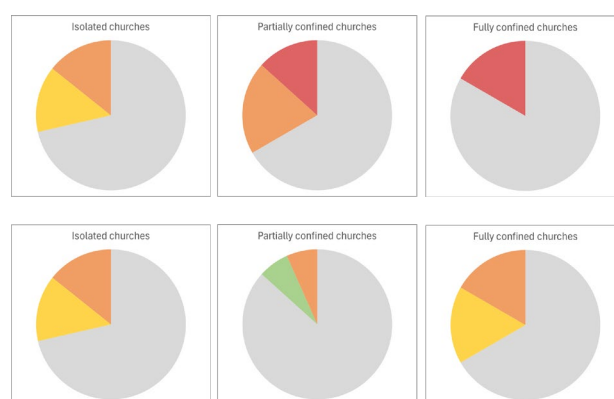
Figure 4. Percentage of M1 (top line), M2 (bottom line) activation for each level of damage (grey for D0; green for D1; yellow for D2; orange for D3; red for D4; brown for D5), for isolated, partially confined, and fully confined churches.

Considering out-of-plane mechanisms (Figure 4), the analysis showed that 72% of isolated churches were undamaged, whereas 28% experienced moderate damage (D2–D3) under both M1 and M2.

Of partially confined churches, 67% showed no damage, while 20% experienced serious damage (D3), and 13% suffered severe damage (D4) under M1. The upper part of the façade (M2) appeared to be more resilient: 86% were undamaged, while 14% displayed moderate damage (D1–D3).

Furthermore, 83% and 66% of fully confined churches exhibited no damage for M1 and M2, respectively. Only one church out of six (17%) suffered severe damage (D4) under M1, while two churches (34%) experienced moderate damage (D2–D3) under M2.

Therefore, partially confined churches exhibited the highest activation rate for M1 (33%) and the highest associated damage levels (D3–D4). This may be due to asymmetric constraints on

the façade, resulting in greater stress concentrations. Conversely, M2 was activated less frequently (14%) and with lower damage levels (D1–D2), likely because seismic energy was dissipated through M1 mechanisms.

On the other hand, fully confined churches exhibited the lowest M1 activation rate (17%), although one instance of damage reached level D4. This suggests that connection to not only orthogonal walls, but also adjacent buildings improved the stability of the façade. This highlights the critical importance of connections against overturning: where they are missing, damage is significantly severe.

By contrast, M2 activation was more frequent (34%) in confined churches, indicating that when the façade is well anchored and cannot overturn, the upper portion (the tympanum) becomes more vulnerable. Nevertheless, M2-related damage remained moderate (D2–D3), which is lower than that observed for M1.

Compared to fully and partially confined churches, isolated churches showed a medium activation rate (28%) and damage level (D2–D3), indicating average vulnerability to seismic activity. Furthermore, it is noteworthy that the activation rate and damage levels were the same for M1 and M2 in isolated churches, whereas the frequency and severity of these mechanisms varied in partially and fully confined churches. This highlights the significant influence of spatial context on seismic performance.

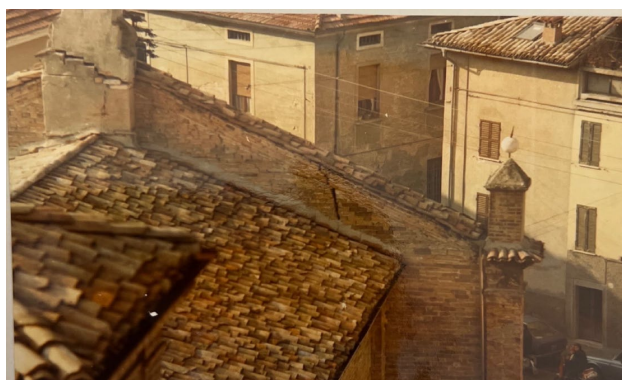
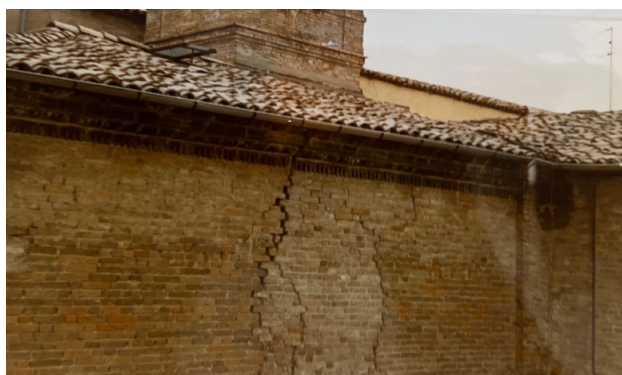
Figure 8. Seismic damages occurred on the façade (top image) and the not-confined nave wall (bottom image) during the 1983 earthquake (Privitera, 2025; SABAP-PR, PR/M 37)

During the 1983 earthquake (Figure 8), overturning mechanisms were activated, especially in the upper part of the façade. The same mechanism was also activated in the longitudinal wall on the west side, which was not confined, and considerable cracks were observed in the vaults of the nave.

Consolidation work involved repairing of the cracks by "*cuci-scuci*" technique in the masonry walls and injecting binding mixtures into the vaults. Additionally, the detached decorative elements of the façade were anchored with metal bars.

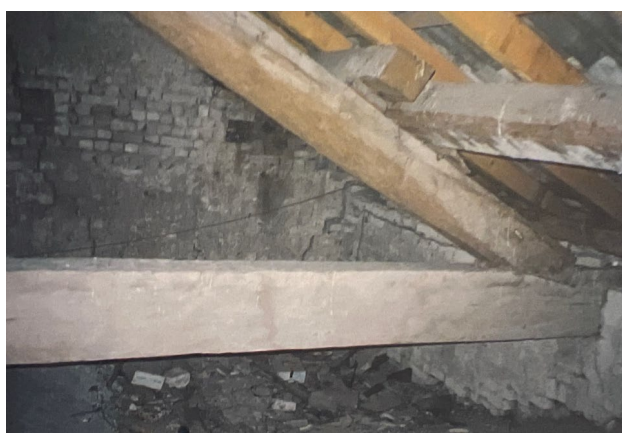
Figure 9. Seismic damages occurred on the façade during the 1996 earthquake (Privitera, 2025; SABAP-PR, PR/M 37)

During the 1996 earthquake (Figure 9), the façade was damaged again, though to a lesser extent, while the side walls remained undamaged.

This is likely because no specific interventions had been previously realized to prevent the façade from overturning, whereas the longitudinal masonry benefited from the work carried out on the roof in 1983, where the main wooden beams were connected to the perimeter masonry using metal anchorages.
