Combining 3D Geometric Documentation with Infra-Red Thermography for Enhancing Cultural Heritage

Keywords: Cultural Heritage, Geometric Documentation, 3D Textured Model, NDT's, Infrared Thermography.

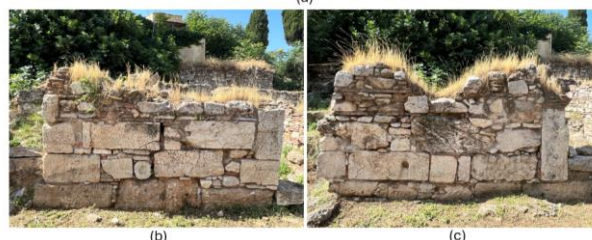
Figure 3. Representative photos of the structures adjacent to the Library of Pantainos: (a) Wall 1, (b) Wall 2, (c) Wall 3.

Wall 1, located near the stairs linking the Ancient and Roman Agoras, is a well-preserved public structure built and constructed using a dry-stone technique. Beneath it, an ancient water pipe carries rainwater from the Acropolis. In contrast, Walls 2 and 3, situated between rooms 8 and 7 and between rooms 7 and 6 respectively, are rubble masonry walls, likely parts of residential or commercial buildings (Figure 3). These walls have undergone restoration interventions and exhibit varying materials and degrees of material decay, making them ideal cases for evaluating the effectiveness of the integration of Infrared Thermography (IRT) with three-dimensional (3D) geometric documentation.

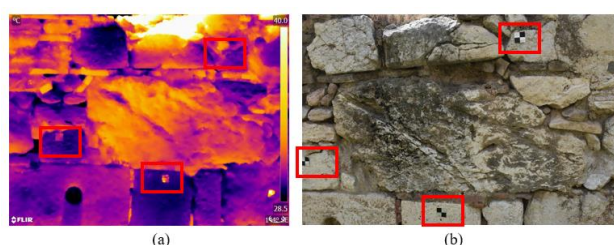
Figure 4. IRT image (a) and RGB image (b) and metal targets in red frames.

Thermal imaging was performed using a high-resolution FLIR T640 camera, capturing thermal and RGB images. Proper camera calibration, emissivity adjustments, and avoidance of extreme conditions ensured measurement reliability. Each IRT (Figure 4) image was also checked to ensure that at least three metal photogrammetric targets were visible, which are required for the creation of the three-dimensional model. The use of metal photogrammetric targets enables clear detection across thermal and visual datasets, as their low emissivity and high reflectivity enhance contrast in infrared images.

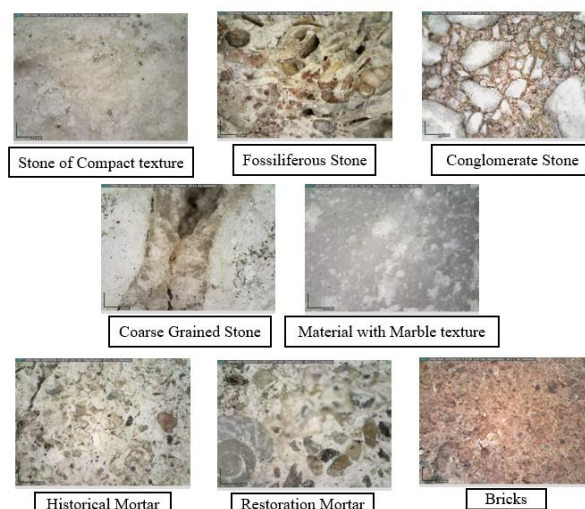
Figure 5. Digital microscopy images of the building materials.

In addition to thermography data, Digital Microscope (DM) data was also collected (Figure 5). The results of DM enabled the observation of the texture, microstructure, and morphology

of the building materials, allowing for the classification of different lithotypes and mortars.

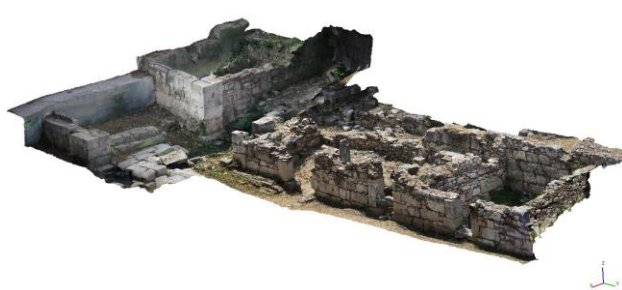
Figure 6. 3D model of Walls in the Pantainos Library.

Since these models were utilized to produce all other required products, it was essential to create precise and integrated 3D models. The triangulated irregular network (TIN), which is a simple way of creating a surface from a collection of irregularly spaced points, was selected to represent the continuous surfaces. The points may be farther apart in regions with a smoother surface, but their density rises in regions with more severe relief. This decreases the number of triangles and points needed to model complex surfaces, which in turn lowers the file size. An accurate 3D representation (Figure 6) and an orthophoto (Figure 7) suitable for further analysis and documentation, were produced.

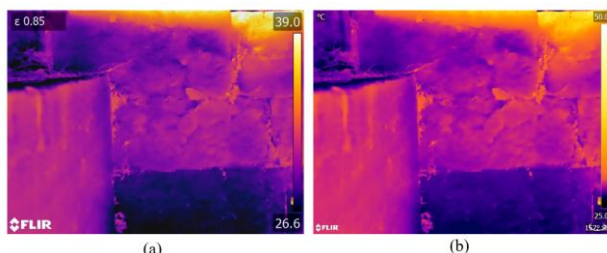
Figure 8. IRT image without processing (a), and with adjusted temperature range of 25°C to 50°C (b).

Each thermograph recorded maximum and minimum temperature values, with color palettes standardized such that the coolest temperatures appeared dark blue (almost black) and the warmest appeared light yellow (almost white). To generate a coherent 3D model with infrared texture mapping, thermographs were processed to unify the temperature range, ensuring consistent color representation. Following relevant testing, a temperature range of 25°C to 50°C was selected for all images (Figure 8).

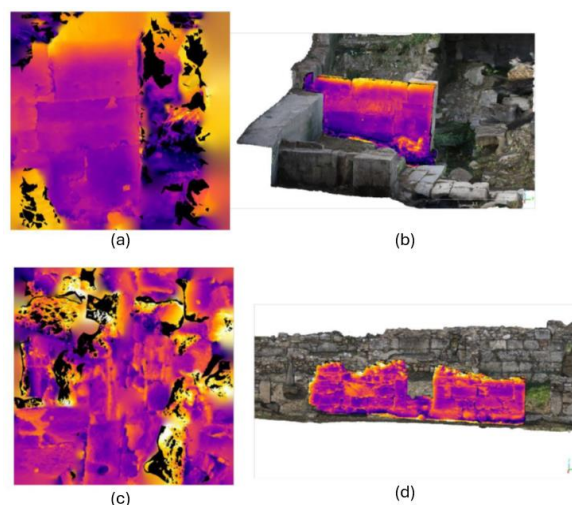
Figure 9. Texture map of Wall 1, as derived from thermograms (a), 3D model of Wall 1 with Thermal texture (b), Texture map of Walls 2 and 3, as derived from thermograms (c), 3D models of Walls 2 and 3 with Thermal texture (d).

Finally, the careful application of the texture from the oriented RGB and IRT images, completed the detailed 3D textured models. Texture mapping onto the 3D model of the library section was performed using Agisoft Metashape Professional. The overall surface was segmented into distinct spatial units, with each unit receiving a texture map derived from the corresponding infrared thermograms. As a result, each wall was represented by a developed surface image containing the mapped thermal texture. For Wall 1 and for 2 and 3 combined, a resolution of 4096 × 4096 pixels was adopted, as this was found to be optimal for compatibility and performance across the various processing software (Figure 9).

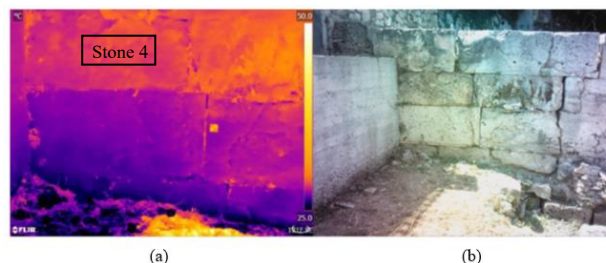
Figure 10. IRT image revealing thermal anomalies (a), Corresponding RGB image of the same section of the Wall 1 (b).

For the presentation and evaluation of IRT results, an IRT image and a RGB one with annotations are presented below for Walls 1, 2 and 3 separately. Figure 10 illustrates the lower left section of Wall 1, where its direct contact with the ground is observed. This area demonstrates increased thermal variability, with surface temperatures ranging from approximately 24°C to nearly 40°C. The lower portion of the wall is consistently depicted as cooler in the thermographic imagery, a clear indication of rising damp. Rising damp presence not only contributes to the reduced thermal reading but also exacerbates the deterioration processes affecting the masonry fabric.

Particularly noteworthy is the fossiliferous stone identified as "Stone 4" which exhibits an average surface temperature of approximately 29°C. Beyond thermal anomalies, this stone displays evident signs of material loss and structural compromise. Cracks and fissures are prominently visible, and the detachment of material fragments points to ongoing decay processes. Cumulative evidence suggests that rising damp penetration, combined with thermal stress and material deterioration, has significantly undermined the integrity of the stones in this section.

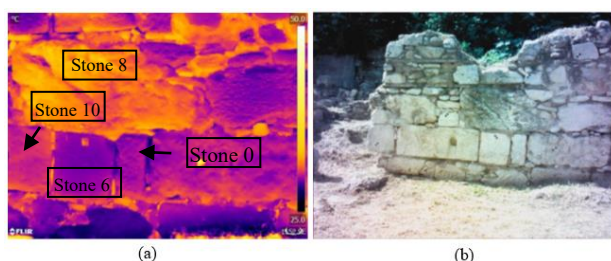
Figure 11. IRT image revealing thermal anomalies (a), Corresponding RGB image of the same section of the wall 2(b).

Figure 11 depicts the middle section of the wall, where a relatively small thermal variation is recorded between materials, with temperatures ranging from 28°C to 33°C. This moderate range is attributed to the predominance of stone masonry in this area, which ensures greater thermal uniformity. The geometric features of the stones, including characteristic tool marks such

as putlock holes, are clearly discernible, alongside visible signs of material degradation.

Particularly significant is the stone 8 displaying the highest recorded temperature within this section. This stone is traversed by a wide, shallow crack that extends diagonally from the upper left corner to the midpoint of the opposite side, effectively bisecting the rectangular form of the block. The presence of this fissure highlights the material's progressive deterioration, likely exacerbated by thermal stress and weathering.

Furthermore, the fossiliferous stones identified as Stones 8, 10, 6, and 0 exhibit distinct thermal variations, which correspond to varying patterns of decay. In Stone 8, for example, thermal imaging reveals a notable 3°C increase in the area flanking the crack, where severe biodeterioration has been observed. In contrast, the right-hand section of the same stone, where a hardened crust has developed, shows comparatively lower temperatures. Meanwhile, the other fossiliferous stones demonstrate a higher degree of thermal homogeneity, closely matching the adjacent solid structural stones, suggesting less active deterioration in those blocks.

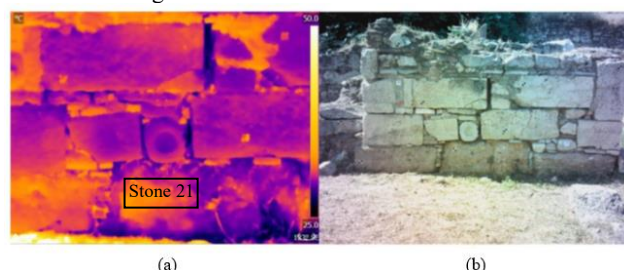
Figure 12. IRT image revealing thermal anomalies (a), Corresponding RGB image of the same section of the Wall 3(b).

Figure 12 illustrates the central portion of the Wall that comes into direct contact with the ground. The geometric features of the stones are clearly discernible, including their outlines, their surface irregularities, and signs of material loss and cracking, which are indicative of ongoing weathering and structural deterioration.

Thermal imaging analysis reveals that the highest temperature readings are concentrated in the restoration mortar, suggesting its greater thermal absorption and retention capacity under the given environmental conditions. In contrast, the lowest temperature is recorded in the degraded conglomeratic stone identified as Stone 21. This cooler reading is attributed to the stone's direct contact with the ground, which exhibits elevated levels of rising damp. The presence of rising damp in the lower section significantly reduces surface temperature, further highlighting areas where rising damp is actively impacting the structure's material.

This pattern of temperature distribution not only underscores the differing physical responses of original and restoration materials but also provides valuable insights into the localized deterioration mechanisms, particularly in zones where masonry interfaces with ground.

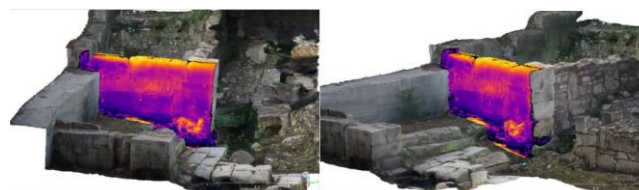
Figure 13. Texture IRT of Wall 1.

Specifically, for Wall 1 (Figure 13), the analysis unequivocally confirms the accumulation of rising damp in the lower masonry sections, a condition that promotes the transport, crystallization, and recrystallization of salts with potentially harmful consequences for the materials. Moreover, the thermographic survey identifies significant degradation affecting the central intermediate stone, signaling advanced material weakening. Notably, bricks located in the lower right of the wall exhibit elevated thermal responses in comparison to adjacent stone elements, suggesting variations in material composition or rising damp, which may account for differential thermal behavior and accelerated decay processes.

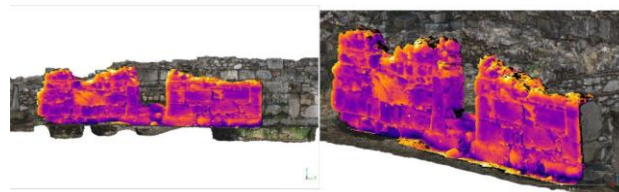
Figure 14. Texture IRT of Walls 2 and 3.

In the case of Walls 2 and 3 (Figure 14), the findings indicate that several structural materials, particularly stone elements, exhibit pronounced signs of erosion and advanced weathering. Furthermore, mortars in these sections are observed to accumulate higher temperatures, creating sharp thermal gradients between adjacent materials. These thermal differentials generate internal stresses that compromise intermaterial cohesion, leading to progressive joint loosening and cracks, with detrimental effects on the structural stability of the masonry system. Additionally, evidence of rising damp is consistently recorded along the essential sections of the walls, especially in areas constructed with conglomerate stones, further highlighting the susceptibility of these elements to rising damp deterioration.

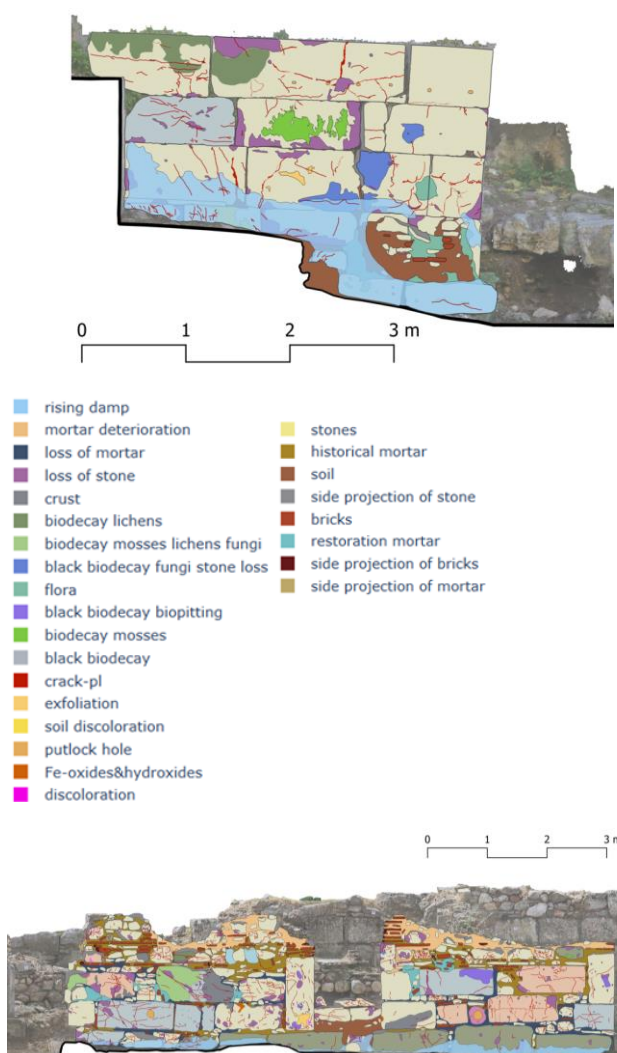
Figure 15. Building material and Decay thematic map and legend of Wall 1(up) and Walls 2 and 3 (down).

As a continuation of the present research, the results were further developed in a subsequent study focusing on the detailed digitization of building materials and decay patterns on orthophotos. This allowed for the spatial representation of these data and their integration into a GIS environment using the open-source QGIS platform. The GIS was designed to record, manage, analyze, and visualize both qualitative and quantitative information derived from the interdisciplinary investigation of the monument. Thematic maps of building materials and decay patterns were created, providing valuable information about environmental impact assessment (Figure 15).
