Tracking the Material History Through the Analysis of Past and Present Alterations and Restorations. Application to Doors and Walls of the Museum Najerillense (La Rioja, Spain)

Keywords: Conservation-restoration, Alteration Monitoring, Historical Graffiti, Weathering of Surfaces.

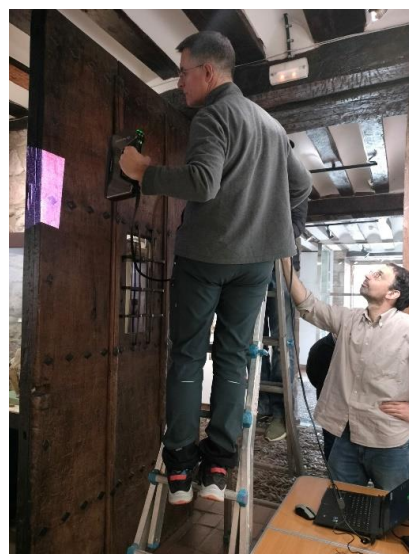
Figure 1. Three-dimensional recording (with a fringe-projection scanner) of the graffiti (and the surfaces where they are) on one of the doors of the museum.

The initial intention was to use a short-range 3D scanner —EinScan PRO HD— for the geometric documentation of the graffiti. As can be seen in the picture (figure 1), the scanner is freely handled at around fifty centimetres from the surface and scans an area of around 20 x 20 cm, by moving the device the surface is progressively swept. The software joins all individual scans to complete the three-dimensional model of the object.

This scanner has two possible configuration modes: the "rapid" one —with a nominal accuracy of around 0.7 mm— is suitable for objects up to 2 meters large. This method was tested firstly, because we wanted to check whether it was versatile and precise enough to record, on one go, the entire door and clearly show the graffiti in the resulting 3D model. Unfortunately, that was not the case. On the one hand, the doors proved to be larger than the recommended objects to scan and that fact produced errors in the 3D models of the elements. In addition, the resolution of the models was insufficient to correctly visualize the engravings.

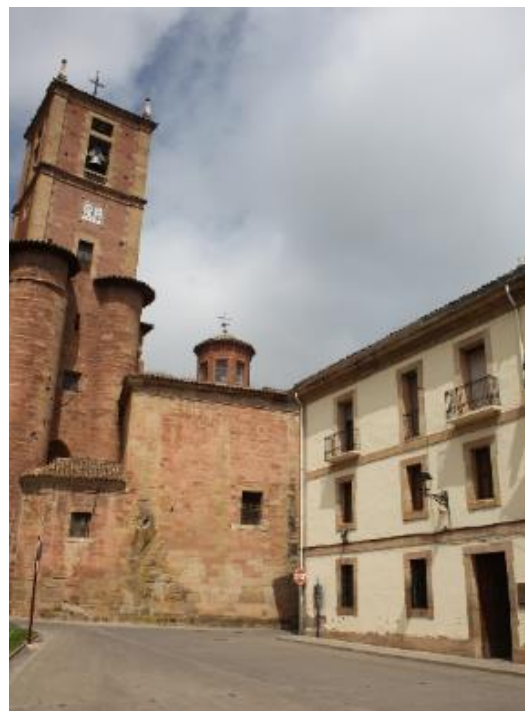
Figure 2. Photograph showing the museum (on the right, with a white façade) near the monastery of Santa María la Real. No remains of the former courtyard are currently visible.

Moreover, the appearance of the block and its surrounding buildings was significantly altered with the demolition of some parts and the erection of new buildings. Of the two original gardens that became the prison courtyards, one of them is now an open square, while the second one was reduced to a small rear alley (figure 2).

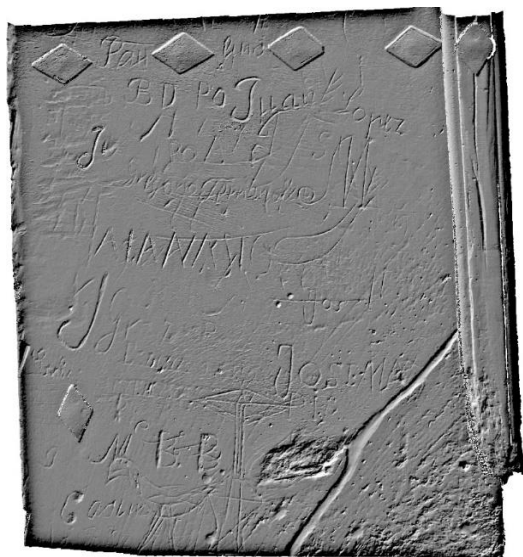
The three-dimensional models are the initial results. However, further processed outcomes, such as enhanced relief shading images were generated (figure 3).

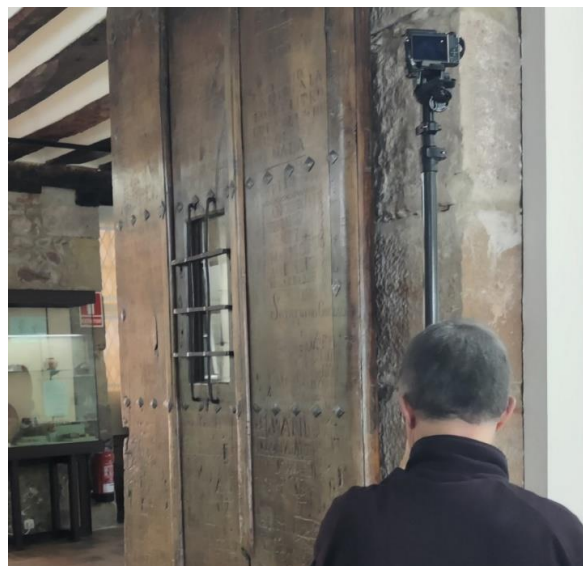
Figure 4. Photographic record and resulting three-dimensional model of one of the doors.

However, the problem of not having complete representation of the elements remained. For that reason, they were documented by means of convergent photogrammetry (figure 4). Indeed, collections of multiple views for each door were obtained and processed. Besides, some control distances were measured with a tape (for the doors) and total station (in the courtyard) so as to give scale to the models.

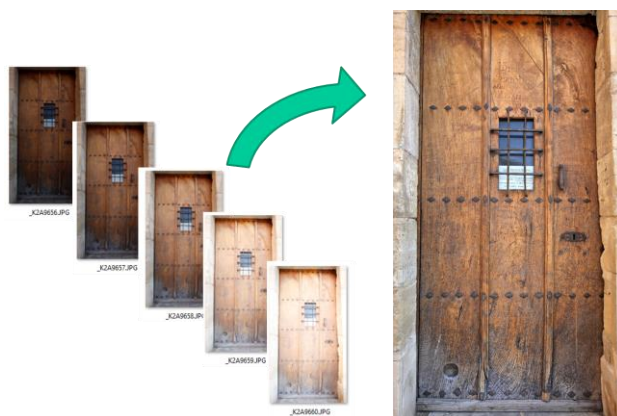
Figure 5. Generation of High Dynamic Range (HDR) images.

A complementary product was a collection of High Dynamic Range (HDR) images (figure 5). These images were generated for the entire doors and for detailed areas. A fifty-megapixel sensor and series of shots of the same area under different exposure parameters were used.
