Sufficiency of Technology Adaptation in Risk Monitoring Criteria for Heritage Sites Management in Malaysia: Site-Based Classification

Norzaihan Mad Zin¹, Farrah Zuhaira Ismail¹, Shahrul Yani Said¹

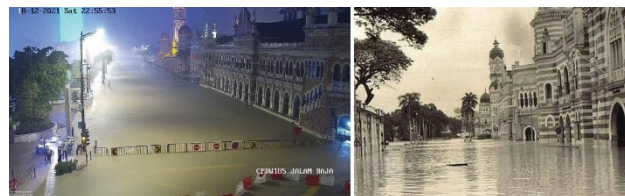
Bangunan Sultan Abdul Samad, located adjacent to the Klang River and the historic Padang Merdeka, has also faced increasing risks from urban flooding due to rapid development, riverbank modification, and inadequate stormwater management systems. Kuala Lumpur experiences flash floods during heavy rainfall, and the location of the building places it within the flood-prone catchment area of the Klang basin (Abdullah et al., 2020; Loo et al., 2015). Historical records highlight multiple incidents of water pooling and seepage within the building's basement and lower floors, often exacerbated by outdated drainage infrastructure (Zamani & Akbari, 2021).

Figure 4. Flooding history at Bangunan Sultan Abdul Samad (Left photo: Flood event in 2021; Right photo: Flood event in 1971) (Source: Berita Harian)

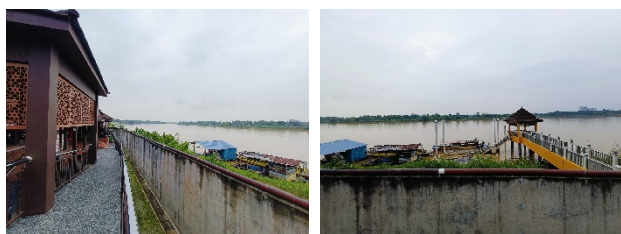
The decision to relocate the Masjid Kampung Laut back to its original place required the involvement of various experts such as architects, engineers, and local authorities. Detailed engineering calculation was made, including strengthening the riverbank of the proposed new location of Masjid Kampung Laut. Acknowledging that Tumpat was severely affected by the flood event in 2014, the Department of Irrigation and Drainage (JPS) decided to build a flood barrier standing 2.4 metres high along the banks of the Kelantan River as a precautionary barrier against riverbank erosion.

Figure 5. Flood barrier along the Kelantan River protecting the Masjid Kampung Laut. (Source: Author)

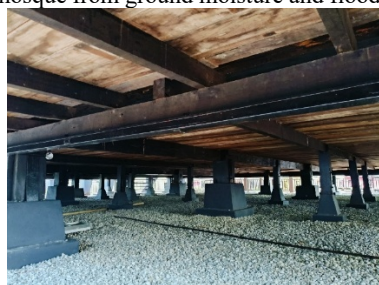
The mosque was constructed using chengal hardwood, a native tropical timber renowned for its exceptional durability and natural resistance to termites and rot (Kamarul Syahril & Ahmad, 2015). The structure follows a post-and-beam system with mortise-and-tenon joints, eliminating the use of nails, which was a traditional Malay carpentry technique. This system, combined with elevated flooring supported by stilts, helped protect the mosque from ground moisture and flooding.

Figure 6. The original 20 structure pillars were supported with modern concrete footing. (Source: Author)

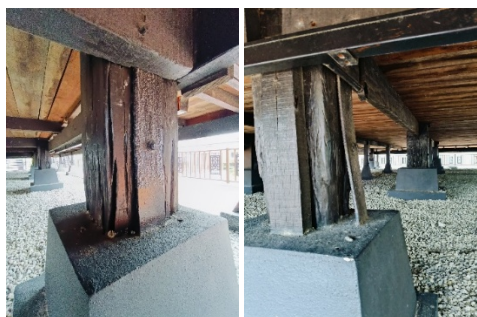
Figure 7. The timber pillar foundation was supported with a metal support. (Source: Author)

Due to the aging wooden structure, new modern joinery support, such as bolt-and-nut, has been adopted to strengthen the overall building structure. The bottom part of the timber pillar was badly damaged compared to the other length of the pillar due to its frequent submergence under water during flood disaster.

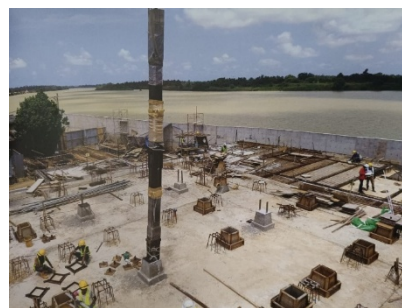
Figure 9. The first Soko Guru to be erected during the reconstruction work in 2021. (Source: ECERDC, 2022)

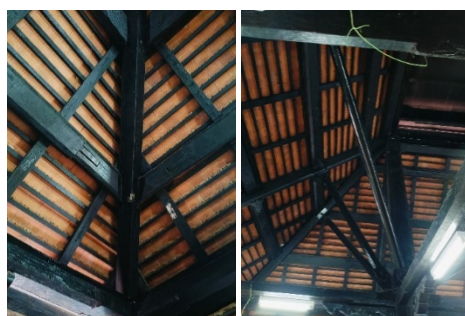
Many of the original 20 timber pillars (*tiang seri*) are still standing and provide vital vertical support to the mosque's superstructure. The preservation of these columns, along with the original beam network and wooden panelling, reflects the high-quality workmanship and architectural foresight embedded in traditional Malay construction practices (Ismail, 2013).

Figure 10. The mortise-and-tenon join for roof trusses is now supported with a metal structure to strengthen the roof. (Source: Author)

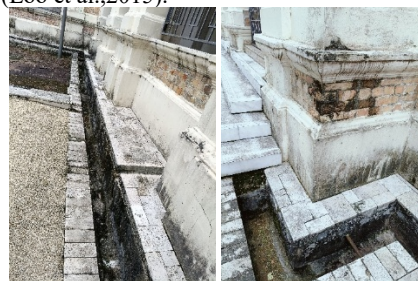
Figure 14. Poor perimeter drainage system of Bangunan Sultan Abdul Samad (Source: Author)

The drainage system surrounding the Bangunan Sultan Abdul Samad was found to be very narrow, and some of the drainage was blocked by road access modification.

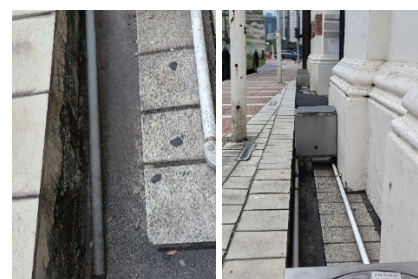
Figure 15. Additional components (Spotlight and piping) were obstructing the existing drainage

The impact of new and non-strategic development and modification conducted at the heritage sites leads to this inappropriate position of all these "add-on" items, including blocking and drainage lines, which are already too narrow to accommodate the overflow of heavy rainwater into the stream.

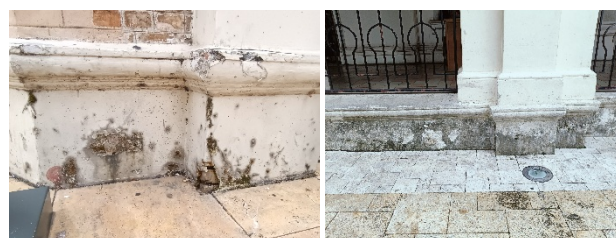
Figure 16. Water damage in the Wall and Foundation

Water infiltration into the basement and lower-level walls due to the frequent flood occurrence has caused rising damp, efflorescence, and mortar degradation, weakened the brick joints and increased the building's vulnerability to structural fatigue. Moisture-related damage is most evident in plaster spalling and cracks at arch junctions and column bases.

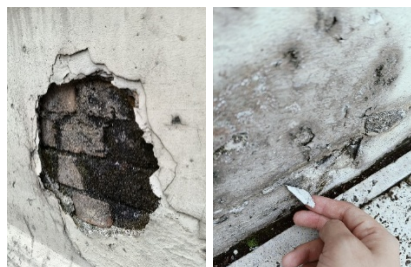
Figure 17. The wall cracked, and plaster spalled.

These issues are exacerbated during intense wet seasons, which are projected to worsen due to climate change impacts on rainfall variability. Beyond flooding, the building also suffers from vibrational stress induced by the high vehicular activity along Jalan Raja and the nearby construction of underground transit systems. These vibrations contribute to micro-cracking in the plaster and render layers, which it left untreated. In a prolonged duration, it can compromise the load distribution and lead to progressive material fatigue (Harun et al.,2015; Moropoulou et al.,2020).

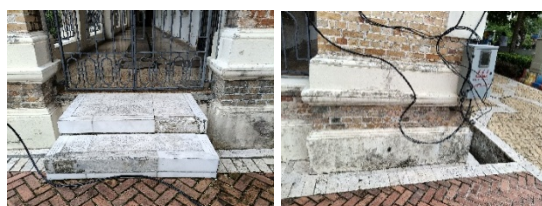
Figure 18. Additional electrical DB and conduit exposed to public access. (Source: Author)

The additional concern that warrants attention at this location pertains to public safety. The alterations made to the site were executed in a manner that was not suitable, resulting in the clear exposure of additional electrical distribution boards along the public walkway. Any acts of misconduct or vandalism directed at the exposed electrical distribution board could potentially result in a disastrous fire incident.
