Digital Documentation and Data Analysis for Safeguarding Heritage at Risk. Condition Assessment of Colonia Varese

Federica Maietti ^{1*}, Martina Suppa ¹, Gabriele Giau ¹, Luca Rossato ¹, Guido Galvani ², Marcello Balzani ¹

Keywords: Heritage at Risk, 3D Laser Scanning, Photogrammetry, Modernist Architecture, Digital Data Analysis.

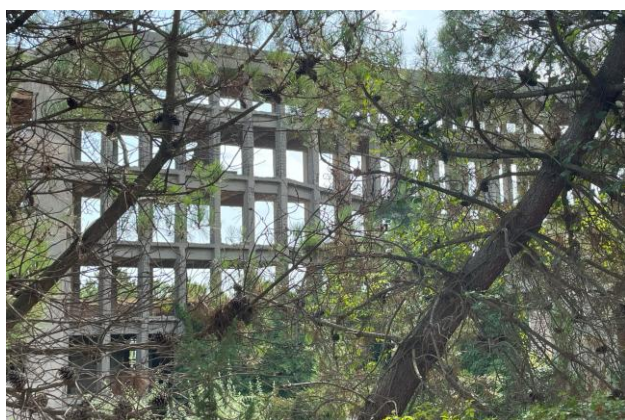
The condition of abandoned buildings, such as the former Colonia Varese (Fig. 2,3), mixes different levels of criticality, adding the lack of conservative interventions to the impact that natural events and environmental conditions have on structures weakened by the lack of maintenance actions (Romão and Bertolin, 2024). In addition to being a unique opportunity to deepen the knowledge of Colonia Varese and increase interest and awareness towards this exceptional example of rationalist architecture, the research has been a testing ground for developing the use digital technologies for documentation of endangered heritage. The digital-based methodology, developed combining the most up-to-date survey tools and methods with traditional on-site inspections, provides an effective means for condition assessment.

Figure 2. Current conditions of the Colonia Varese reinforced concrete structure (photo by the authors).

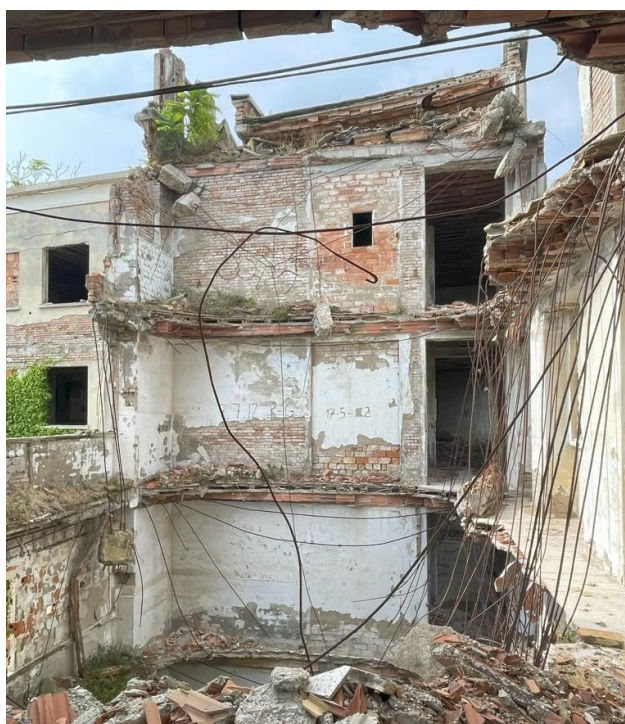
Figure 3. View of a portion of Colonia Varese affected by collapses of horizontal structures (photo by the authors).

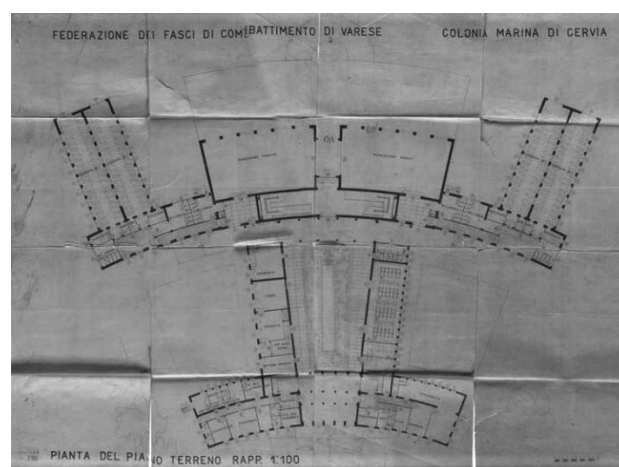
The Colonia Varese was built between 1937 and 1938 on the initiative of the "Federazione dei Fasci" of the Province of Varese to provide children with a seaside colony on the Adriatic Sea. The building was designed by the architect Mario Loretì and opened in 1939 under the name "Colonia Costanzo Ciano". Mario Loretì (Rome, 1898) began working in the field of industrial design as a furniture designer. In 1928 he registered with the Order of Architects of Rome, listed as an engineer; probably he first attended the faculty of engineering, since the Higher School of Architecture for the professional training of architects was established only in 1919, becoming operational in 1920. He then began working in the studio of the architect Pietro Aschieri. In 1930 Loretì visited Germany and the austerity of new architectures of that period deeply impressed him. In 1932 he joined the National Fascist Party, and his career had a sharp increase. In 1929 he carried out the intervention in Piazza Bologna, starting to apply the new rationalist language in his design. In following interventions his style became even more dry, assuming the linear severity of 1930s constructions. An example is the Singer headquarters in Rome, where the preciousness of the materials balanced the project austerity. In the mid-1930s, thanks to his membership in the regime, Mario Loretì obtained some government commissions in Northern Italy, including the design of Piazza Monte Grappa and the Palazzo del Littorio in Varese. In 1936 he was involved in two important social projects of the Varese community: the maritime colony of Cervia and the sanatorium of Sondalo (Mazza, 2010). From the Colonia Varese project plan, it seems that Loretì wanted to give the plant the shape of an aircraft complete with wings, tail and fuselage (Fig. 4).

Figure 4. Colonia Varese project plan (Ravenna State Archives).

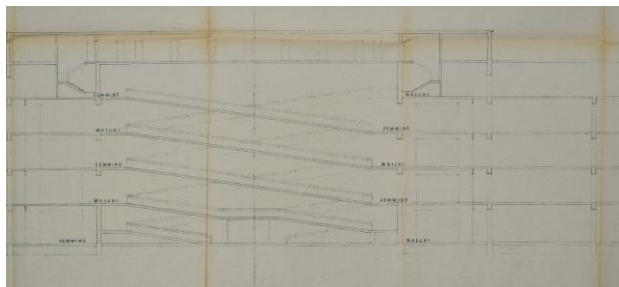
The ramps, which are one of the Colonia's most characteristic and peculiar architectural elements, originally provided access to the five dormitory floors via separate paths for boys and girls (Fig. 5, 6).

Figure 5. Project drawings of the ramps (Ravenna State Archives).

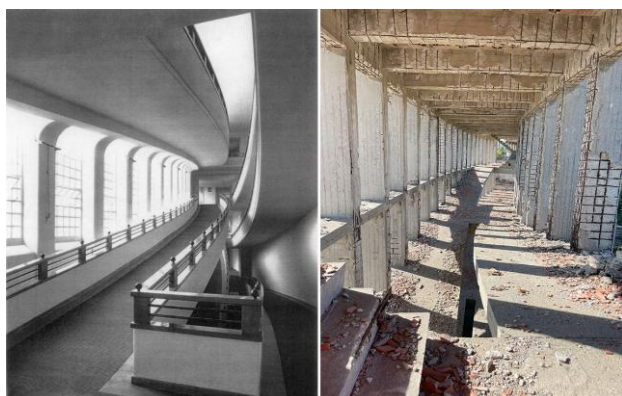
Figure 6. View of the ramp structure in a comparison between a period photo (Ravenna State Archives) and the current condition.

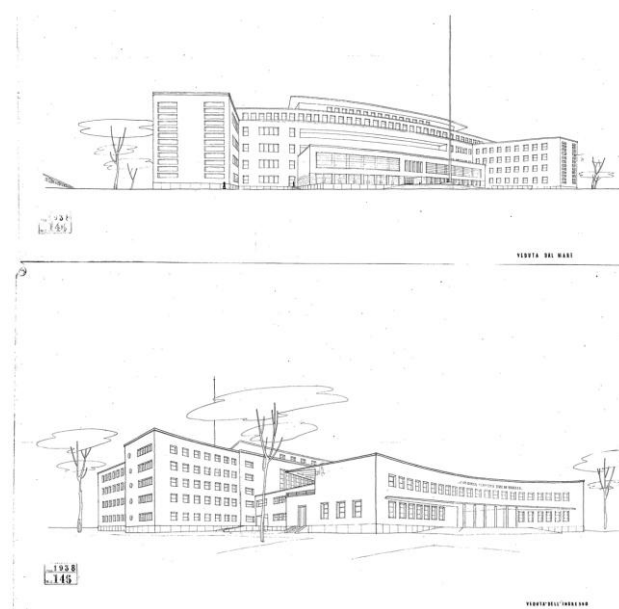
Figure 8. Project drawings. On the top, view from the sea, on the bottom, view from the entrance (Ravenna State Archives).

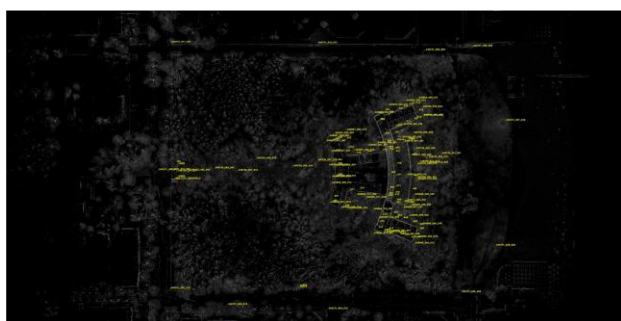
In order to guarantee the required accuracy despite the obstacle of vegetation, the topographic survey was used to define a high-precision local coordinate system (Fig. 9), the boundaries of relevance and the support of sub-networks necessary for the detailed survey (Fig. 10).

Figure 9. The topographic model (graphic elaboration by the authors).

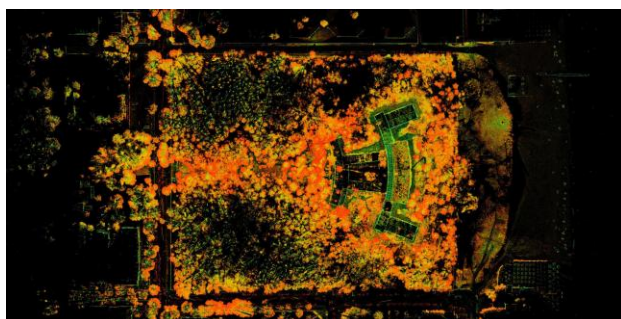
Figure 10. Plan view of the 3D laser scanner model (graphic elaboration by the authors).

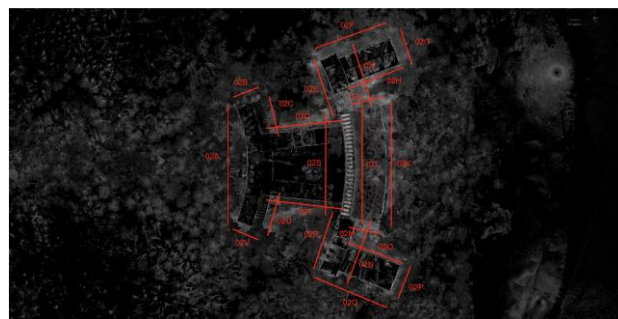
The sections were directly edited on the point cloud following a rigid scheme of coordinate systems and section planes (Fig. 11). This procedure also established the nomenclature through which the elevation-sections extracted from the 3D models were identified, to be used as a basis for the mapping of the state of conservation of the surfaces and for the representation of damages and deformations.

Figure 11. Vertical section extraction scheme (graphic elaboration by the authors).

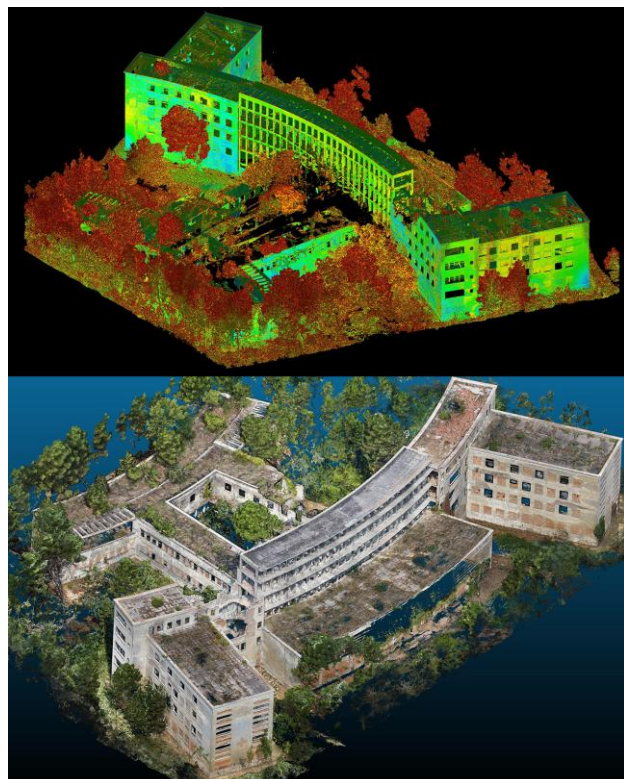
Figure 12. Views of the 3D point cloud and the model obtained through photomodelling (graphic elaboration by the authors).

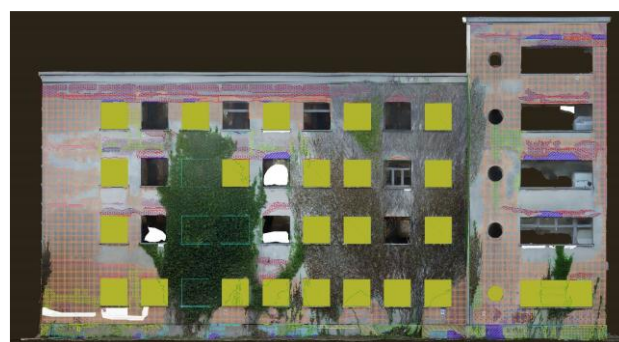
Mapping of surface degradations was carried out by combining field observations (which produced a preliminary annotation on sketches of the elevations) with the identification of decays and degradation mechanisms on DEMs. The extractions of the elevations from the model obtained via digital photogrammetry were essential to outline the degraded areas with great precision, being the model metrically accurate and consistent with the integrated laser scanner and topographic survey.

Figure 13. Sample of degradation outlining on the surfaces of one of the elevations, using the DEM as a basis for mapping the conservation conditions in detail (graphic elaboration by the authors).

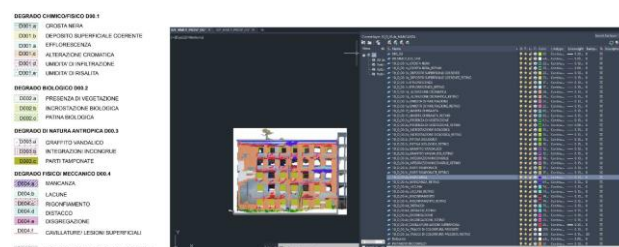
Then the degradation mapping has been represented on CAD drawings. The macro areas of degradation and conservation conditions were assigned to specific layers on the software (Fig. 14), with graphic patterns and related abacus.

Figure 14. Sample of CAD mapping, where states of conservation are assigned to specific layers (graphic elaboration by the authors).

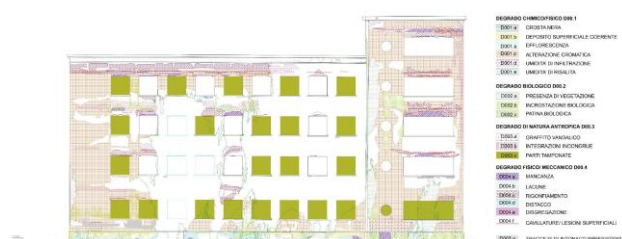
identification of degradation, has been integrated with additional classes specifying different anthropic degradations and inconsistent/incompatible interventions. The creation of vector files (Fig. 15) including the mapping of the state of conservation of the surfaces on an accurate geometrical basis is essential for the computation of conditions and possible interventions. Mapped areas are indeed manageable by levels and the extension of the surfaces affected by specific degradation is a measurable area, providing additional elements for the evaluations relating to possible future actions and strategies.

Figure 15. CAD mapping, with degradations represented in vector format for computational purposes (graphic elaboration by the authors).

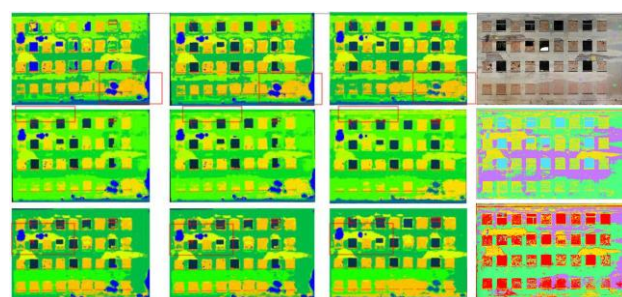
Figure 16. Comparison between different methods of material classification starting from the point cloud and, on the right, segmentation from images (graphic elaboration by the authors).

The dataset related to Colonia Varese is the 3D point cloud, in which each point is described by features, including spatial coordinates, RGB values and different geometric features. For training the model, a subset of the original dataset was used, enriched by the additional variable related to materials, which specifies the class of material associated to each point.

The dataset includes 8 classes of materials, representing the different structural components of the building. The different processes tested starting from the manual annotation of parts of the model up to the automatic classification of the features, demonstrate how the AI model is able to accurately segment the different surfaces of the building, replicating and systematizing the information provided by human annotation. The analysis of the state of conservation requires a more structured approach
