Geospatial Analysis for Decoding Architectural Configuration of Ruins of a Coastal Fort: The Case of Fort Vijaydurg, Konkan, India

Keywords: Viewshed Analysis, Ruins, Architectural Configuration, Coastal Forts, Vijaydurg, Konkan

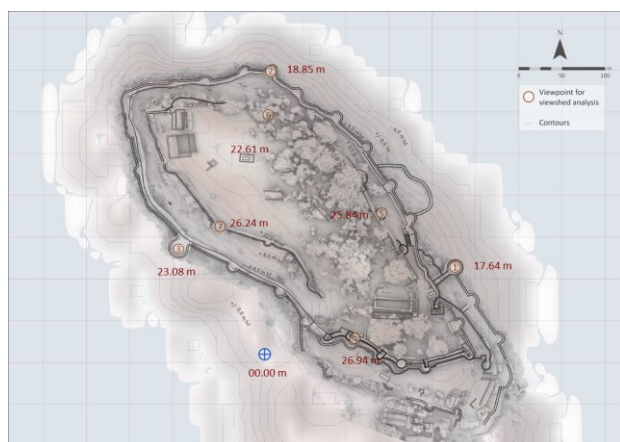
Figure 2. The layout and 3D photogrammetric model of Fort Vijaydurg is georeferenced with a Digital Elevation Model generated in ArcGIS. The map depicts location and assumed heights of the viewpoints considered for viewshed analysis. © Authors

The surviving remains of the fort mainly consist of outer and inner fortification walls (Figure 2). The fortification walls follow the profile of natural contours. The inner layer is constructed at a higher level, and the outer layer is constructed at a lower level. The outer layer is constantly exposed to the ocean waves and winds. There was a third layer of fortification wall towards the land side. However, most of the third layer is lost today. Only the traces of a few lower stone courses are visible on site. A moat running from the beach to the creek provided additional protection to the fort. The moat is now barely identifiable due to deposition debris and vegetation growth. The fortification walls are intercepted with bastions of varied diameters and heights. A total of 27 bastions are identifiable in the outer layer. The inner layer is broken and lost at multiple points. Some of the bastions in the outer layer were provided with multistorey towers. The towers were constructed above the finished top level of the bastions. As evident in the eighteenth-century illustration (Figure 7), the towers were capped with either conical or sloping roofs. None of the towers' roofs has survived to present times. In some cases, the upper floors are also lost. Only a handful of the buildings inside the fort have survived. Moreover, only two structures still have their roof intact. Numerous structures are buried under debris, soil deposits and decades of vegetation growth.

From the surviving remains, a total 7 locations were identified for conducting viewshed analysis (Figure 2 and Table 2). Four locations are part of the outer fortification, and three are of the inner. The rationale for selecting these seven locations was to analyse the architectural elements spread across the fort and which are at different stages of ruination.

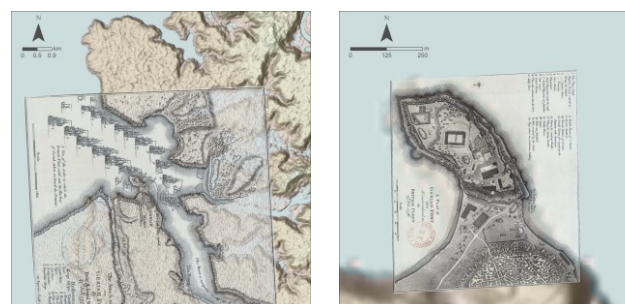
Figure 5. Archival maps (Figure 5) are georeferenced with DEM in GIS. The DEM illustrates present-day topography. Left: Profile of Vaghotan Creek. Right: Vijaydurg fort and land connection to the town. © Authors
