ESTIMATION OF VERTICAL DEFLECTIONS IN CONCRETE BEAMS THROUGH DIGITAL CLOSE RANGE PHOTOGRAMMETRY

I. Detchev^{a,*}, A. Habib^a, M. El-Badry^b

^a Department of Geomatics Engineering

^b Department of Civil Engineering

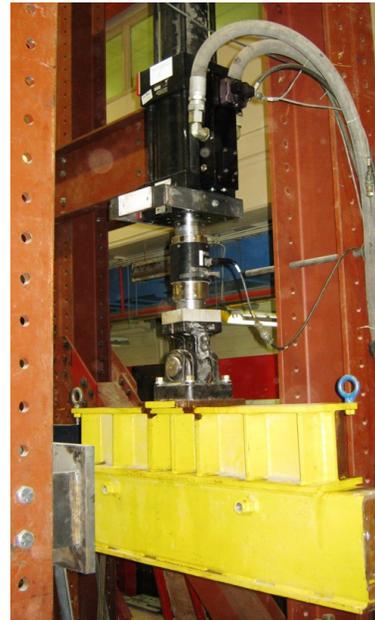
Figure 1. Spreader beam (in yellow) attached to a hydraulic actuator (in black and silver)

A multiple camera and projector photogrammetric system had to be installed on both sides of a 250 kN hydraulic actuator with an attached spreader beam (see Figure 1) in a structures laboratory. It was to be used in photographing concrete beams (see example in Figure 2) under different loading conditions, where the changing loads would be applied by the above-mentioned actuator. A metal frame had to be designed and welded around the actuator (see Figure 3) in order to hoist the cameras and the projectors in secure positions above the beam being tested. Observing the top surface of the beam was preferred to observing its longitudinal side, because the bulk of the deformation was naturally anticipated to be along the gravity vector.

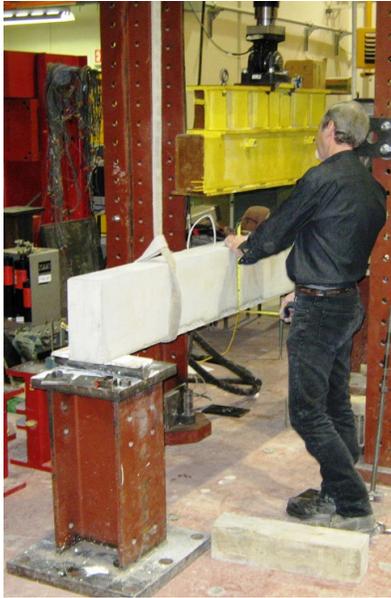
Figure 2. Placement of a concrete beam to be used for the experiment

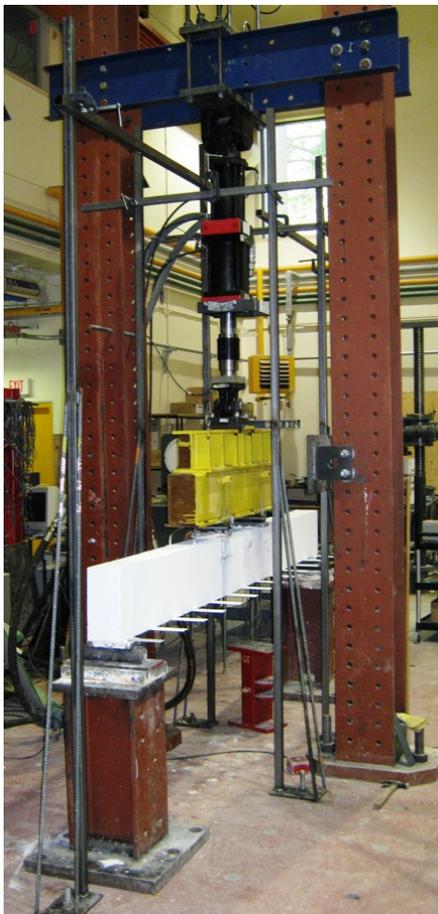
Figure 3. Part of the metal frame built to hoist the cameras and the projectors of the digital photogrammetric system

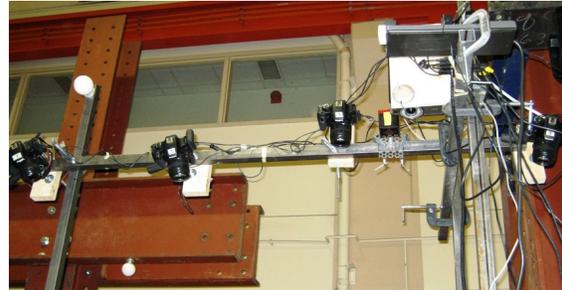
Figure 4. Example of the multiple camera and projector setup on the west part of the metal frame

Four digital cameras were mounted on tripod heads, and attached to the west part of the metal frame (Figure 4), while three other cameras were mounted and attached to the east part. One digital projector was also attached on each side of the supporting frame.

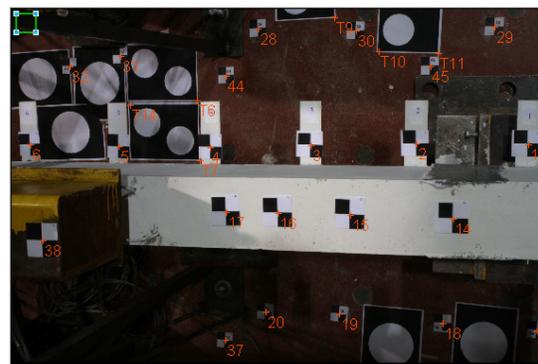
Figure 5. Example of the distribution of signalized targets on the floor, on the concrete beam, and on the spreader beam

Before the cameras were used for this project, they were geometrically calibrated. It was also verified that their internal orientation parameters (IOPs) were stable, i.e. they did not change significantly over time. After the cameras were installed on the metal frame, they had to have their relative orientation estimated. The location and the orientation, i.e. the exterior orientation parameters (EOPs), of each camera were obtained through a bundle block adjustment procedure using checkerboard paper targets. These signalized targets were spread out on the lab floor, on the concrete beam and on the spreader beam attached to the hydraulic actuator (see Figure 5). The scale for the bundle block adjustment was defined by several distances measured with a steel tape between some of the targets on the floor. Since the cameras were rigidly mounted on the metal frame, their relative EOPs were assumed not to change for the full duration of each experiment. This is why the bundle block adjustment was done only once before the beginning of each of the conducted experiments, and the paper targets were removed right before the commencement of the actual beam testing (see Figure 6), i.e. they were not used for reconstruction purposes.

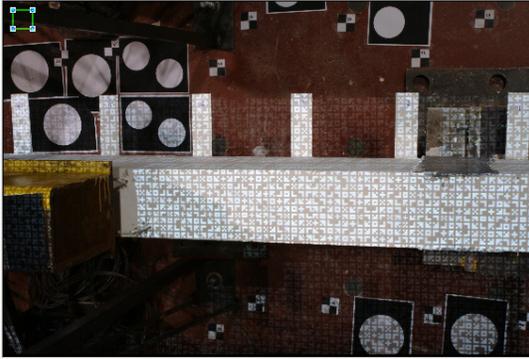
Figure 6. Example of the absence on signaled targets and the presence of a projected random pattern on the surface of the concrete beam during the testing

As mentioned in the previous section, the digital projectors were used to project a random pattern image in order to facilitate the matching problem of conjugate features between the overlapping camera images. As seen from Figure 6, the projected pattern image added artificial texture to the otherwise white-washed concrete surface, and this made the subsequent matching portion of the data processing not only possible, but also reliable.

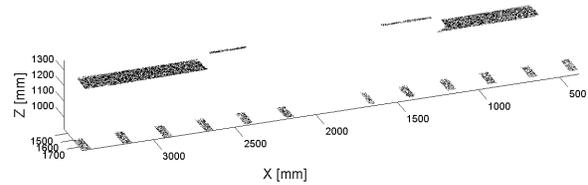
Figure 7. Example of the photogrammetric reconstruction for the 0 mm load stroke epoch for one of the experiments

The processing required for the photogrammetric reconstruction involved corner detection in all images, images matching between all image pairs, corner tracking for the detected corners common to at least three consecutive images, and multiple light ray intersection for computing the X, Y, and Z coordinates of the unknown object points using the known IOPs and EOPs for each camera. The above-mentioned processing steps were automatic, except for the selection of the region of interest in the images, which was done manually. Examples of the resulted 3D reconstruction can be seen in Figure 7 and Figure 8. Note that plate #7, i.e. the centre plate, was not reconstructed, because it was not observed by three neighbouring cameras.

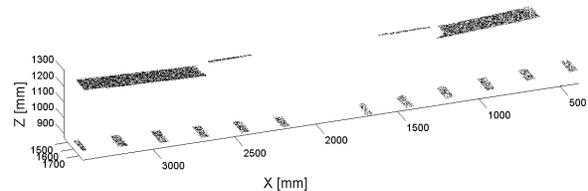
Figure 8. Example of the photogrammetric reconstruction for the 65 mm load stroke epoch for one of the experiments

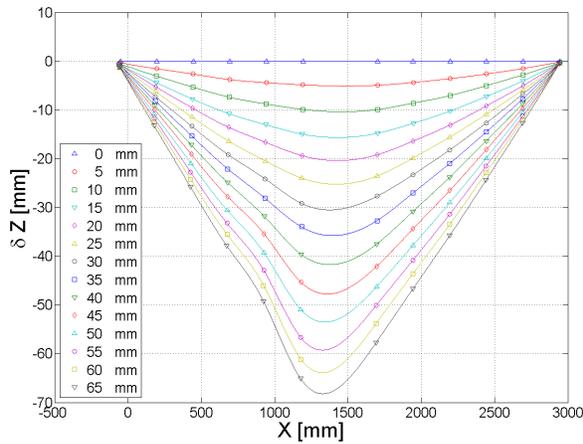
Figure 9. Cubic spline plots of the beam deflections for the first experiment using the photogrammetric reconstruction

The different reconstructed surfaces were first segmented, and then the X, Y, and Z object coordinates of all the points belonging to the same plates were averaged thus computing the centroids of each of the available plates. Subtracting the Z value of the centroids of each plate for the first epoch from the Z values of the centroids for the corresponding plates for the rest of the epochs yielded the beam deflections (δZ) at each available plate for each observed epoch. Example plots (produced using the cubic spline function in MATLAB) of Phase II for the two experiments can be seen in Figure 9 and Figure 10.

In order to check the quality of the photogrammetric reconstruction, the δZ values for plates #5 and #9 resulted from the photogrammetric system were compared to the δZ values computed from the 1D laser transducers (see Table 1). For the first experiment, the mean for the difference values ranged between -0.06 mm and -0.10 mm, with standard deviations of ± 0.11 mm and ± 0.08 mm, for overall RMSE values of 0.12 mm and 0.13 mm. The results from the second experiment were not as good – the mean for the difference values ranged between -0.9 mm and 1.9 mm, with standard deviations of ± 0.6 mm and ± 1.1 mm, for overall RMSE values of 1.1 mm and 2.5 mm. The reason for the higher discrepancies for the second experiment was that after the 25 mm load stroke, the polymer sheet separated from the concrete beam, and the metal plates were

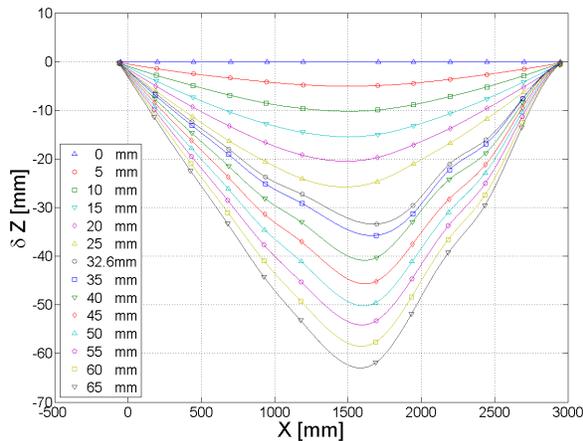
Figure 10. Cubic spline plots of the beam deflections for the second experiment using the photogrammetric reconstruction

tilted, so their centroids were no longer valid offset witnesses to the bottom surface of the beam. Hence, the deflections computed from the centroids of the metal plates no longer represented the deflections measured by the 1D laser transducers.

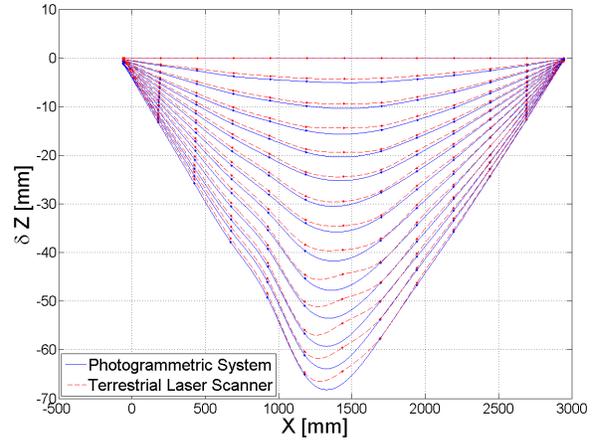
Figure 11. Cubic spline plots of the beam deflections computed using the photogrammetric reconstruction vs. the terrestrial laser scanner for the first experiment

The deflections computed from the photogrammetric reconstruction were also compared to the ones resulted from one of the laser scanners. From Table 2, it can be seen that the discrepancies between the two systems were similar for both experiments. The RMSE values of about 0.5 mm were acceptable, because they are comparable to the previously published precision of terrestrial laser scanning geometrically fitted data. From Figure 11 and Figure 12, it can also be seen that for the most part, the discrepancies in the estimated deflection values between the photogrammetric reconstruction and the laser scanner data was at plate #7. This was the plate, which could not be observed by three consecutive cameras, and the cubic spline interpolation method did not correctly predict its deflections.

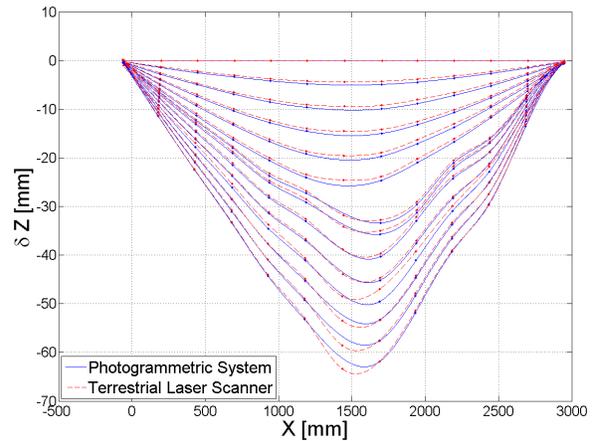
Figure 12. Cubic spline plots of the beam deflections computed using the photogrammetric reconstruction vs. the terrestrial laser scanner for the second experiment
