## COMPARING TIME-OF-FLIGHT AND PHASE-SHIFT. THE SURVEY OF THE ROYAL PANTHEON IN THE BASILICA OF SAN ISIDORO (LEÓN)

**KEY WORDS:** Scanner comparison, accuracy, inspection, polychromies, translucency, apparent micro-relief

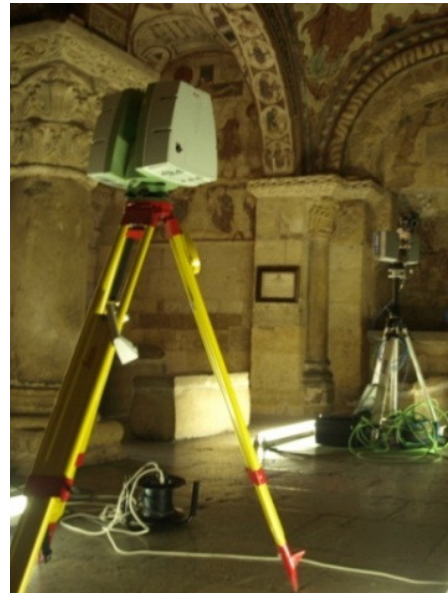
Fig 1. Leica ScanStation C10 and Faro Photon 80 face to face.

For data collection two laser scanners were used, Faro Photon 80 and Leica ScanStation C10, that were operated simultaneously to prevent differences in the atmospheric parameters of temperature, humidity and pressure for both data capture.

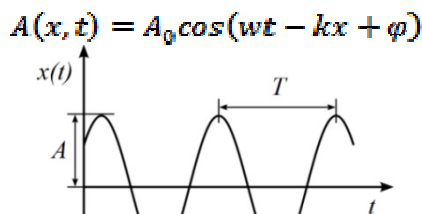
The tls (Terrestrial Laser Scanner) Photon 80 made by Faro, uses the phase-shift principle comparing the phase of the laser source with the same when the radiation comes back again to the scanner after its reflection on object's surface. This type of tls emit continuously a periodical signal of moderate intensity.

Figure 2. Phase-shift principle

The accuracy of the measurement will be influenced by the length of the cycle of periodicity and also by the wave-length itself that introduce ambiguity in the range estimation. That's why several frequencies are used (multi-frequency-ranging or MF), being the higher to calculate range and the lower to eliminate ambiguity. The pointcloud that arises from the ranging scanner can be colorized by means of a color sensor (typically a digital camera) by fusing both the image and the range data. The technical specifications for the device that we have tested are the following.

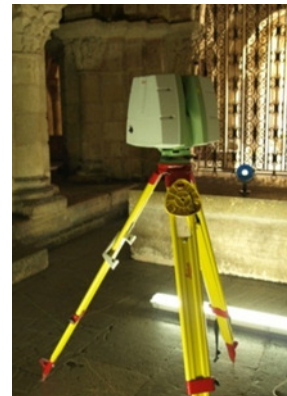
The ScanStation C-10 by Leica-Geosystems uses the LIDAR "time of flight" principle for ranging. A short laser pulse is emitted towards the object and is reflected on its surface; a part of the reflected radiation comes back to the scanner where it is detected by a sensor. As the light-speed is well known and time elapsed between emission and reception of the pulse can be measured (or inferred from a different magnitude measurement), the range to de object can be determined by half of the round-trip distance.

Figure 3. Pulse round-trip timing as ranging principle in TOF

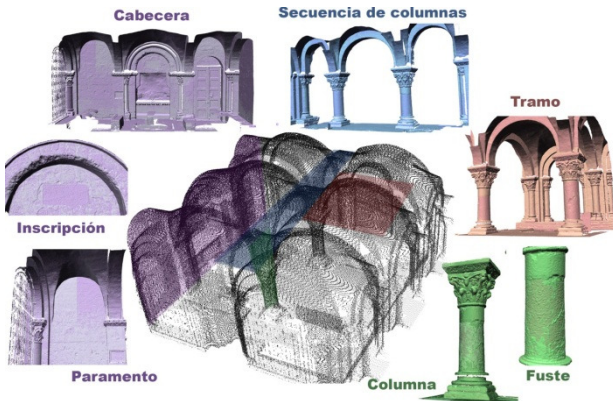
1. Head
2. Column
3. Shaft
4. A column sequence
5. Engraved Tablet
6. Wall face
7. Aisle

Figure 4. Subprojects.

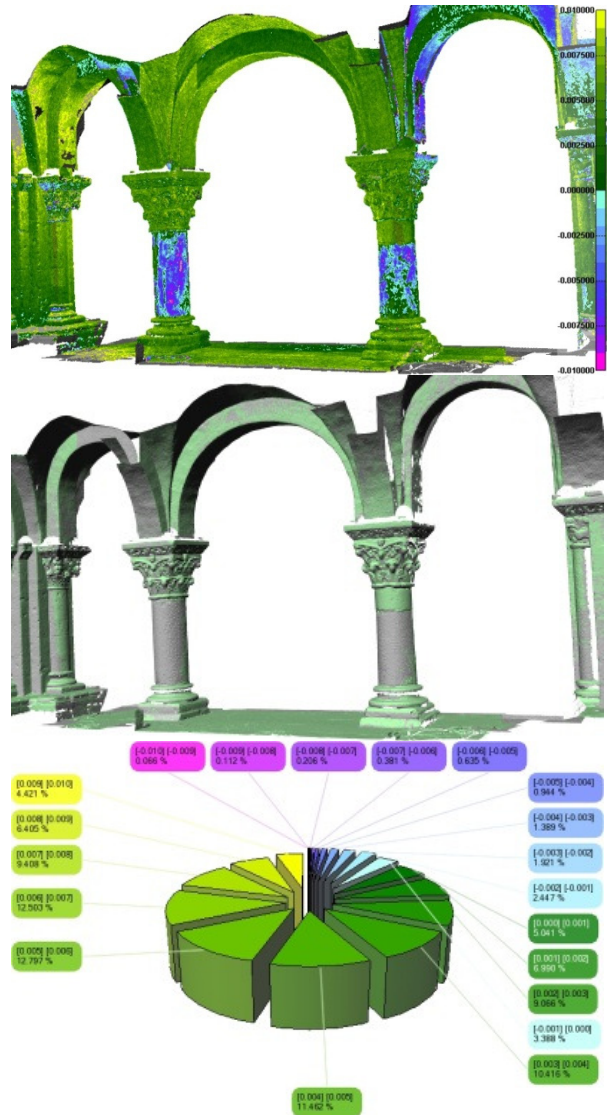
Figure 5. Error-map color mode, per scanner color mode and pie-type error distribution chart for subproject 1.

- ICP Alignment (with a max search-distance of 0.01m) stopped after 5 iterations. The convergence reported was below 7.85 nm
- Colours represent distance between the two meshes measured along normals to reference. The colour scale is set to show distances from -0.01 to +0.01
- Number of points compared 2.320.503
- Average distance. 0.004454m
- Standard deviation: 0.003771m
- RMS 0.005836m
- 99.85% points within 4 times StdDev.

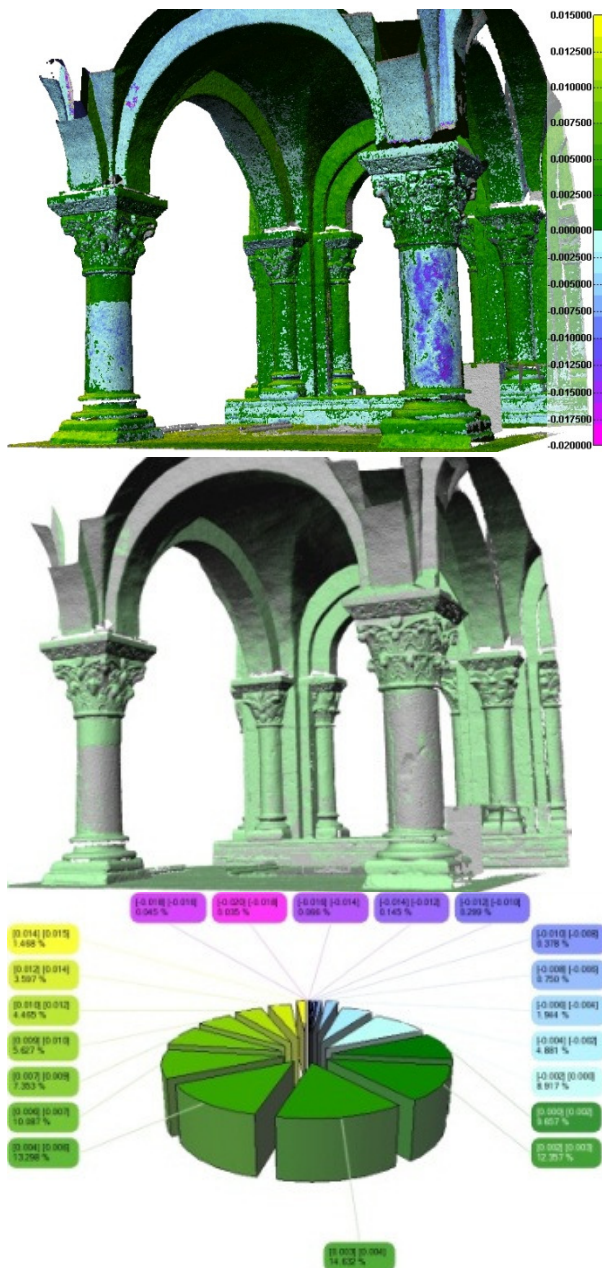
Figure 6. Error-map color mode, per scanner color mode and pie-type error distribution chart for subproject 2.

- ICP Alignment (with a max search-distance of 0.01m) stopped after 4 iterations. The convergence reported was below 1.14 nm
- Colors represent distance between the two meshes measured along normals to reference. The color scale is set to show distances from -0.02 to +0.015
- Number of points compared 1.408.250
- Average distance. 0.004656m
- Standard deviation: 0.015374m
- RMS 0.016064m
- 99.18% points within 5 times StdDev.

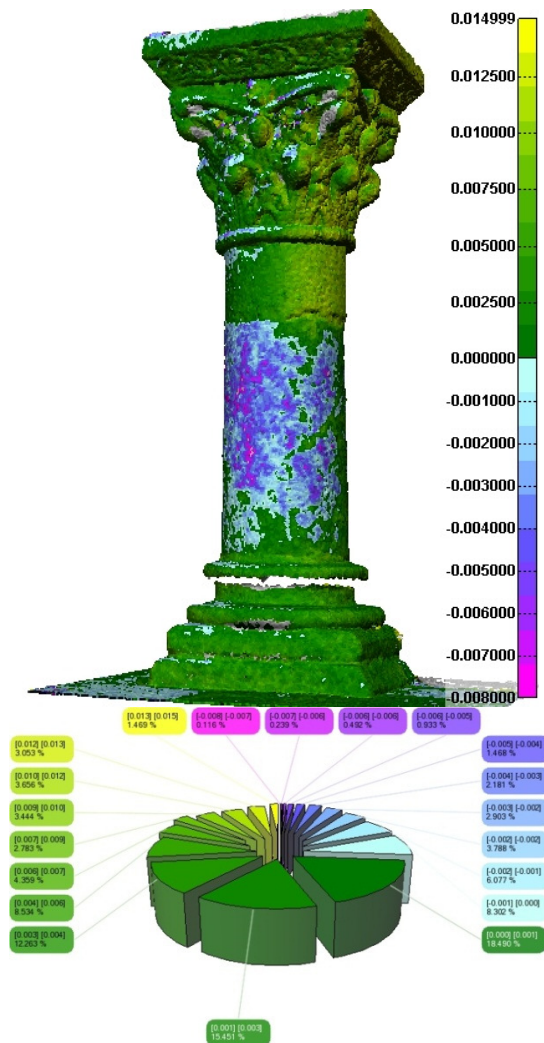
Figure 8. Error-map color mode and pie-type error distribution chart for subproject 4.

- ICP Alignment (with a max search-distance of 0.01m) stopped after 6 iterations. The convergence reported was below 0.216 nm
- Colors represent distance between the two meshes measured along normals to reference. The color scale is set to show distances from -0.008 to +0.015
- Number of points compared 261.864
- Average distance. 0.002708m
- Standard deviation: 0.004369m
- RMS 0.005140m
- 99.89% points within 3 times StdDev.

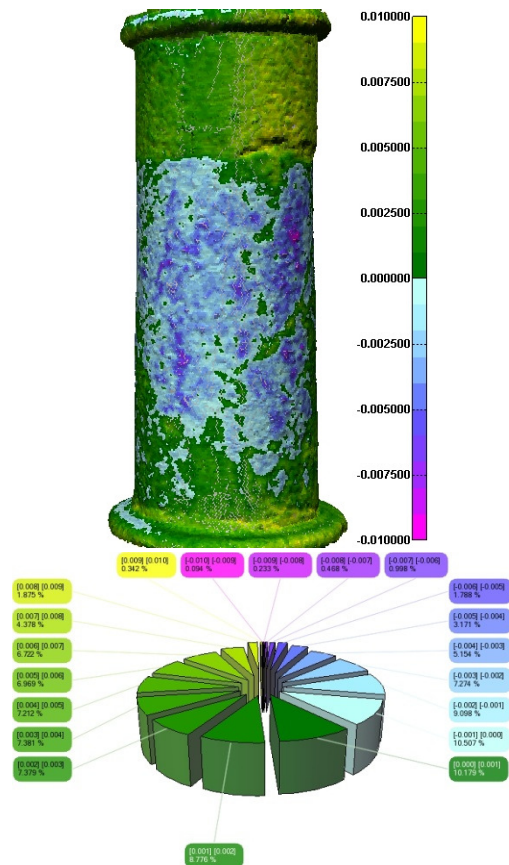
Figure 9. Error-map color mode and pie-type error distribution chart for subproject 5.

- ICP Alignment (with a max search-distance of 0.01m) stopped after 6 iterations. The convergence reported was below 0.078 nm
- Colors represent distance between the two meshes measured along normals to reference. The color scale is set to show distances from -0.010 to +0.010
- Number of points compared 88.358
- Average distance. 0.003703m
- Standard deviation: 0.003948m
- RMS 0.003948m
- 99.91% points within 3 times StdDev.

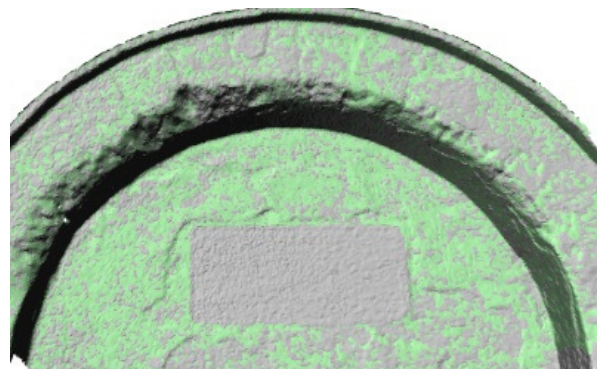
Figure 10. Per Scanner color mode rendering. Subproject 6.

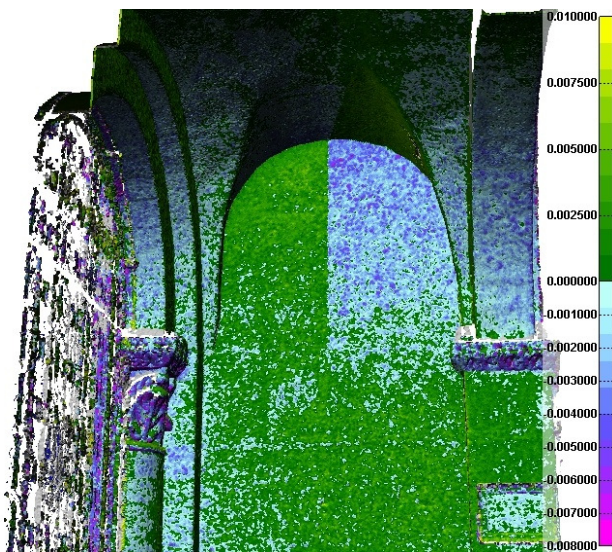
Figure 12. Error map for subproject 7 showing a turning-break

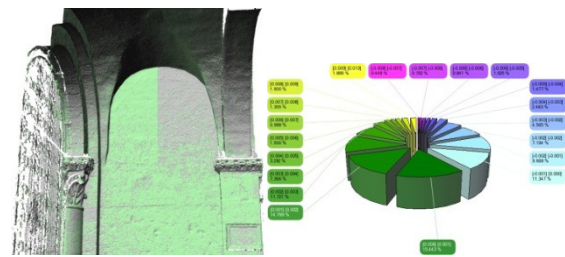
Figure 13. Per mesh color and error pie-chart for sp. 7.

- ICP Alignment (with a max search-distance of 0.01m) stopped after 4 iterations. The convergence reported was below 0.33 nm
- Colors represent distance between the two meshes measured along normals to reference. The color scale is set to show distances from -0.008 to +0.010
- Number of points compared 534.398
- Average distance. 0.002784m
- Standard deviation: 0.002212m
- RMS 0.002230m
- 99.06% points within 4 times StdDev.

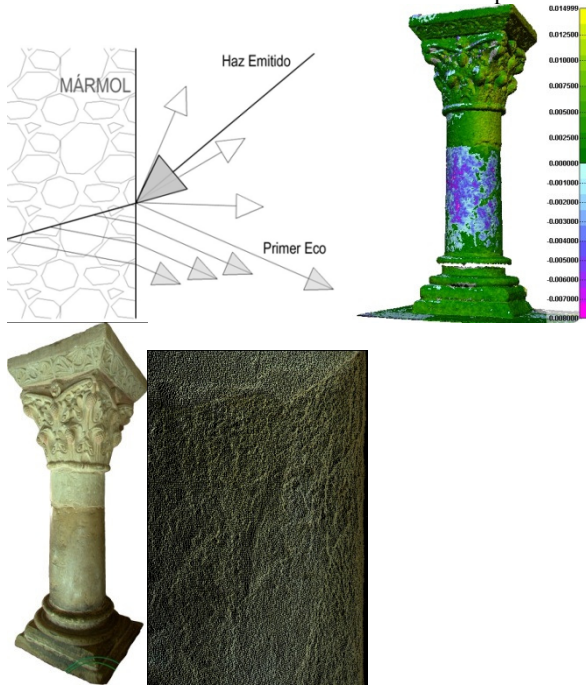
Most materials, especially the ones involved in Architectural and Urban heritage, are opaque enough to avoid the light to penetrate too much when obtaining a digital 3D representation. In the case of marble, given the refraction index of its main component, the light wave emitted by the laser scanner Faro Photon does penetrate into the material. The heterogeneous composition eliminates the possibility of a constant or typical penetration of the light beam, so the mistake depends not only on the translucency of the marble but also on the direction of the

pulse, the shooting distance, the beam print size, etc. The reflected wave train received by the sensor and containing enough information to compare it with the emitted pulse, will be the one which will establish the coordinates of the point.

Figure 14. The light permeability issue.

Nowadays there are multi-pulse laser scanning systems that allows receiving more than one echo; they can distinguish among 6 different ones. Leica C10 cannot do that, it computes just the first return of the emitted pulse. This makes that once the beam has interacted with the surface, it returns with enough energy for the scanner sensor to evaluate it and calculate the coordinates of the 3D point. This way there is no mistake due to the translucency of the marble. For other scanners, where the evaluated pulse is not the first, an error will be introduced because of the change of velocity when changing from one material to the other (Snell's law).

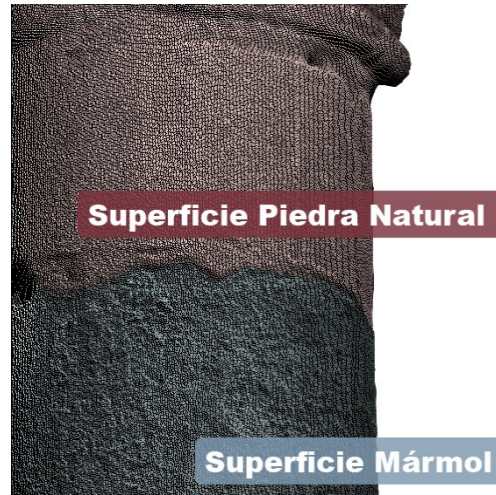
Related to the surface previously mentioned, the marble presents an increase of the noise in its data. For a general surface documentation, a 3D coordinate summarizes the measurement of the area touched by the laser beam. The heterogeneous composition of materials with different optical properties implies that each point will be calculated as an average material, introducing therefore some noise on each evaluation. This noise will depend both on the scale of the heterogeneous micro-regions and on the size of the laser beam print, defined by the pulse diameter, the shooting distance, the obliquity... etc. The image shows the noise provided by the Faro scanner between the natural stone and the marble.

Figure 15. Despite of the model appearance, the finish of the entire shaft is the same for both stones.

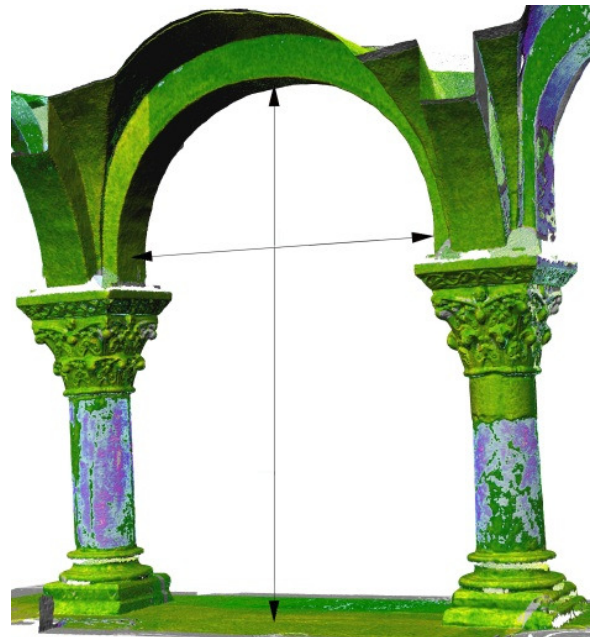
The comparison of both data was performed with the IMInspect module of Polyworks software. The alignment was conducted in two parts: firstly a manual approximation, by introducing several pairs of tie points, and then an automatic one, using the "Best Fit" tool, with maximum distances of comparison between 0.1 - 0.01 m and maximum angle of 45 °. The adjustment was repeated until obtaining convergences ranging from 7.85nm – 78.4 μm.

Figure 16. Dimensional inspection

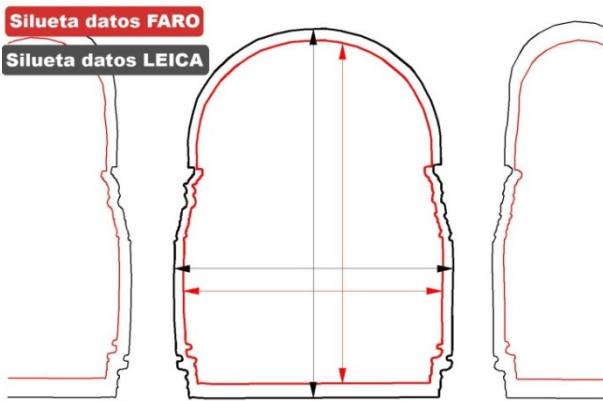
The comparative research between data obtained with Faro Photon scanner and Leica C10 shows the existence of scale differences. Interpreting each pair of captures individually, we can observe that data provided by Faro Photon present a larger scale, so the model obtained is smaller than the similar one obtained with the Leica scanner.

Figure 17. Significant scale differences have been found.

Automatic alignment obtained by “Best fit”, despite introducing less uncertainty when superimposing both point clouds, performs the process calculating the average among all the composing parts of the object, therefore the alignment will be determined by a function which simulates the correspondence between the centroids of two clouds with similar data. In this way the scale mistake performance cannot be studied through the whole scanning process, which could include an enlargement or reducing factor or present divergences between the horizontal and vertical components. The observed scale error is 0.358%, representing a reduction of 3.58 mm per actual meter on the scene. There also were documented differences of 1,5 mm for the same capture in the domes of nearly 4.18 m height.

This scale difference phenomenon is related to an internal issue of the scanner, probably due to the equipment calibration. Laser scanners are accurate devices, with much optical, micromechanical and electronic complexity. Continuous use implies the exposure to dust, humidity, vibrations, impacts... as well as to the wear of mirrors and prisms because of the own hit of the laser beam. All of this contributes to reduce the proper operation of the equipment, hence the need for periodic calibration by specialists that are technologically qualified to perform these operations. Leica ScanStation C10 scanner was calibrated by the own Leica Geosystem firm shortly before performing the documentation of the Pantheon, whereas Faro scanner has not been calibrated since more than a year (In addition, the owner of the scanner reported to have detected some deficiencies in the operation occurred around the time of this experiment). This suggests that the scale error is due to the Faro Photon 80 scanner, because of its lack of calibration.

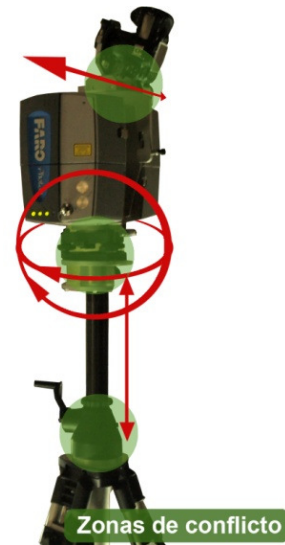
The dslr camera is mounted on top of the scanner head but decentred to allow the laser vertical rotation during scans. The unbalanced weight of the camera might cause some torque on the tripod column that result in a sort of precession of the rotation axis.

Figure 18. Possible weak points in the Photon setup.

The geared column clamp might not be tight enough to fully avoid any vertical displacement or even tilt of the whole set. The levelling tribrach or the fixing bolt might have been causing small gap jumps during rotation of an unbalanced head

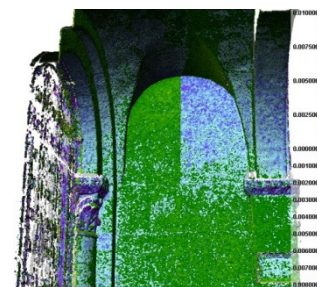
Figure 19. The error map highlights a jump in the Photon data.

The discontinuity presents an inflection point in the edge that divides the wall face and vault, happening between the vertical quadrant and the horizontal one, a way change in the vectors of displacement normal for the compared clouds. This event answers to a possible translation and draft of the scanner laser equipment with regard to his initial position, happening a change of the reference point, fundamentally in the X and Z axes, for what the displacement or "nod" will have different components in both axes. The maximum of this gap on the wall face is of 0.013 m while, on the flying buttress (vertical quadrant) it is 0.008 m. This estimation takes incorporated the scale error between the scanners described in the section 6.2.
