CONSERVATION OF THE SINCLAIR INN MUSEUM, AND THE PAINTED ROOM ANNAPOLIS ROYAL, NOVA SCOTIA, CANADA

Ann Shaftel^a, John Ward^b

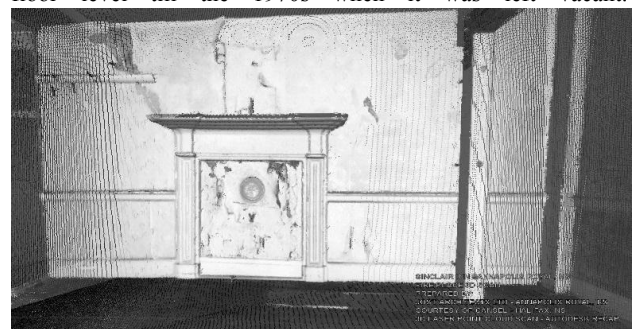
Figure 2: Interior of the Painted Room, 2014, prior to “reveals”. Source: Ann Shaftel

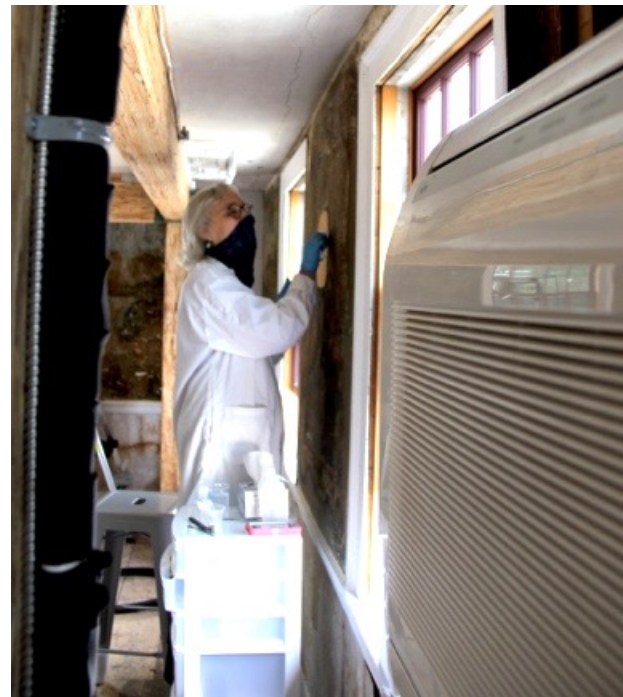
Figure 7: Conservator working next to AHS-installed environmental control unit.

- Painted Room: Recommend not to insulate this room separately to the rest of the building; rather, leave the room unheated and uninsulated, and to environmentally control the interior relative humidity to be consistent with ASHRAE Class of Control “C” ie. 25-75% RH through introducing mild heating in the room in the winter season (3-4 degrees C).
