DAMAGE CLASSIFICATION TO HISTORICAL WOODEN STRUCTURES: A PRELIMINARY SURVEY AND RECOMMENDATION FOR DONG MINORITY DRUM TOWERS

Shiruo Wang^{1*}

¹ School of Architecture, Soochow University, 215000, Suzhou, Jiangsu, China

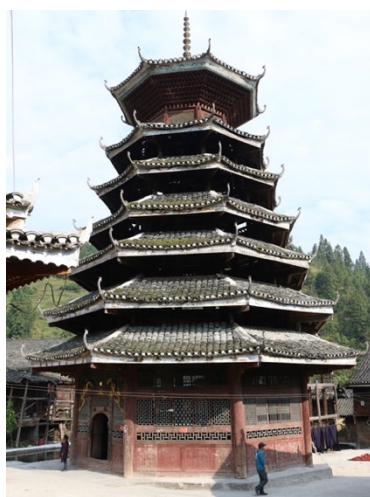
Figure 11. Zengying Drum Tower

Zengying Drum Tower locates at Congjiang county, Guizhou. A typical Chuan-dou Drum Tower with 7 stories. It is protected at provincial level since 2015 (Figure 11). However, through field surveys, it is found that the wooden components of Zengying Drum Tower have been damaged in various grades and types, as well as additions and reconstructions. It is urgent to conduct damage investigation and analysis.

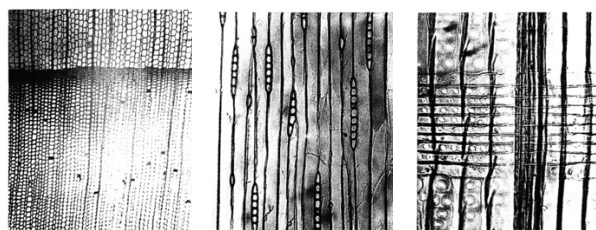
Figure 12. Microscopic structure of wood sampling

At present, the commonly used method for identifying tree species of wood components is based on the anatomical characteristics of wood. This identification method can generally identify the "genus" or "family". Follow the sampling method and slicing method in GB/T29894-2013 "General Methods of Wood Identification" (Standardization Administration of China, 2013). First, take on-site sampling of the wooden components of Zengying Drum Tower, and observe the macroscopic characteristics of the samples with visual inspection or a 10x magnifying glass. Secondly, by slicing the sample and preparing permanent sections, observe the microscopic characteristics of the sample from the transverse, tangential, and radial section (Figure 12). Finally, combining the macroscopic and microscopic characteristics, comparing the characteristics of wood specimens, it is comprehensively judged that the wood species used in the wood components of Zengying Gulou is China Fir (genus).
