INSAR-BASED INVESTIGATION OF SURFACE DISPLACEMENT OVER THE AREA OF THE COLLAPSED BUILDINGS IN ISTANBUL

Nusret Demir^{1,2}, Ufuk Yazgan³

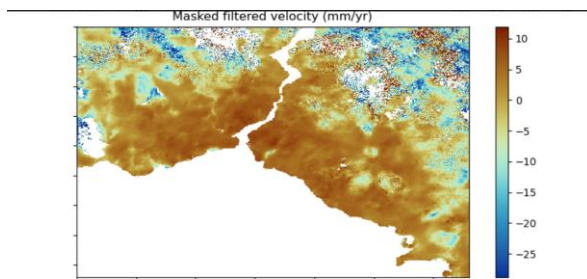
Figure 2. Annual displacement velocity calculated in Ascending mode for Istanbul City (mm/year).

The surface displacement has been calculated for the years 2015, 2016, 2017, and 2021 from January to the end of December, covering the dates of each building's collapse. Figure 2 depicts, as an example, the displacement map between January 1, 2016, and January 1, 2017. It was produced in ascending mode.
