## An Examination of the Conservation Philosophy in Korea's Wooden Cultural Heritage Using HBIM – A Case Study of Geungnakbojeon Hall of Muwisa Temple, Gangjin

**Keywords:** HBIM, Conservation Philosophy, Seokkarae, Podongjaju, Maksae Giwa, Geungnakbojeon Hall of Muwisa.

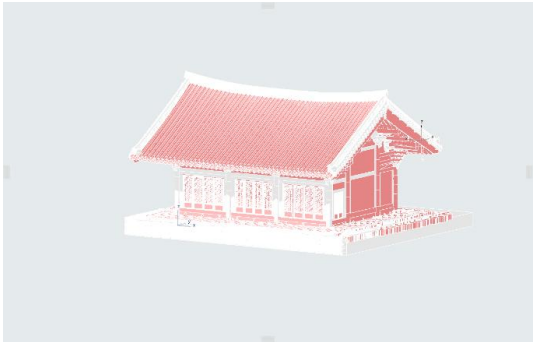
Figure 2. Highlighted components from the 1956 repair.

As a result of the visualization, components repaired in 1956 were marked in orange, with key highlighted elements shown in sky blue (1956 column of Table 1). For the 1983 repairs, the overall components were represented in light purple, while emphasized elements were shown in pink. (1983 column of Table 1) According to the 1983 repair report, the dismantling and restoration primarily focused on components above the bracket sets, indicating that the repair work largely centered on the roof structure. However, reinforcement of certain column members was also observed, although no components were explicitly recorded as having been "restored." The report does mention modifications to certain shapes, but these changes pertained to internal structural reinforcements, such as within the roof framing, that were not readily visible from the exterior.

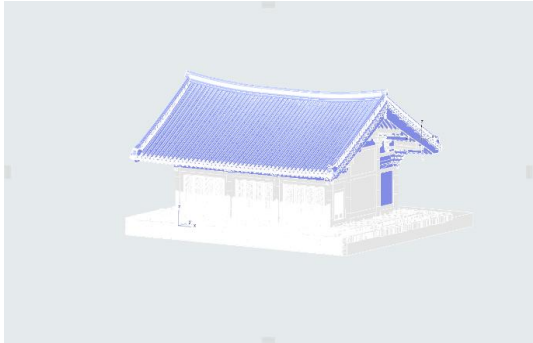
Figure 3. Highlighted components from the 1983 repair.
