REMOTE SENSING APPLICATION OF THE GEOPHYSICAL CHANGES IN THE COASTLINES AND RIVERS OF ZAMBALES, PHILIPPINES

Annie Melinda Paz-Alberto, Melissa Joy M. Sison, Edmark Pablo Bulaong and Marietta A. Pakaigue
Institute for Climate Change and Environmental Management, Central Luzon State University, Science City of Muñoz, Nueva Ecija,
3120 Philippines, Email: melindapaz@gmail.com; melissajaysison@gmail.com; epbulaong@gmail.com; mayetpv@gmail.com

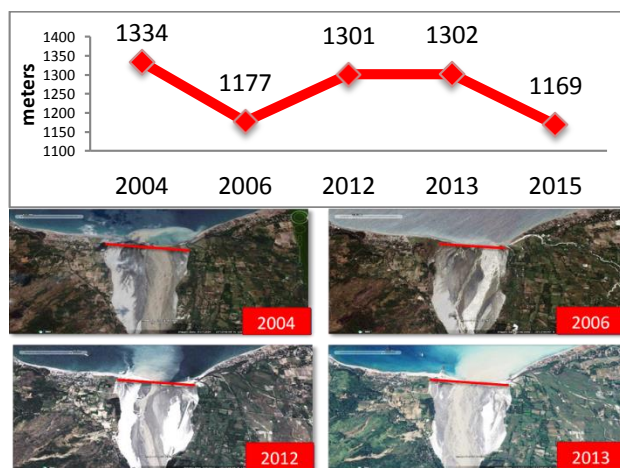
Figure 2 presents the measurement of the width of Bucaio river outlet from 2004 to 2015. The data from 2004 to 2013 were gathered from the Google Earth Satellite imagery while data in 2015 were the actual validated data gathered by the LIDAR-1 researchers. The graph shows that the Bucaio river outlet decreased and increased in width size overtime which is probably due to erosion and accretion. Erosion was identified when there was an increased measurement in the width of the outlet.

Figure 2. Bucaio River Outlet

Accretion of Bucaio river outlet in year 2006 and 2015 could be due to the Pinatubo discharged accumulated in the riverbank. Moreover, the accumulated sediments in year 2006 were rapidly washed-out in year 2012. Inconsistent changes of Bucaio river outlet is possibly due to the Pinatubo lahars triggered by intense rainfall (Rodolfo et. al., 1999) and extreme velocity of water and current brought by typhoons. Siringan and Ringor (1995) stated that the Bucaio river outlet experienced progradation after eruption but rapid retreats also occurred. Physical changes of the Bucaio river outlet is due to the continuous supply of sediment caused by the after effect of 1991 Mount Pinatubo eruption.

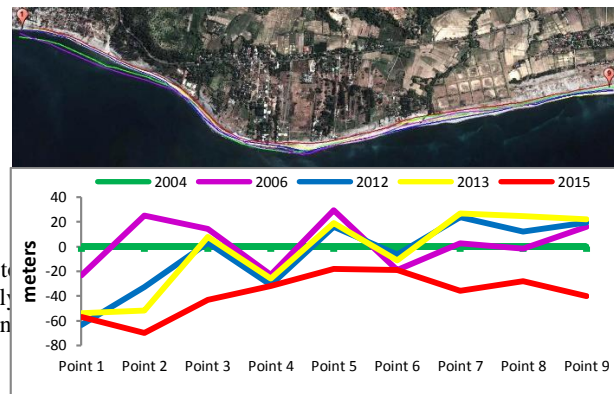
The result of the coastline analysis revealed that from 2004 up to 2015 the coastline of the study area has considerably changed. Negative and positive values were observed in coastlines analyzed showing that both erosion and accretion occur. The coastal erosion was prevalently observed on the point near Bucao

river outlet while accretion and erosion were both identified on the middle up to the last part of the corresponding points analyzed. The result of validation showed rapid coastal erosion in the study area. High waves and strong winds resulted to rapid erosion, steep coasts and damaged the houses and properties which occur in the study area. Coastal residents also observed that waves during storms reached up to 3 meters high but the winds did much more damages than waves.

Figure 5. South Coast of Bucao River

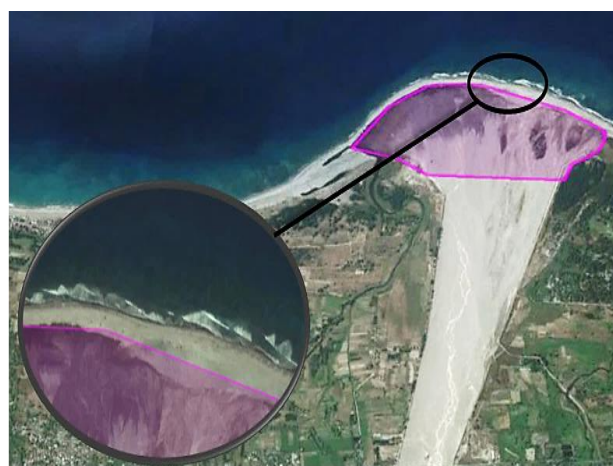
No water was visible in the river wherein the lahar deposit was with the same level as the water. When rains occur, the river is quickly flooded with water. Lahar deposits can also be observed in the river outlet and form to what as the residents called as natural formation of a coast or a sandspit as can be observed in Figure 7.

Figure 7. Santo Tomas River Outlet

Validated points and measurement of the river outlet showed a vast land formation called sandspit. Validated points recorded and obtained as of August 5, 2015 indicated an increase of diameter of the river outlet. Lahar deposits were observed inside and outside the river covering the entire area. Interviewed locals also identified the outlet to be gradually steep near the ocean and flat along the vast river area. The area may seem to be dry in hot season but when it rains the water surfaced quickly from the ground forming muddy water.
