## BRIDGE SURFACE DAMAGE DETECTION APPLICATION WITH A LASER-BASED SOFTWARE PROTOTYPE

**KEY WORDS:** Terrestrial Laser Scanners, Texture-Mapped Point Clouds, Point Cloud Processing, Surface Damage Detection, Software Application

This short paper focuses on the field application of a recently developed software prototype, on which the authors' have been working on (Guldur Erkal, 2017), that utilizes the previously developed surface damage detection algorithms. The details of the developed software application are given in Section 2.

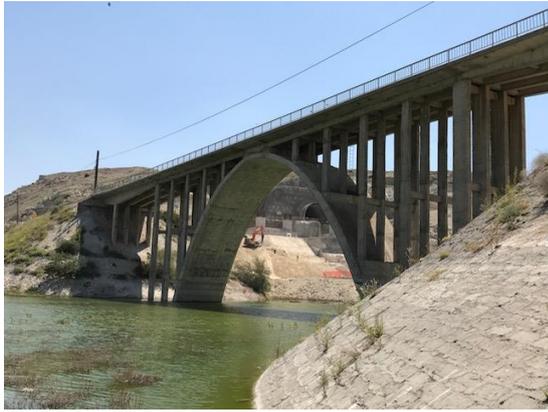
Figure 1: The image of the Çayırhan Bridge.

The bridge, which was laser-scanned for this field application, is the Çayırhan Bridge. This bridge is located on the state road, D140, that lays in between Ankara – Nallıhan, Turkey. The Çayırhan Bridge was built in 1955 and since then, it has been constantly operating. This bridge is a reinforced concrete arch bridge with a total deck length of 105.7 m. The image of the bridge is given in Figure 1 and the captured point cloud is given in Figure 2.

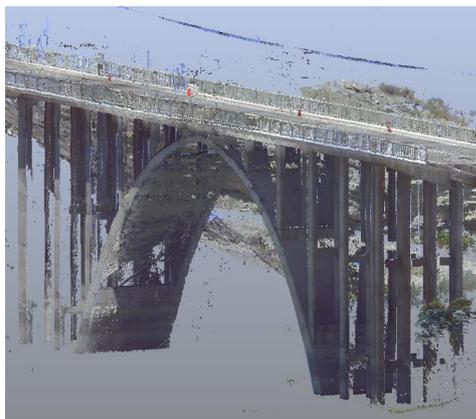
Figure 2: The texture-mapped point cloud of the Çayırhan Bridge. As already mentioned, a portion of the deck has been extracted in order to perform surface damage detection by using the

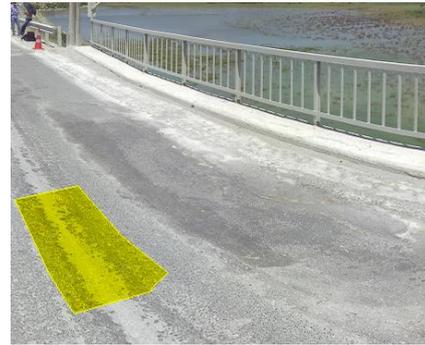
Figure 3: The selected region on the bridge deck for surface damage detection.

developed software prototype. The selected region is yellow-marked in Figure 3.

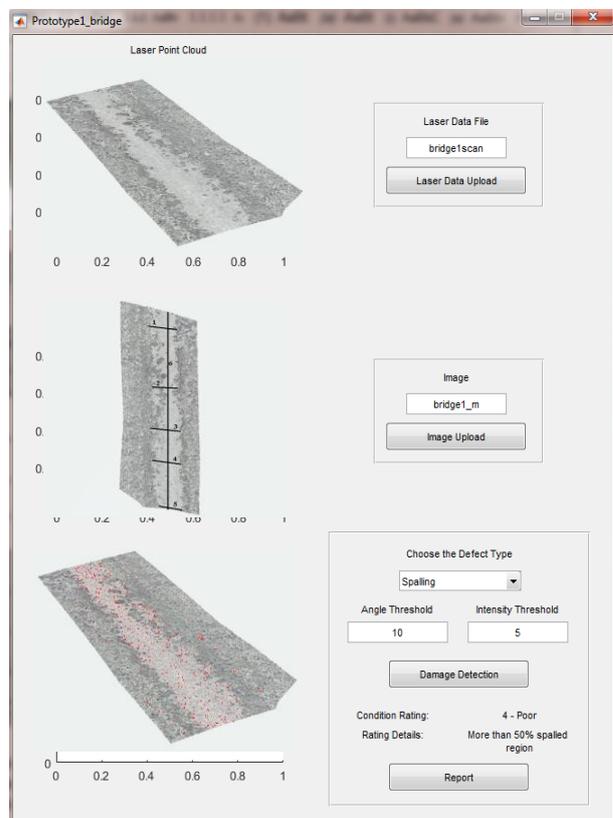
Figure 4: The screenshot of the software prototype that displays the damage detection results of the selected region.

The texture-mapped point cloud of the selected region is uploaded in the software prototype. Then, the image that is marked with physical measurement locations is uploaded. The damage type is selected from the drop-down menu and the associated parameters, angle threshold and the intensity threshold, are inserted. The procedures for selecting these parameters are described in Guldur (2014). Finally, once the “Damage Detection” is completed, the damage detection results, the computed condition rating and the associated rating details are displayed on screen. The comparison between the field measurements and the computed surface damage dimensions are given in Table 2.
