IMAGE-BASED 3D RECONSTRUCTION DATA AS AN ANALYSIS AND DOCUMENTATION TOOL FOR ARCHITECTS: THE CASE OF PLAKA BRIDGE IN GREECE

T. Kouimtzoglou^{a,*}, E. K. Stathopoulou^b, P. Agrafiotis^b and A. Georgopoulos^b

KEY WORDS: Photogrammetry, image-based 3D reconstruction, Architecture, Cultural Heritage

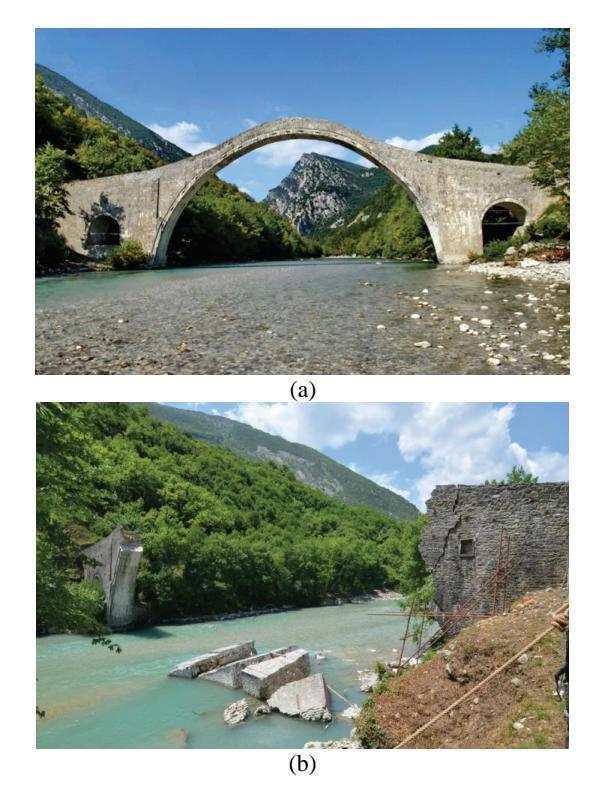
Figure 1. The bridge (a) before and (b) after the collapse.

Plaka bridge (Figure 1a) was an one-arch limestone bridge situated in the Epirus region in northwest Greece that was recently lost due to massive flash floods. The bridge, a declared monument under protection by the Greek State, was built over the river Arachthos. It is not exactly known when the first version of the bridge was constructed, but after a collapse in 1860, the bridge was rebuilt in a location 100m south of the initial position (current bridge location). Subsequently, it was rebuilt in 1863 and 1866, after two more collapses.

It was considered as the widest single arched bridge of the Balkans, with a ~40 meter diameter of the main arch and an average height of 20 meters. Next to the main arch, there were two smaller ones, 6 meters wide, the so-called relief arches. In February 2015, the central section of the bridge's central arch collapsed due to the aforementioned extreme weather conditions caused on by prolonged heavy rainfall (Figure 1b). Most of the collapsed parts, especially some of the most massive ones, lie in the river area near the abutments that remain intact.

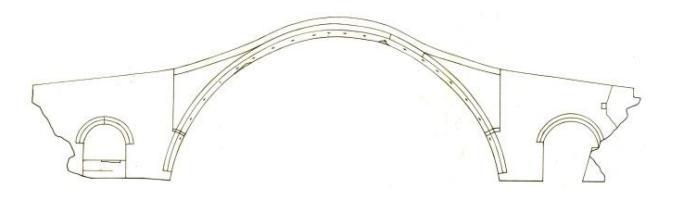
Figure 2. Plaka bridge South Façade plan (1984).

Older survey plans, such as facades presented with outlines and/or standard hatch patterns (Figure 2), were mostly considered as incomplete in terms of information needed for an architectural restoration study, as they provide few or insufficient information about crucial morphological elements of the monument, such as details of the stonework, the metal and wood reinforcement systems, etc. (Interdisciplinary Research Team of NTUA, 2016).

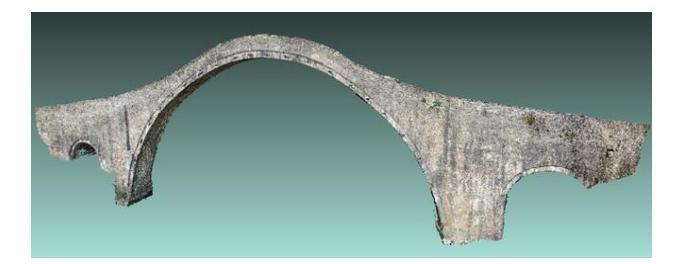
Figure 3. 3D point cloud of the bridge using crowdsourced images by (Stathopoulou et al., 2015).

As presented in Stathopoulou et al., (2015), crowdsourced images have been used in order to create the 3D model of the south façade of the bridge as well as orthorectified images of the bridge before the collapse using image based 3D reconstruction software (Figure 3).

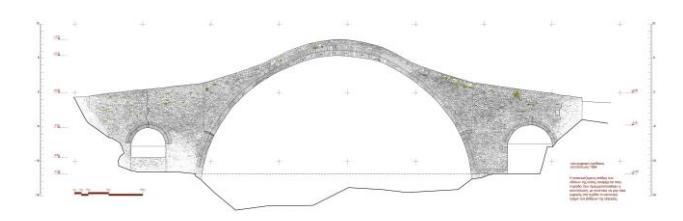
Figure 4. South façade plan of Plaka bridge before the collapse.

These data have been combined with the field surveying study of 1984 and the more recent architectural restoration study of 2005, in order to create a series of plans of the monument showing the state before the collapse (Figure 4). This combinatory approach, led to the production of more complete and detailed architectural plans of all aspects of the structure, thus, eliminating the majority of the deficiencies and information gap of the previous studies.

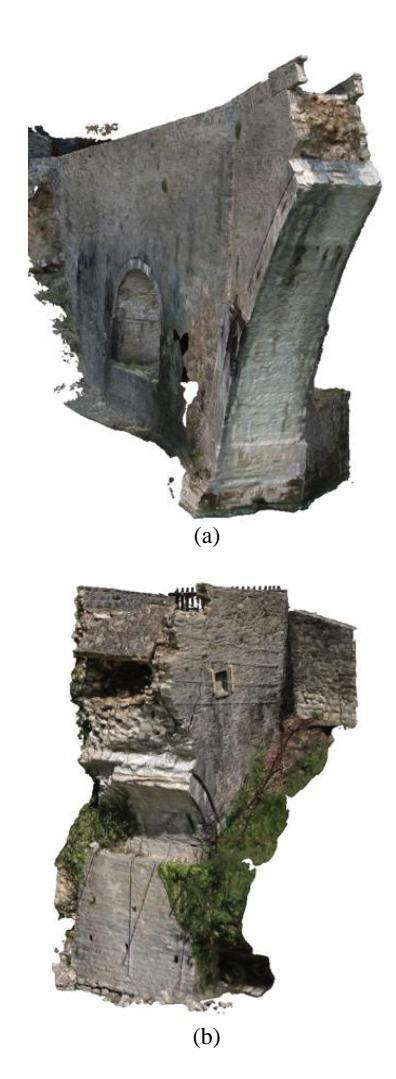
Figure 5. 3D textured meshes clouds of the (a) west and (b) east ruins.

Agisoft Photoscan Pro® software was used for the image based 3D reconstruction in order to create a dense point cloud of the object and a triangulated textured mesh was generated thereafter (Figure 5). Each part of the bridge ruins was treated as an individual entity during data acquisition as well as the processing steps.

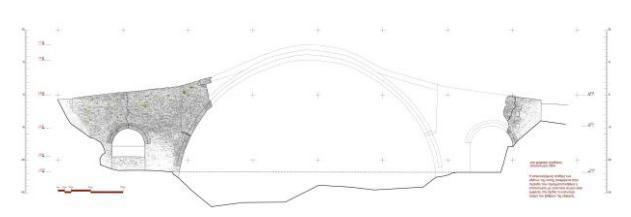
Figure 6. South façade plan of Plaka Bridge after the collapse.

High quality orthorectified images of both facades of the remains of the bridge were produced. These data were in turn prepared for use in a similar way as in the ones referring to the before the collapse state in order to produce accurate 2D vector architectural drawings of the monument in a following stage of the study (Figure 6). The 3D point cloud and the high resolution textured mesh provide the opportunity to examine all the areas of interest in detail, especially those of particular difficulty in access and/or danger in approach and verify the in situ remarks.

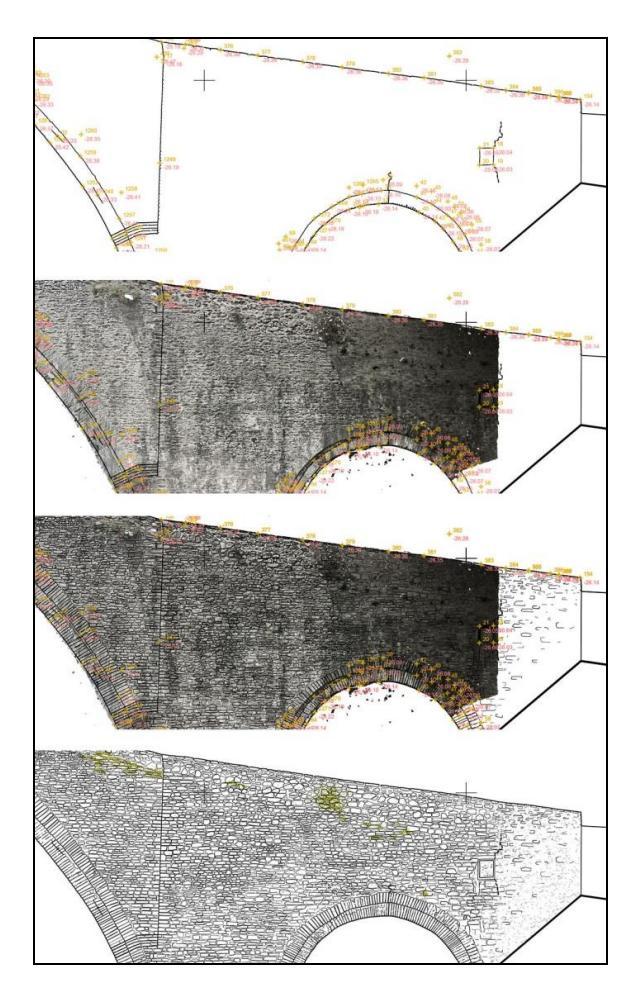
Figure 7. Details of redesign and data gathering process of the South façade before the collapse, by combining orthoimages with the 1984 data. From top to bottom: 1984 plan, 1984 plan / orthoimage, 1984 plan / orthoimage / 2D CAD drawing, 2D CAD drawing.

The orthorectified images of the bridge were combined with the field surveying data of the campaigns of 1984, 2005 and 2015 in CAD environment (Figure 7). Accurate elevation plans of the north and south facades were created, depicting the outline of the monument, the past and current pathology (Figure 8) - cracks, fissures, detachments, deformations (Figure 9), biological degradation, etc.- and the sizes and types of the construction elements and building blocks.

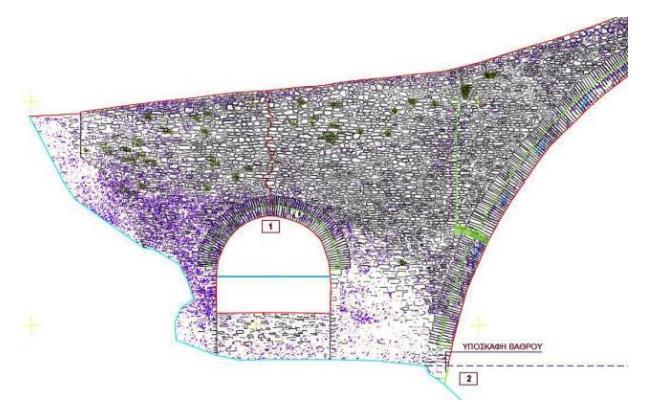
Figure 8. Pathology elevation plan of the South Façade before the collapse.

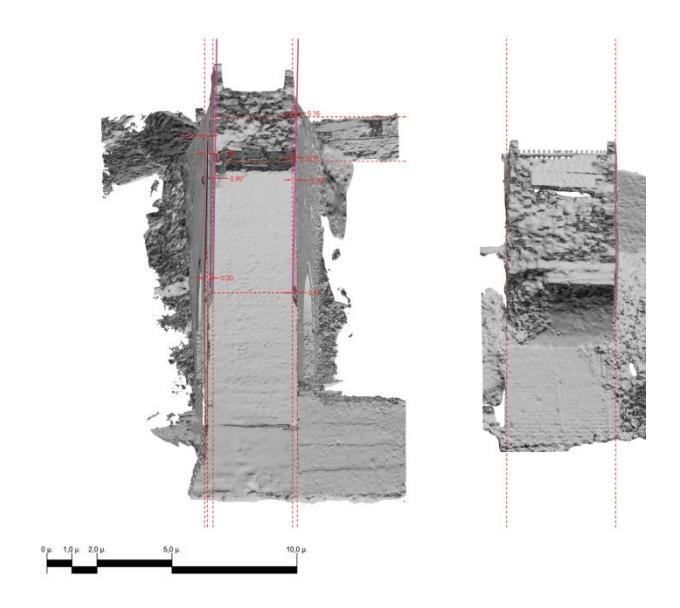
Figure 9. Deformation study of west (left) and east (right) sections of the remains of the Bridge based on the 3D mesh geometry.

The image-based created 3D model of the bridge ruins was also used to distinguish minor changes and deformations of the remains of the monument (Figure 9). The high geometric accuracy of the 3D model grants the opportunity to examine with the utmost detail any potential changes in geometry and deformations that would have otherwise been difficult to identify or record with conventional surveying methods. Such a detailed 3D model provides the opportunity to the researchers to immerse deeply in the process and examine their subject from all possible aspects, both space and scale wise.

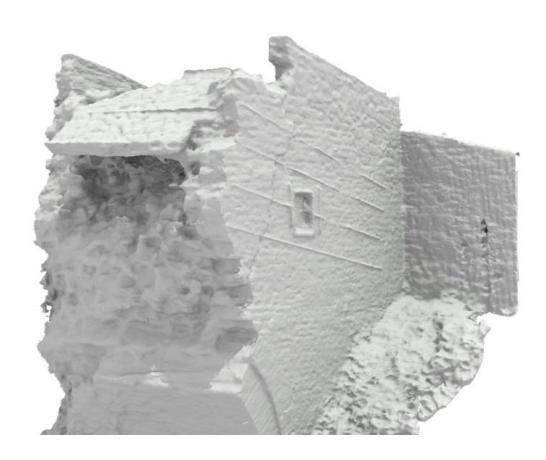
Figure 10. Untextured detail of the east pillar ruins: Larger and minor cracks are easily noticed, as well as grout depth and stone sizes and shapes differentiations.

The image-based generated 3D mesh was also used by examining it after texture information removal. By using only shadow and global illumination information in a Sun simulation study, the 3D models present only geometric visual information. As colour and texture information is omitted, details are more easily observed and evaluated (Figure 10).

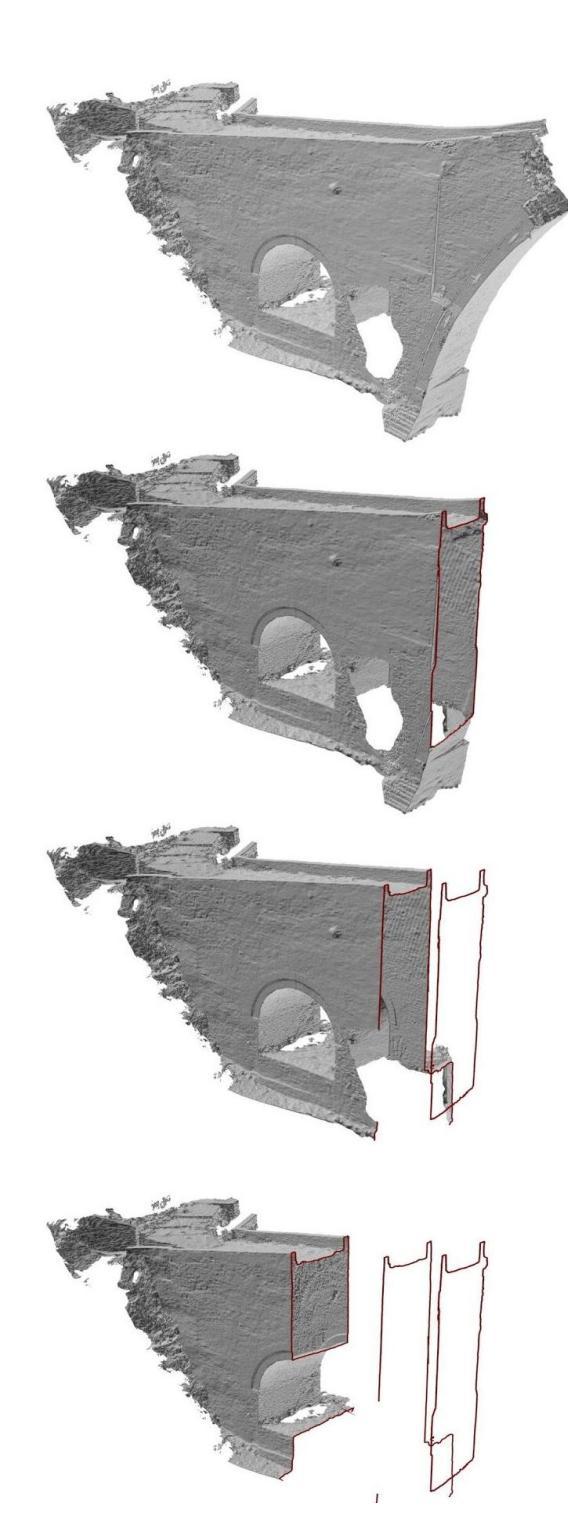
Figure 11. Section creation process directly from the 3D mesh in 3ds Max commercial software.

Accurate sections of the object were produced in the areas of interest automatically from the 3D mesh in the commercial 3D modelling software 3D Studio Max (Figures 11, 12). The resulting section outlines were exported in CAD format for further manipulation. Façade detail elements were also vectorized directly from the 3D mesh and were combined with the aforementioned plan sections and other conventionally drawn elements (Figure 13). New hybrid drawings were created, incorporating the accuracy of the reconstruction and at the same time trying to express the unique architectural and structural character of the monument.

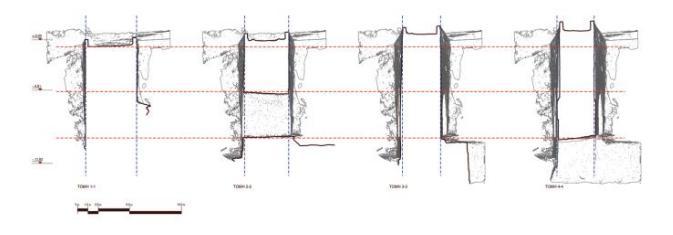
Figure 12. Sections of the remaining west pillar of the Bridge created directly from the 3D mesh.

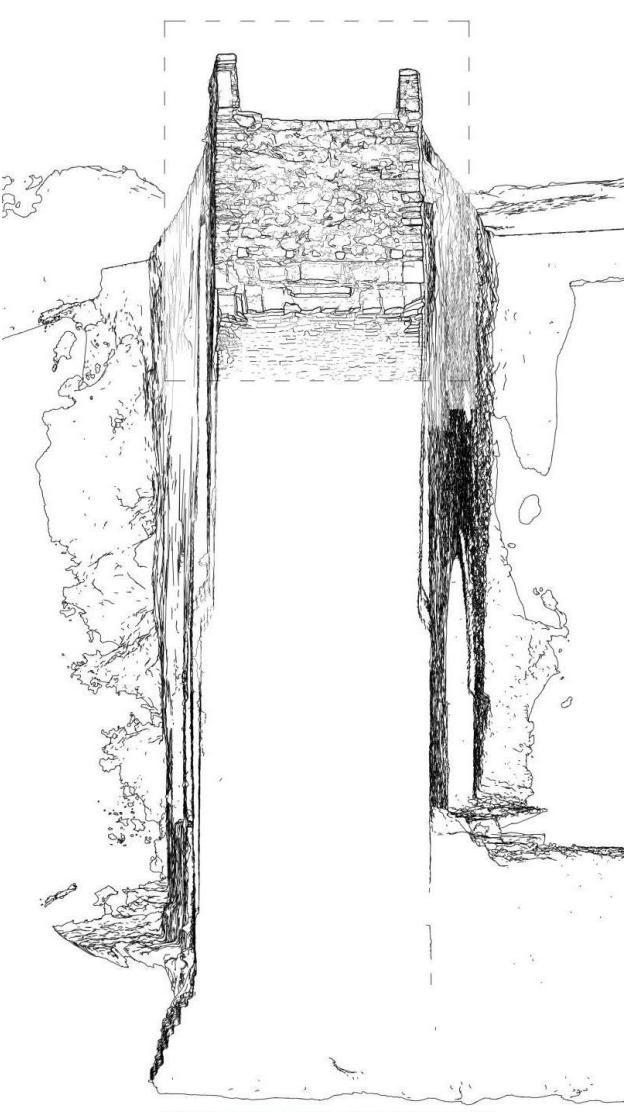
ΟΨΗ ΚΑΤΑΡΡΕΥΣΗΣ ΔΥΤΙΚΟΥ ΒΑΘΡΟΥ

Figure 13. Façade of the West Pillar ruins. 2D elevation plan created form the 3D model, enhanced with CAD drawn details

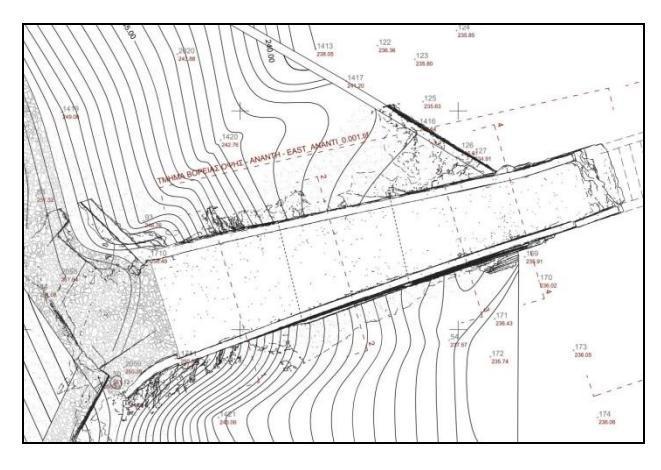
Figure 14. Plaka Bridge, West pillar plan, after the collapse.

The same method was used to produce the main plan of the bridge after the collapse. The model extracted data were combined with the survey plan of 2005 (Papageorgiou G. and A., 2005) and all the recent - after the collapse - field surveying acquired data. The result was once more a hybrid plan that maintained the original and newer digital data accuracy (Figure 14).

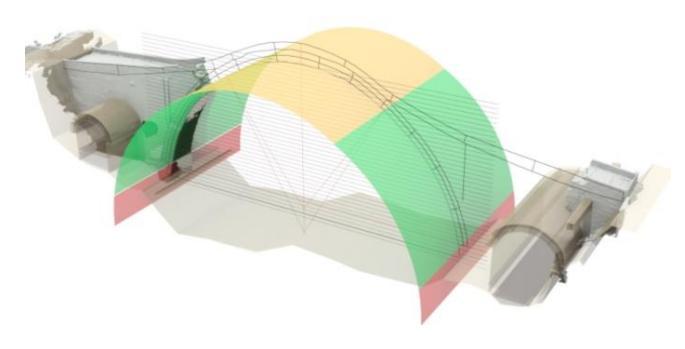
Figure 15. 3D verification, in relation to the ruins geometry of the original outline tracing of the main arch, by using the image-based generated 3D model.

Also, the exact geometric state of the bridge after the collapse was crucial for the redesign of the main geometric characteristics of the monument (main arch, secondary relief arches, pillars of the bridge, etc.) in a precise way (Figure 15). The geometry of the current state had to be combined with the ideal original form of the monument (e.g. the double curvature of the main arch) after the removal of the pathology deformations.
