LOST WATERWAYS: CLUES FROM DIGITIZED HISTORICAL MAPS OF MANILA AND OTHER PHILIPPINES CITIES

K. G. Jubilo¹, M.R. Algodon¹, E.M. Torres¹, Z.D. Abraham¹, A. Ide-Ektessabi², M. Soriano¹, * ¹ National Institute of Physics, University of the Philippines Diliman Quezon City 1101, Philippines - msoriano@nip.upd.edu.ph ² Advanced Imaging Technology Laboratory, Graduate School of Engineering, Kyoto University – ektessabi@gmail.com

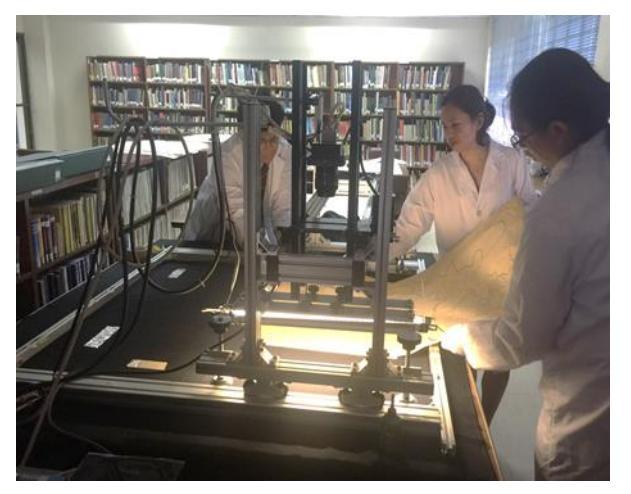
Figure 1. Map digitization using the NIJI-S scanner.

Historical maps were sourced from the National Archives of the Philippines, museums, libraries, and online repositories. Hard copies of maps were digitized using the NIJI-S Scanner developed by the Advanced Imaging Science and Technology Kyoto University. The NIJI-S uses cold light (white LEDs) for illumination and a line scan camera for capture and is custombuilt for digitizing fragile 2D cultural heritage objects such as old paintings and historical documents. Figure 1 shows our team performing map digitization in the School of Urban and Regional Planning Library using NIJI-S.

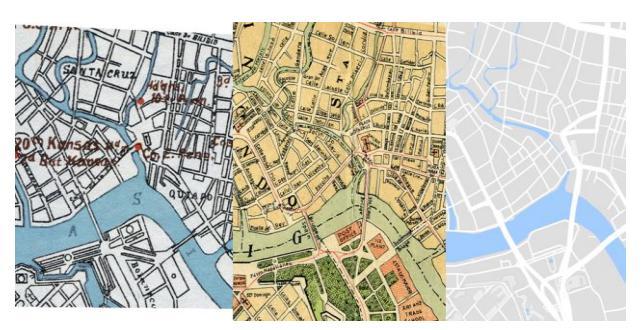
Figure 2. Georeferenced maps of Manila showing a portion of Pasig River and its estuaries: Left - 1899 map courtesy of the Filipinas Heritage Library, Center- 1908 map courtesy of the Filipinas Heritage Library, Right - Google Map.

Figure 2 shows two historical Manila maps (1899 and 1908) along with a recent Google map where the Pasig river and its estuaries cut through. Through time several small estuaries have disappeared. The lower leftmost body of water in the 1899 map disappeared in the 1908 and Google map. Another estuary present in the middle upper portion of the 1899 and 1908 maps disappeared completely in the Google maps.

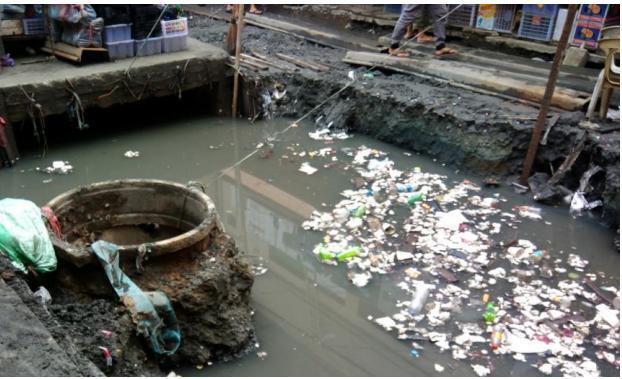
Figure 3. An exposed culvert discovered by the validation fieldwork team.

The validation fieldwork team discovered that an exposed culvert (Figure 3) can be seen on top of estuary that disappeared in the 1908 and Google maps. This opens the possibility that estuaries that are absent in Google map could have been channeled underground.

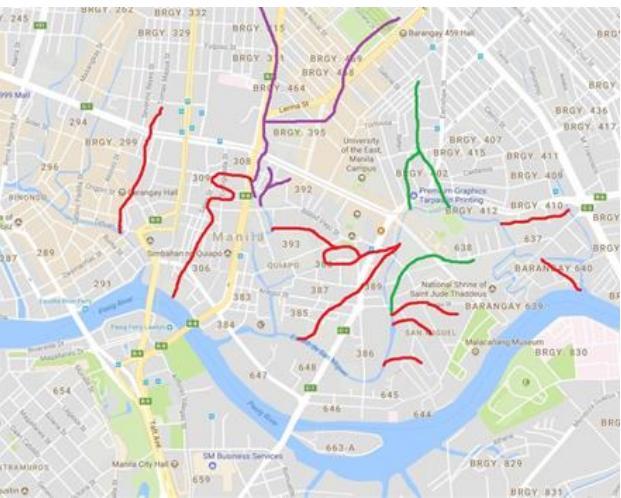
Figure 4. Detected changes in waterways around Manila: Red disappeared, Green - still present, Violet - possibly underground.

Traced in Figure 4 is a map summary of field-surveyed Pasig River estuaries that are confirmed to have vanished (red), are still existing but not present in Google map (green) or may have been diverted underground (violet).

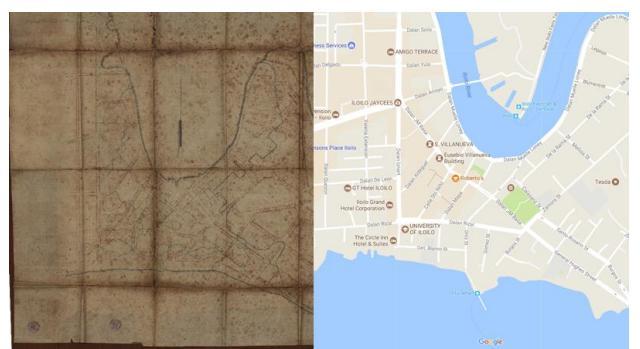
Figure 5. Left - Portion of 1833 Iloilo City map courtesy of the National Archives of the Philippines. Right - corresponding Google Map

Figure 5 shows a portion of the 1833 Iloilo map and its corresponding Google map. The team observed that the local government was installing big box culverts (shown in Figure 6) on areas where old tributaries of the Iloilo river were located. According to local officials the area is a high flooding risk and the civil works were part of their continuing effort to improve the drainage system. In contrast to flooding risks, community wells like the one pictured in Figure 7 were found in the area where the waterways disappeared, an indication of a freshwater source underground.

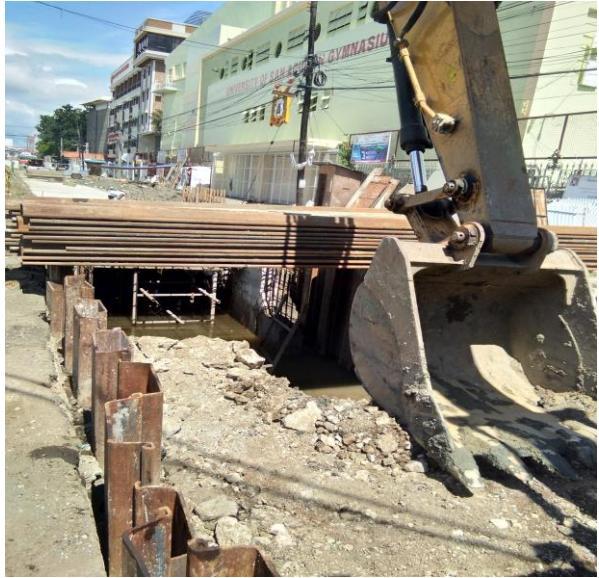
Figure 6. Culverts in Iloilo City being installed in a high flood risk area.

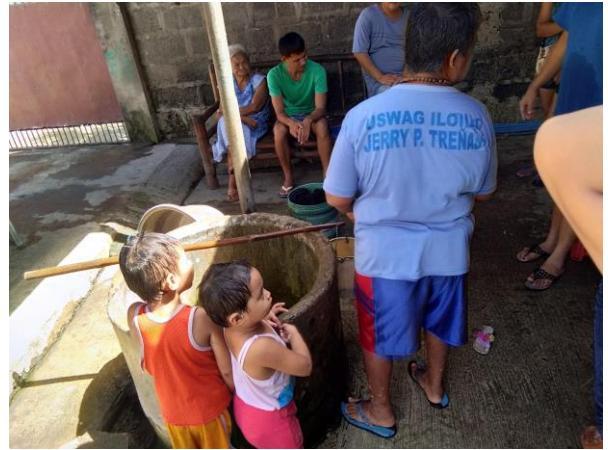
Figure 7. A community freshwater well was found in the vicinity of an old natural pond.

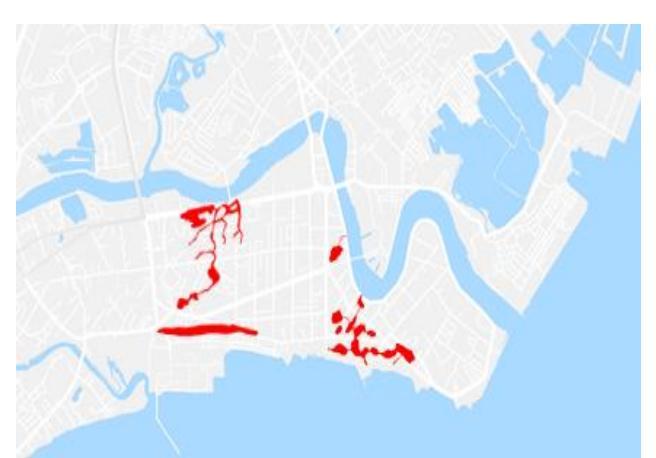
Figure 8. Vanished bodies of water (red) in Iloilo City.

that was identified by our team to be of high risk to liquefaction. According to the mayor's personal account, a building, more than five stories high, was built on the said lot, however, only after a few months, the building was observed to be tilting. Construction was then halted until thorough inspection was made on the property. Based on the 1833 map, the present Dalan Montinola appears to be a backwater of the Iloilo River. Figure 8 shows the visited sites in Iloilo City that were confirmed to have vanished bodies of water.

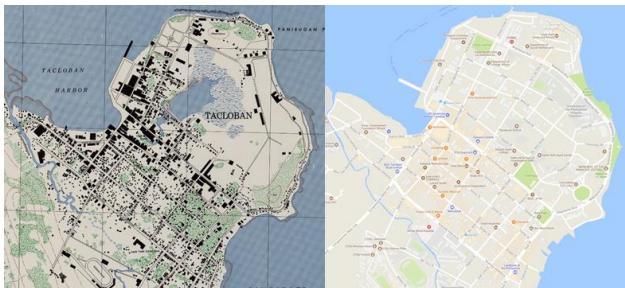
Figure 9. Left - 1944 map of Tacloban City courtesy of the University of Texas Libraries. Right- corresponding Google Map.

Figure 9 shows that there was a pond in the middle of Tacloban City in the year 1944. In the present, this pond is no longer visible. Since the area is an old body of water, locals said that the area is prone to flooding that is why there is also an effort to make proper drainage systems as shown in Figure 10.

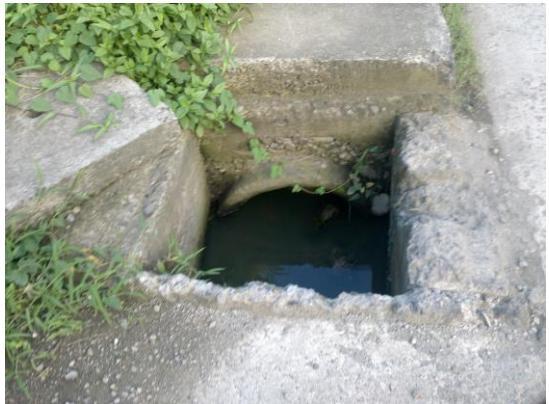
Figure 10. Part of a drainage system around the former pond area in Tacloban City.

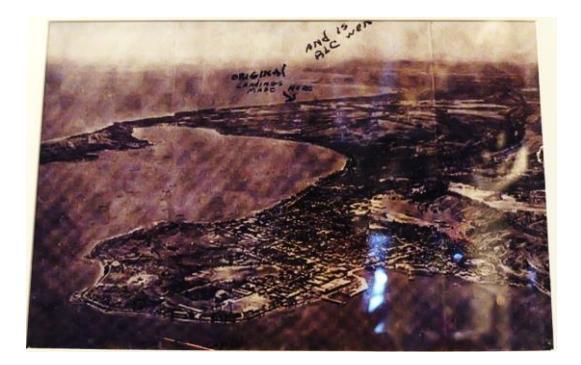
Figure 11. Vintage aerial photograph of Tacloban City displayed in Hotel Alejandrino. A pond can be clearly seen in the moddle of Tacloban City.

While the survey team was scouring local museums and libraries for old Tacloban maps they found a 1940 aerial photograph of Tacloban City (Figure 11) displayed in Hotel Alejandro, one of the oldest hotels in the city. From the photograph, the pond in the middle of the city is clearly visible. Shown in Figure 12 is the trace of the validated vanished pond and reclaimed areas both in the pond and along the shoreline.

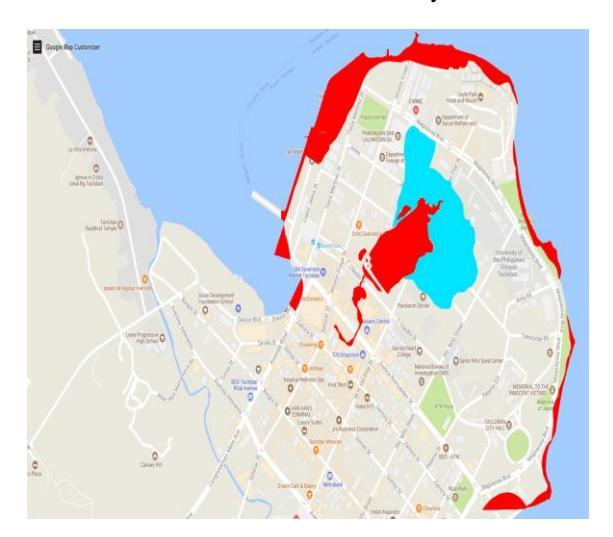
Figure 12. Trace of validated changes in Tacloban City. In the interior: Red - vanished bodies of water, Blue - reclaimed land. Along the coastline: Red – reclaimed land.

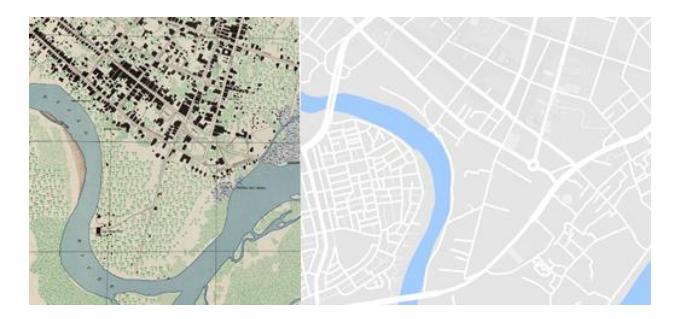
Figure 13. Left - 1944 map showing Davao River courtesy of the University of Texas Libraries. Right - corresponding Google Map.

The missing bodies of water in the Davao maps (shown in Figure 13) are the results of changes in the meandering of the Davao River. Maps from 1944 showed the Davao River flowed towards the eastern part of the city. Presently, the river cut downwards, flowing straight to the sea. The old path of the river dried up and a community was built on top of it. Locals living

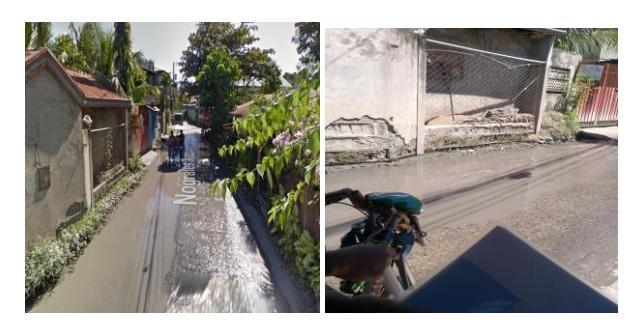
Figure 14. Left - Google Street View image of a street in Davao City. Right - Photograph of the same location during the validation fieldwork.

in that community said that their area is prone to waist-level floods, especially during high tide. Figure 14 shows Google Street View and fieldwork photographs of the same location, in the community built on top of the dried up river. The water remnants indicate the lack of a proper drainage system so flooding has an amplified effect on the community. Shown in Figure 15 is the validated path change of Davao River.

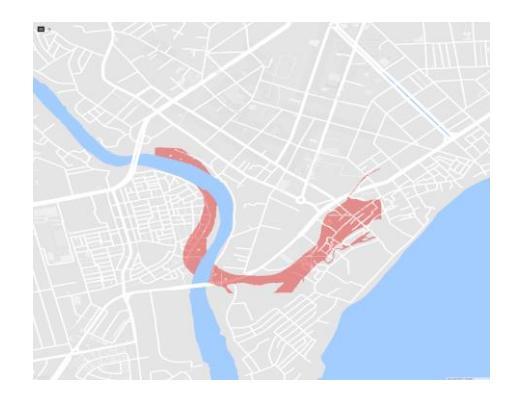
Figure 15. Red - original path of Davao River. Blue - Current Davao River meander in Google Map.

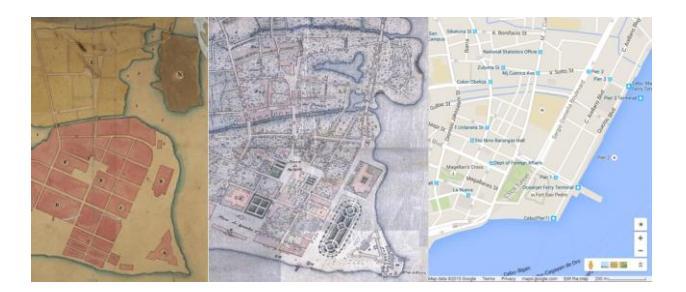
Figure 16. Georeferenced historical maps of Cebu City: Left -1833 map courtesy of the National Archives of the Philippines, Middle - 1873 map retrieved online, Right - Google Map.

Figure 16 shows three maps of Cebu City. The left map shows a large body of water extending towards the ocean on the right side of the map. In the middle map, the waterway closed off and formed a lagoon. And on the right map, the lagoon disappeared completely. The fieldwork team surveyed the area of the missing lagoon and found out that there is still a body of water (shown in Figure 17) passing through the south side of the original lagoon. A whole community has taken residence in the

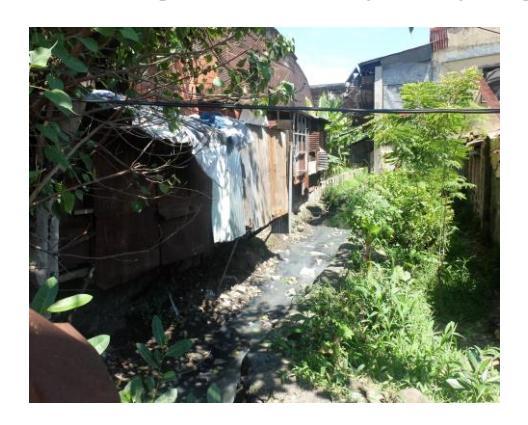
Figure 17. A small creek on the south side of Tinago. This creek does not appear in Google Maps.

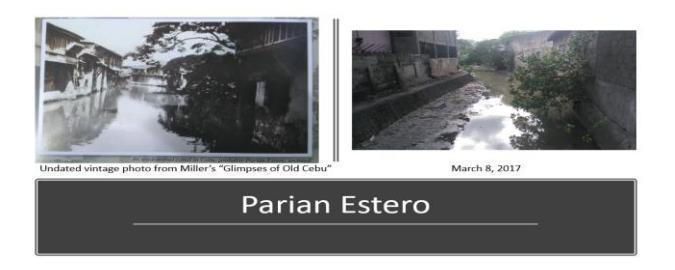
Figure 18. Left - An undated photo of an estuary from Miller's "Glimpses of Old Cebu" possibly showing Parian Estuary. Right - Image of the same estuary taken during fieldwork.

Figure 18 shows the Parian Estuary in Cebu City. This image shows an example of the reduction of the size of old bodies of water, not necessarily disappearing. The vintage photograph appears to be Parian Estero which used to be wide enough for bancas or small boats to pass through. The image on the right meanwhile is Parian Estero (estuary) at the time of field work. It appears narrower and shallower. Finally, Figure 19 shows the validated traces of lost bodies of water in Cebu City.

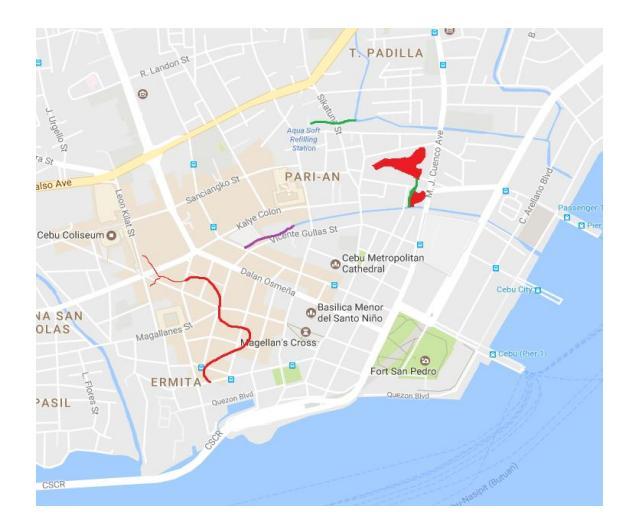
Figure 19. Red - lost bodies of waters in Cebu City. Green - still existing estuaries. Violet - Estuaries that have gone underground.

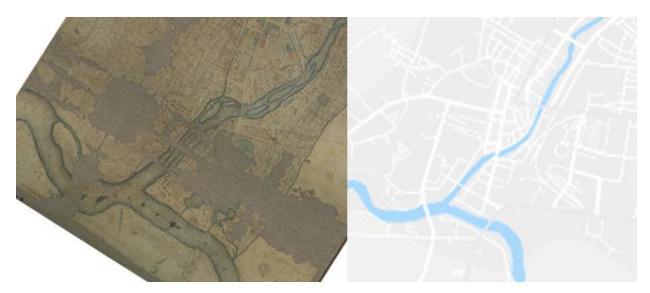
Figure 20. Left - Georectified 1890 map of Naga City, Bicol Province courtesy of the National Archives of the Philippines. Right - same area in Google Map.

Figure 20 shows the georectified historical map of Naga City. The fieldwork team confirmed that main parts of the Naga river are still present but the islands within the river that are seen from the historical map are not. The old waterway jutting from the river going northwards is no longer present. That waterway was believed to be man-made according to Naga City historian Dr. Danilo Gerona and was used to transport goods needed by the bishop. At the end of this waterway is the Naga Cathedral. Another observation is that the local government already started posting signs (shown in Figure 21) warning the locals about the dangers of the area. The sign directly translates to "Warning! This area is flood prone. Be cautious! Each life is precious."
