6.1 Case study: a concrete arch dam in France

6.2 Case study: a concrete cooling tower in France

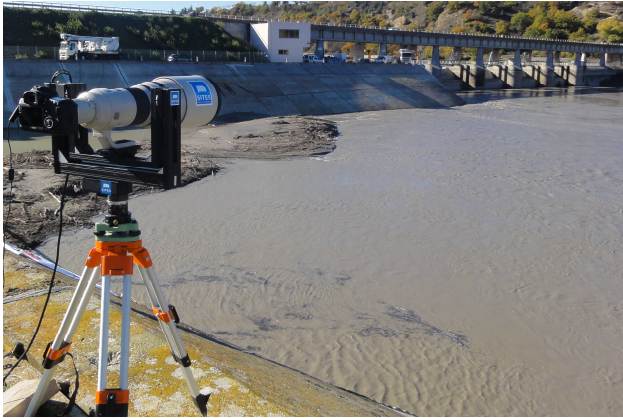
Figure 6. High resolution camera, 600 mm lens and panoramic head facing upstream wall of a dam

The LIDAR, the SCANSITES[®] and/or the photogrammetric head are set at different locations in order to cover the structure's entire surface. The high gain video camera and quality lenses of the SCANSITES[®] allow it to work with low ambient luminosity. The LIDAR, for its part, can work without light.

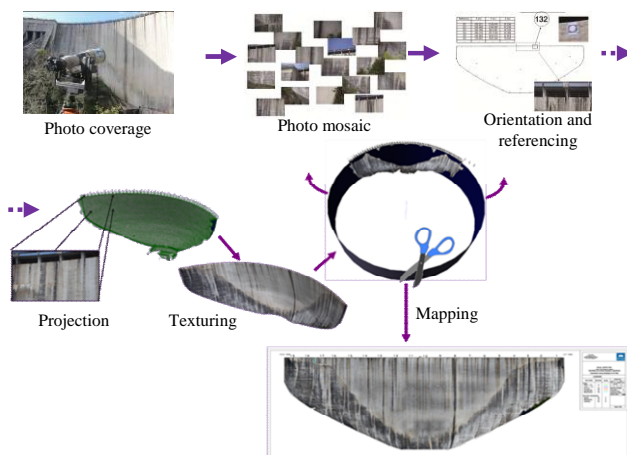
Figure 7. Block diagram of orthophotography operations

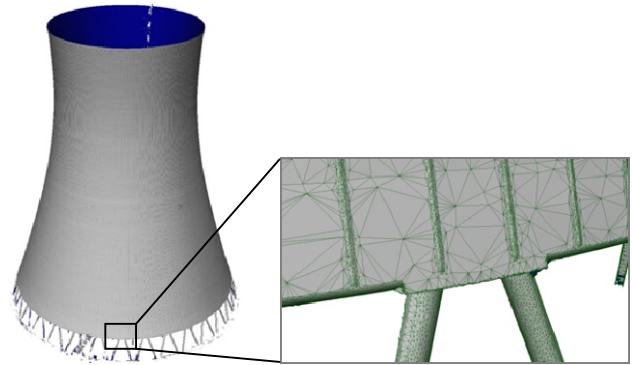
Figure 8. Triangular meshing

With the LIDAR, a complete scan is realized. Based on this point cloud, a triangular meshing "Figure 8" is generated and converted in a 3D shape. The first use of this 3D shape is to allow the SCANSITES[®] to locate the defects in 3D and/or to project the photos in order to create the very high resolution orthophotography.

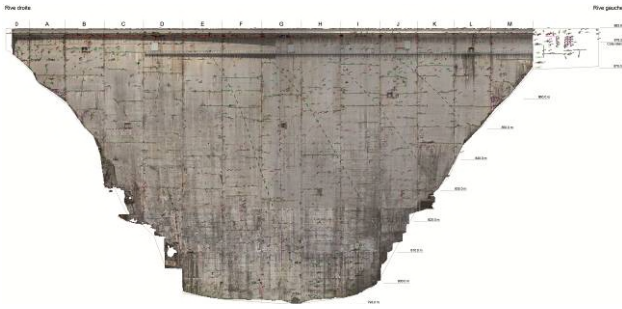
Figure 9. Orthophotography of the downstream wall with defects overlaid

The SCANSITES3D[®] method was applied to a large dam located in France. Its main figures are a height of 95 meters and a crest length of 200 meters. The average distance between the points of view and the downstream facing was about 100 meters. The aim of this job was to connect the geometric deflections to the defects surveyed. The LIDAR survey recorded 70 million points, and the defects' total quantity was near 4000. "Figures 9, 10"

The focal lens of photogrammetric coverage has been adjusted between 100 and 500 mm in order to produce an orthophotography of 1.5 billion pixels with a pixel size of 5 mm. The detailed inspection was performed by the SCANSITES[®] tool with a focal length of 1000 mm.

The defects and photogrammetric coverage have been mapped using a cylindrical projection based on the mean cylinder of the downstream wall.

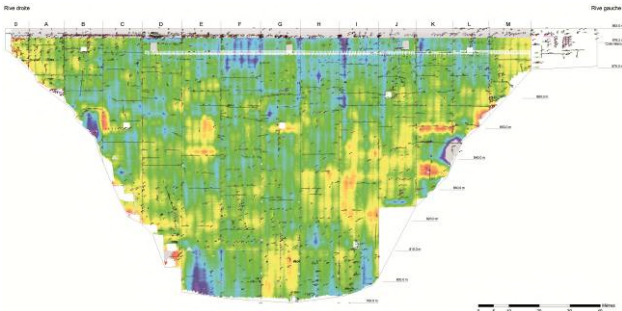
Figure 10. Map overlaying deflection/defects and magnifying

The first step is to compare the structure's 3D shape to the theoretical shape or to a previous survey. The 3D deflections are extracted and a map is generated. "Figures 10, 12" Two ways of representation are possible. One is a coloured map: each colour depends on the deflection value. The other way is to carry out a contour line representation.

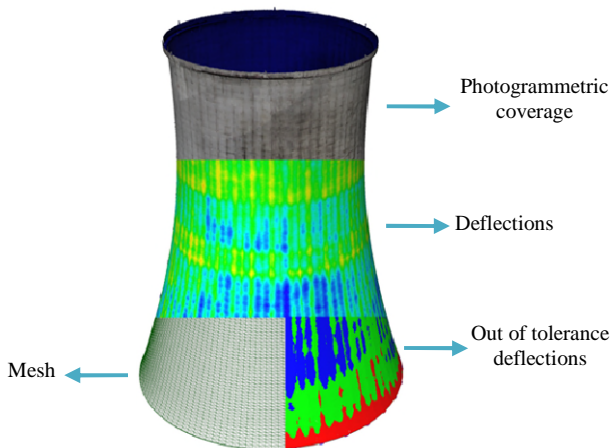
Figure 11. Representation of 3D model, deflections and photogrammetric coverage

The aim of the job was to get the tower's geometric deflection and an accurate visual inspection with a global photogrammetric coverage "Figures 11 and 12".

As carried out on the previous case study (dam), a LIDAR point cloud was generated representing 150 million points. In parallel, we covered the whole shell with high resolution pictures, projected it on a 3D shape, and then on a projection cone, for a total quantity exceeding 25 billion pixels.

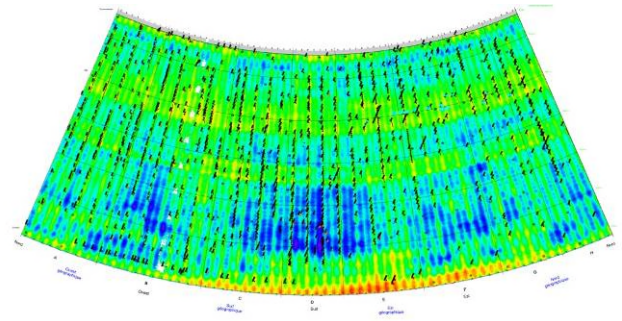
Figure 12. Map overlaying deflection/defects and magnifying

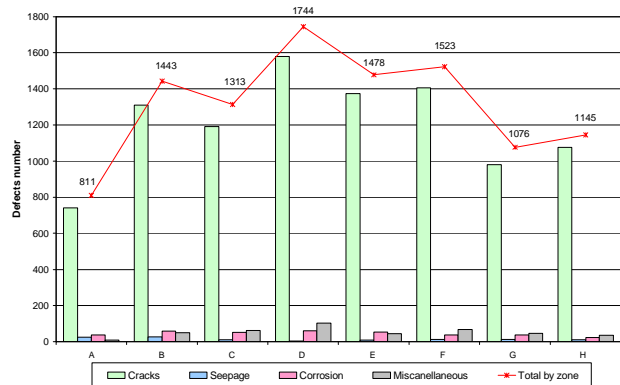
Figure 13. Number of defects by family and zone

Concerning the visual inspection, the traditional way is to produce a sketch based on a close inspection (rope access) or binocular observations. The consequent difficulties of these methods are to get a good location of the defects and their evolution. SCANSITES3D® provides some digital results: a scaled defect map and defects database. The first result is to produce an accurate report emphasizing defects evolution between two inspections, and the number of defects divided by zone "Figure 13".

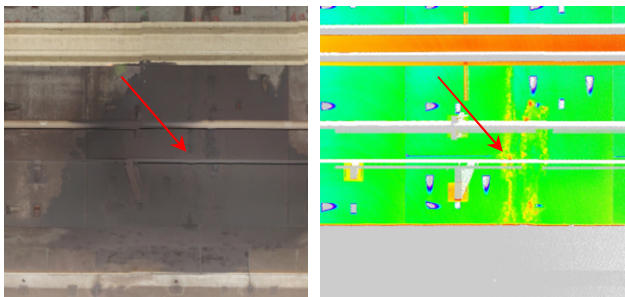
Figure 14. Water leakage and concretions (left : orthophoto – Right : distortion map)

The view rendered and referenced is useful to detect leaks, concretions and parts of the concrete ready to fall. “Figures 14, 15 and 16”.

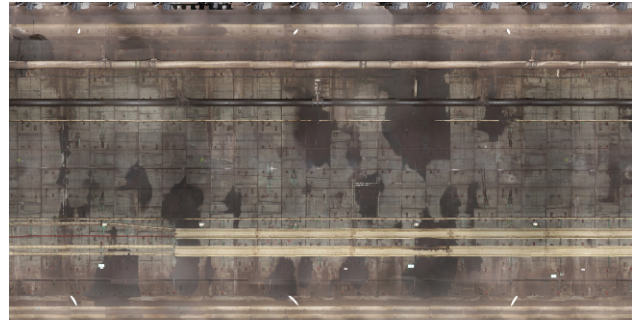
Figure 15. Orthophotography of Tunnel (cylindrical projection)

A version of the SCANSITES3D® has been adapted for tunnel auscultation. The tools are about the same: short range laser scanner, digital camera with wide lens, thermographic camera and odometer mounted on a trolley. The data is mapped on a mean cylinder representing tens of kilometers of tunnel wall enabling direct access to the visual aspect, distortions linked and position in the tunnel (kilometer point – KP).

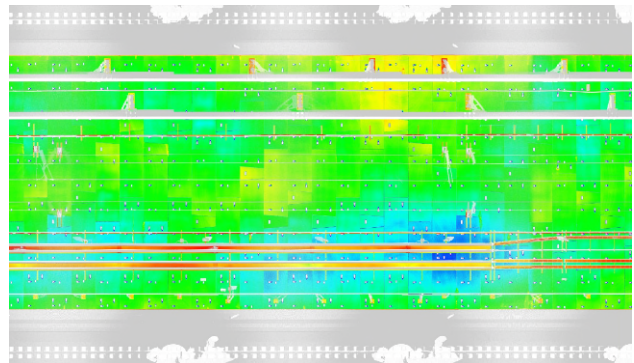
Figure 16. Distortions of Tunnel (cylindrical projection)
